**Draft Arborist Report**

**3720 Hopyard Road  
Pleasanton, CA**

**PREPARED FOR  
Anabi Development, LLC  
Upland, CA**

**May 2019**

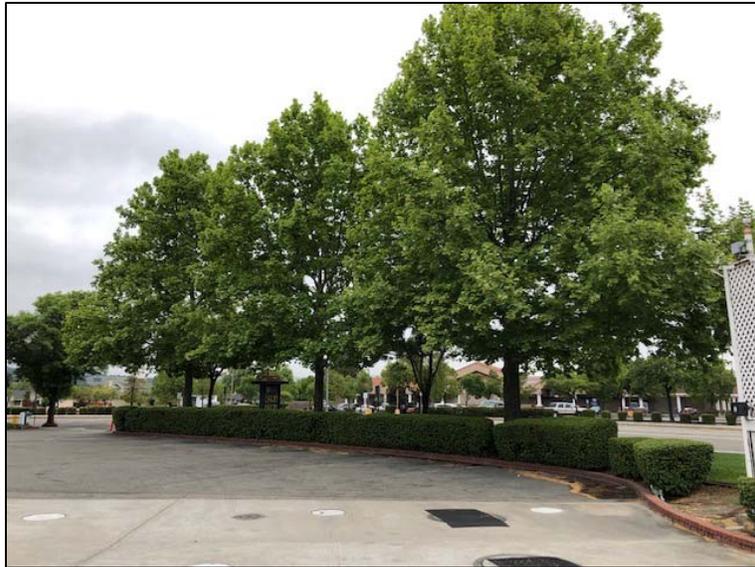
Four (4) London planes were assessed on the site. Three of them (tree #55-#57) were planted in turf in an irrigated island and formed a nice group along W. Los Positas Boulevard. All 3 trees were in excellent condition. They were semi-mature to mature in development and ranged in size from 16" to 22" in diameter. (**Photo 1**). London plane #64 was a 10" street tree planted along Hopyard Rd. and was in moderate condition.

**Photo 1:** London planes #55-57 (R to L) formed the backbone of the landscaping at the corners of W. Las Positas Blvd. and Hopyard Road. All 3 London planes were in excellent condition and had good form and structure.

London plane #55 is currently proposed for preservation. However, successful preservation of the tree will require the location and/or the design of the bioretention area proposed immediately east of the tree be adjusted to provide a minimum of 10' between the tree trunk and edge of excavation.

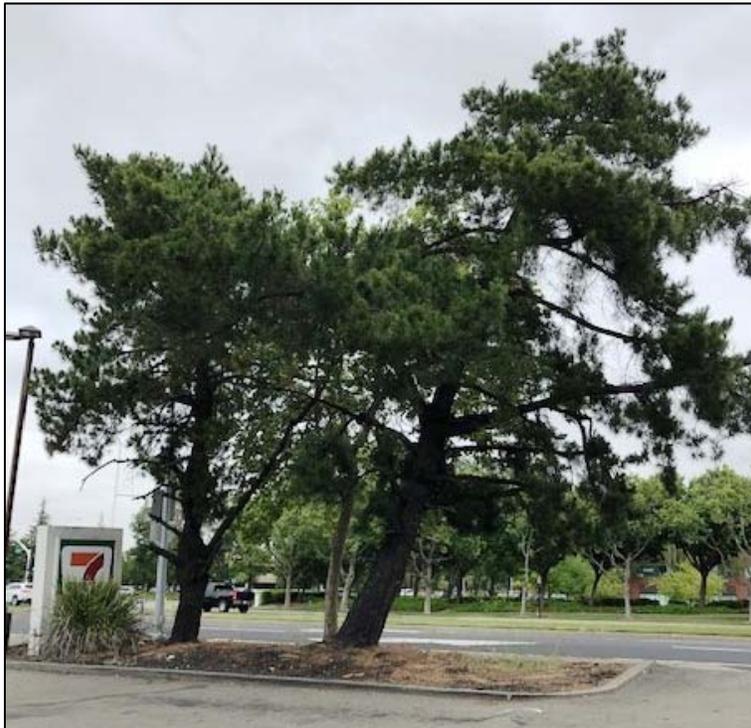
Two (2) Monterey pines were growing in the southeast corner of the site. They were semi-mature and were located in an unirrigated landscape island between the parking lot and sidewalk along Hopyard Road. Monterey pine #65 was 18" in trunk diameter and #66 was 21" and leaned to the south. They were both in poor condition and showed signs of being drought stressed (**Photo 2**).

**Photo 2:** Looking northeast at Monterey pines #65(L) and 66 (R). Both trees were in poor condition, with lower branches dead. Monterey pine #66 leaned strongly to the south and had dieback of branch tips consistent with the fungal pathogen pine pitch canker (*Fusarium subglutinans*).
