ARBORIST REPORT

3192 SANTA RITA ROAD

PLEASANTON, CALIFORNIA

July 8, 2013

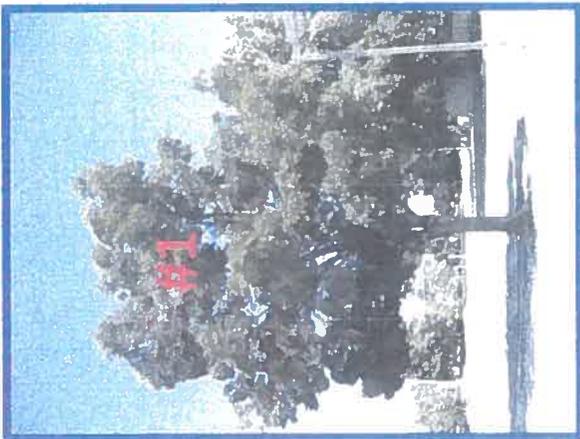
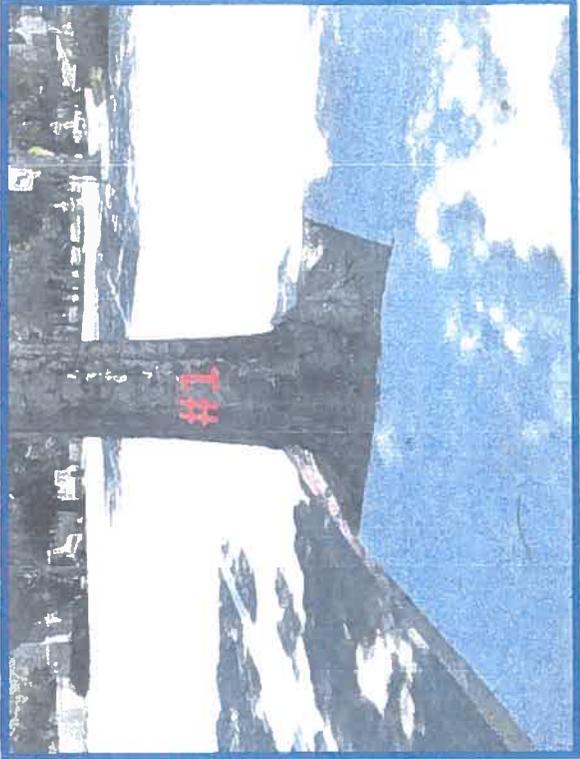
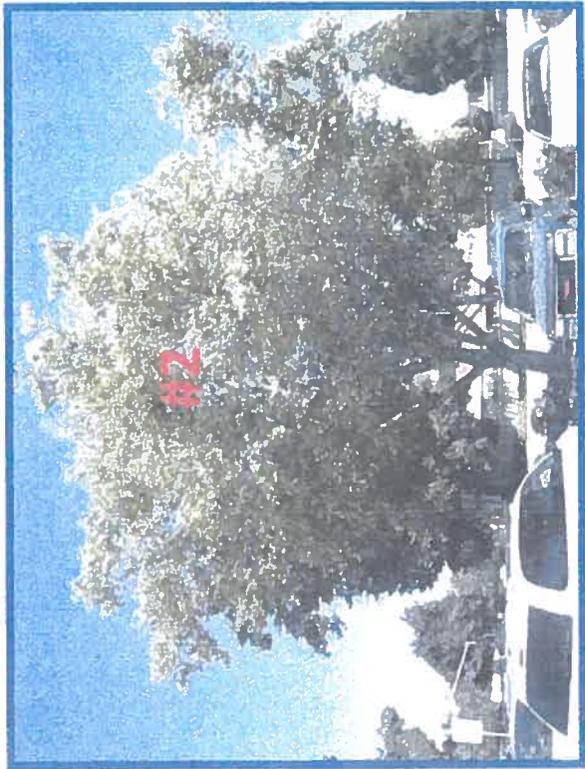
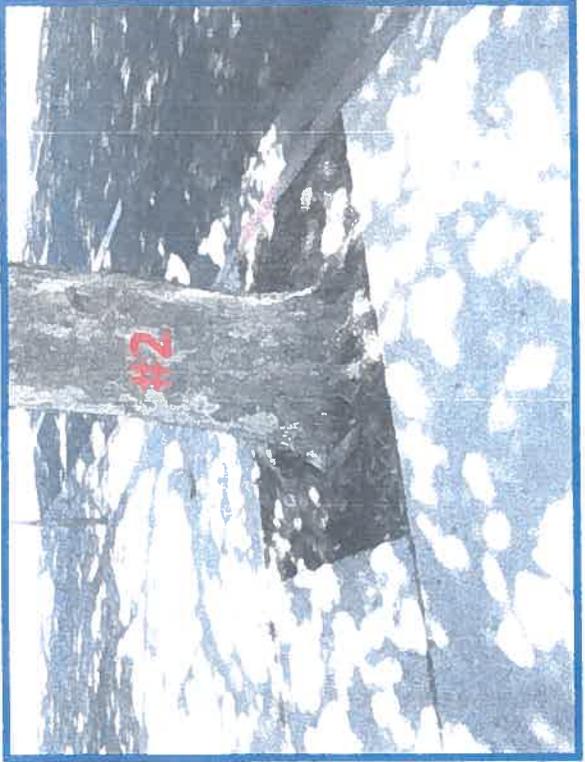
Page C-1: Trees #1 and 2

Comments: Street tree. Trunk within a rectangular-, nearly square-shaped planter. Sidewalk raised and repaired in past. Current damage includes a section of walk (road side) being raised and the adjacent curb being slightly damaged. Main trunk divides into codominant leaders at nine feet high and forms a weak attachment. Deadwood in canopy from ash blight. Has a large, pronounced girdling root surfaced around the trunk's base along the sidewalk side.

Comments: Street tree. Trunk within a rectangular-, nearly square-shaped planter. A girdling root was partially cut sometime ago. On road side, the sidewalk is raised and curb somewhat damaged.

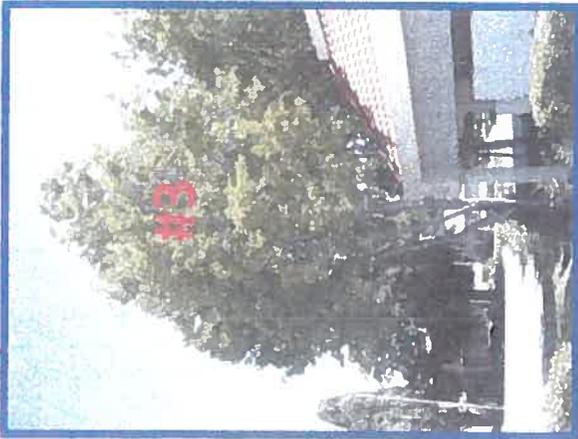
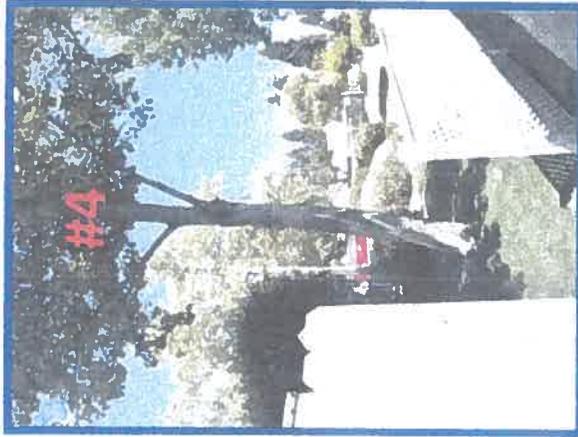
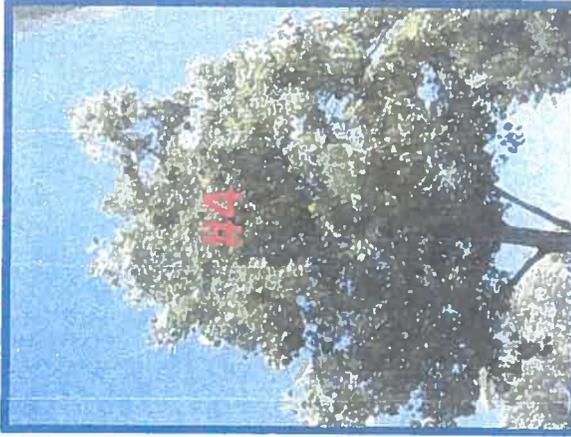
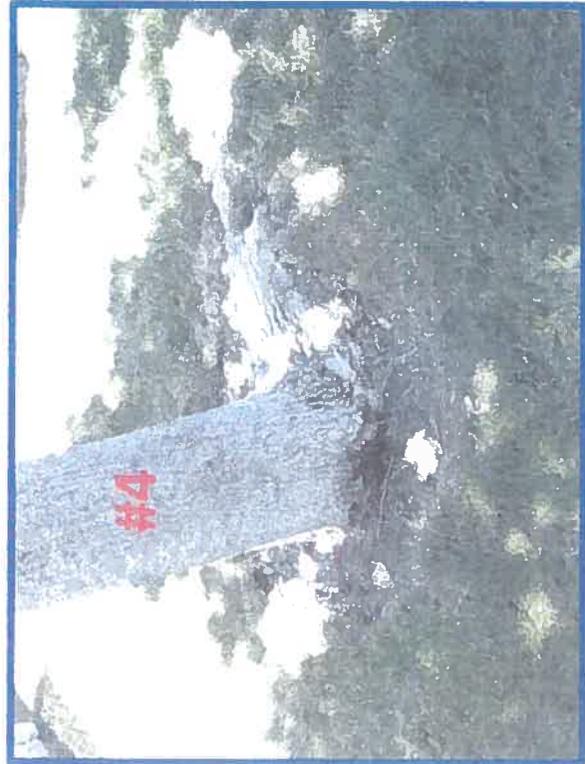
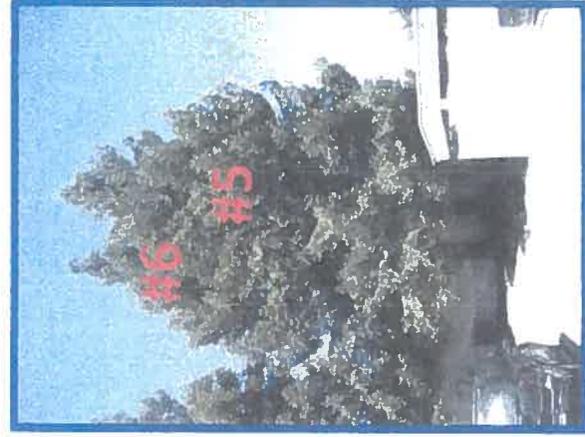
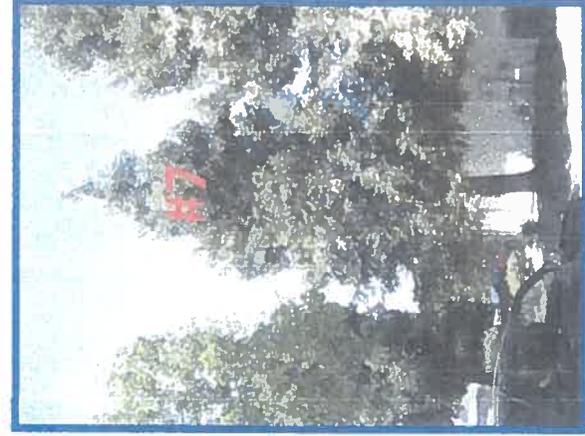
Page C-2: Trees #3 thru 7

Comments: Trunk is situated on adjacent property, and canopy overhangs site by a few feet. Has an asymmetrical canopy that has been significantly raised. Formed by a main trunk that divides into multiple leaders.

Comments: Trunk is situated on adjacent property, and canopy overhangs site by five or more feet. Canopy has been significantly raised. Has a pronounced buttress root that surfaces and is directed towards the project site. Decay visible at trunk's base, and possibly has a girdling root along the opposite side.

Comments: Has a contiguous canopy with #6. Adjacent to PG&E underground vault.

Comments: Has a contiguous canopy with #5. Adjacent to PG&E underground vault.

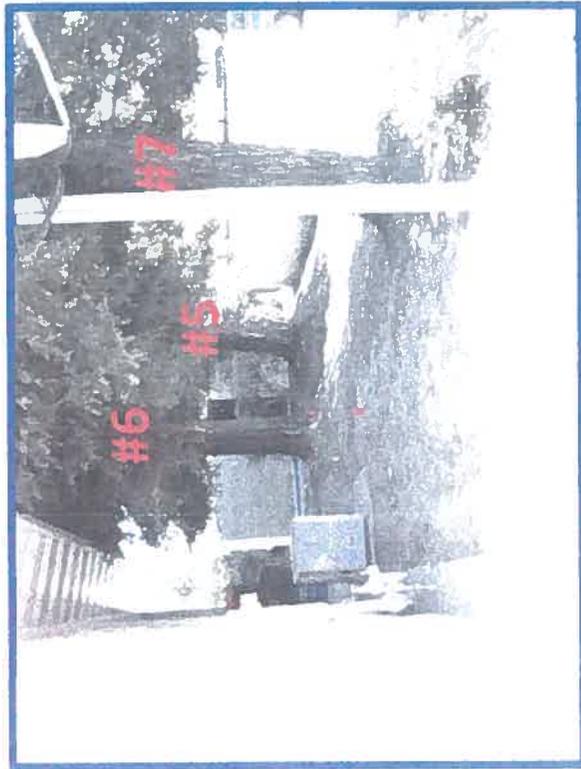
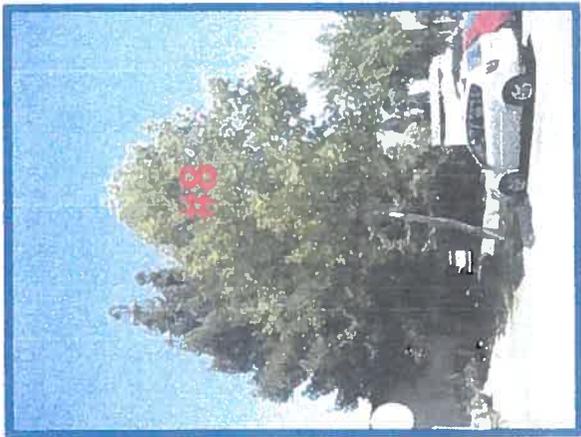
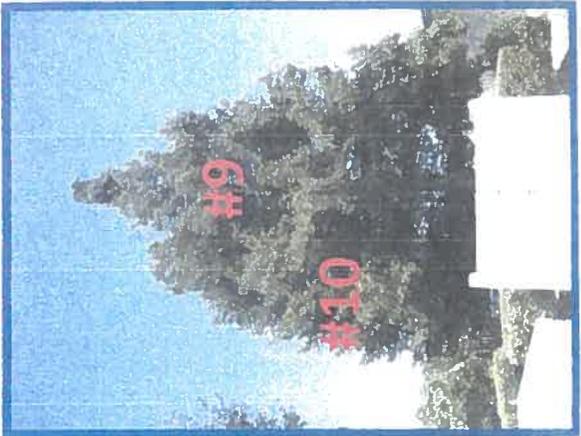
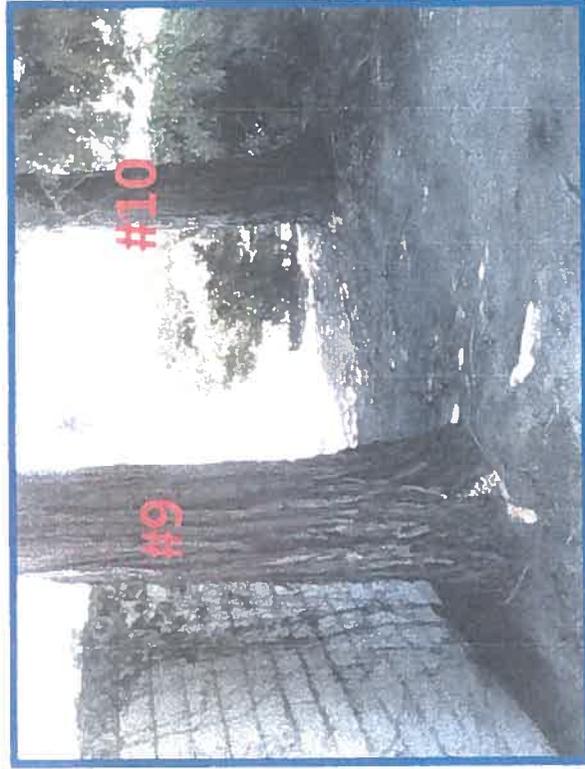
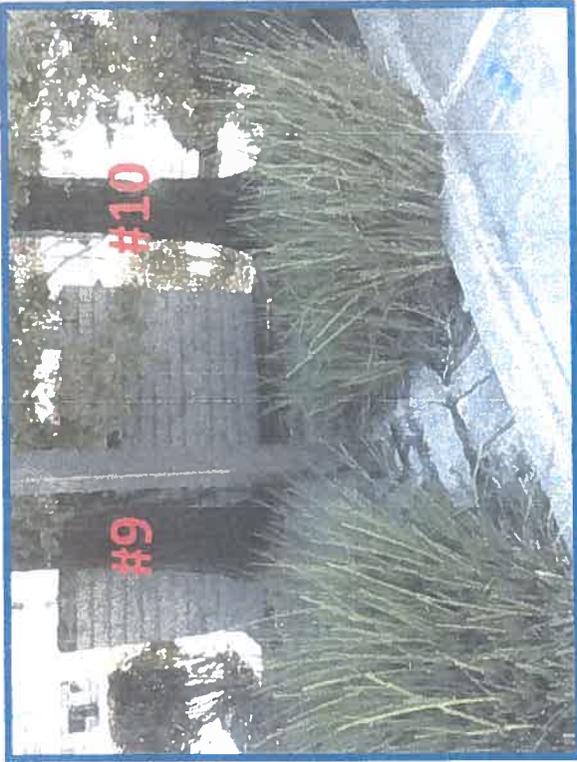
Page C-3: Trees #5 thru 10

Trees #9 and 10 are coast redwoods and considered "heritage trees," #9 for its trunk diameter and height, and #10 only for its height. The proposed drive aisle for the future car wash would excavate into their root zones, and potentially within only a few feet of the trunks when considering overexcavation to form and pour the new drive. If this impact was to occur, the trees would become exposed to premature decline and possible uprooting (due to the loss of numerous buttress roots serving to anchor the trees into the ground).

Comments: Is situated on adjacent property. Small girdling roots are developing.

Comments: Has a contiguous canopy with #10. Prominent buttress root in direction of proposed drive aisle. Base of trunk is two feet from existing trash enclosure wall. Some of the canopy's outer foliage is scorched (appears to be from excessive heat). Also appears to be drought-stressed (due to sparse canopy). Has small girdling roots developing. Trunk appears to span shared property line.

Comments: Has a contiguous canopy with #9. Base of trunk is 6.5 feet from trash enclosure wall. Has a sparse canopy likely due to the tree being drought-stressed.

Should #9 and/or 10 be retained with a reasonable degree of assurance for their survival and stability, I recommend the drive aisle is setback by *at least nine feet* from the base of their trunks, and overexcavation beyond the proposed drive aisle edge is reduced to **12 inches**. Any additional distance from the trunks would only decrease the risk of potential impacts.

14. The **light post footing** at trees #9 and 10 should be carefully removed to avoid inadvertently damaging the trees' roots.
15. The **staging area(s) and routes of access** should be established beyond TPZs.

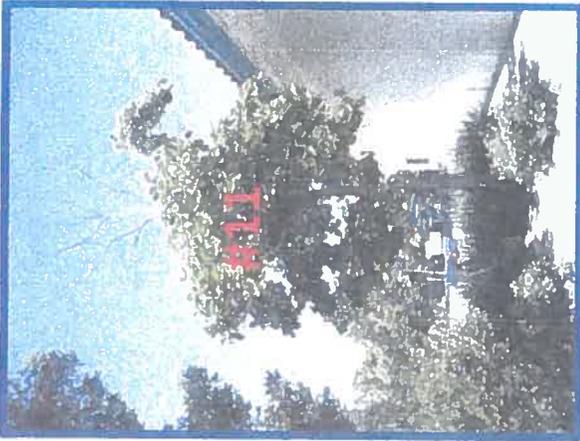
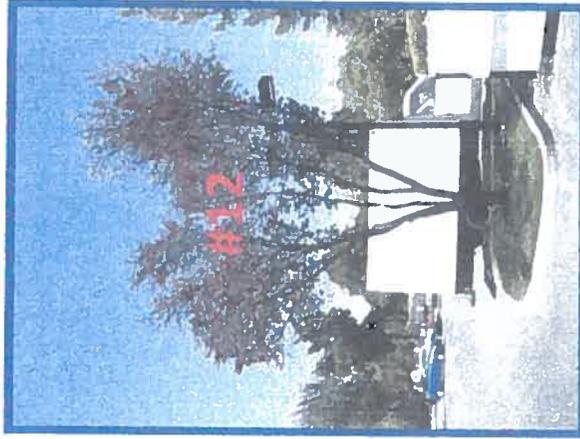
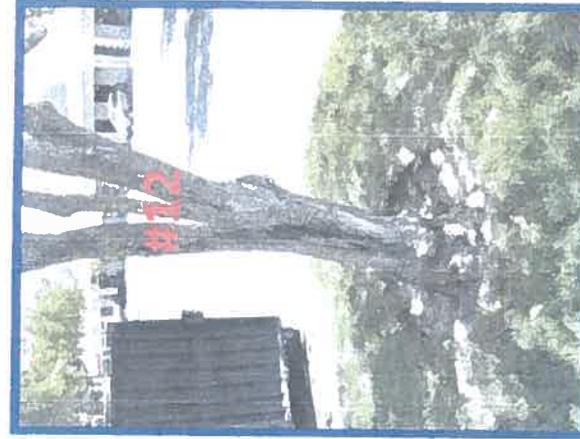
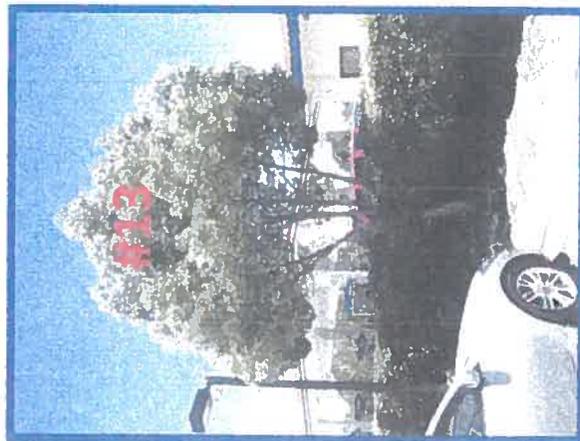
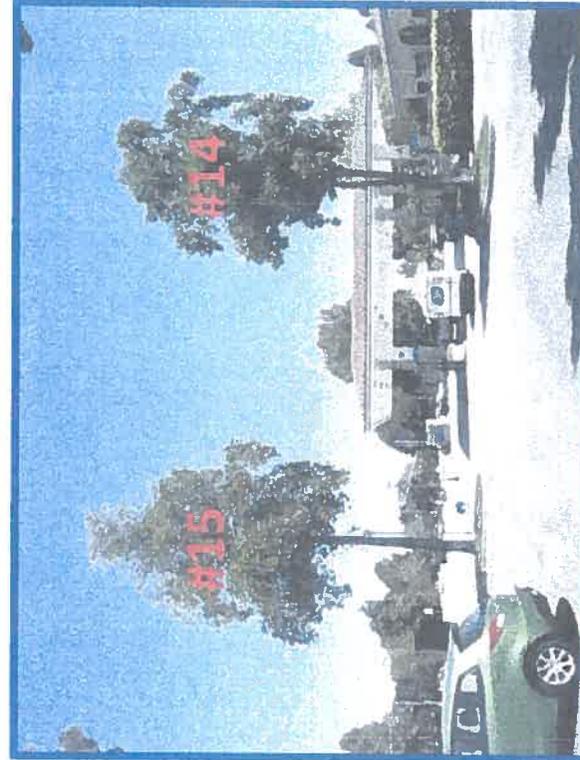
Page C-4: Trees #11 thru 15

Tree #11 is a small, non-heritage tulip tree that has a dying top (nearly half of the tree), and its removal is appropriate regardless of the proposed project.

Comments: Top eight feet is dead, and has numerous dead branches in lower canopy.

Comments: Sparse and one-sided canopy. Large stem wound along lower trunk, and substantial wounds (with decay) along all leaders. Is situated on adjacent property.

Comments: Multi-trunk tree. Umbrella-shaped canopy. Is situated on adjacent property.

Comments: Has deadwood throughout canopy. Small girdling roots developing. Main trunk divides into codominant leaders at nine feet high. Within a narrow planter and canopy has been significantly raised. Is situated on adjacent property.

Comments: Within a narrow planter and has girdling roots. Canopy is sparse and has been significantly raised. Is situated on adjacent property.
