Tree Report
Anton Hacienda
5725 West Las Positas Blvd.
Pleasanton, CA

PREPARED FOR
St. Anton Partners
1801 I Street, Suite 200
Sacramento, CA 95811

PREPARED BY:
HortScience, Inc.
325 Ray St.
Pleasanton, CA 94566

August 16, 2012

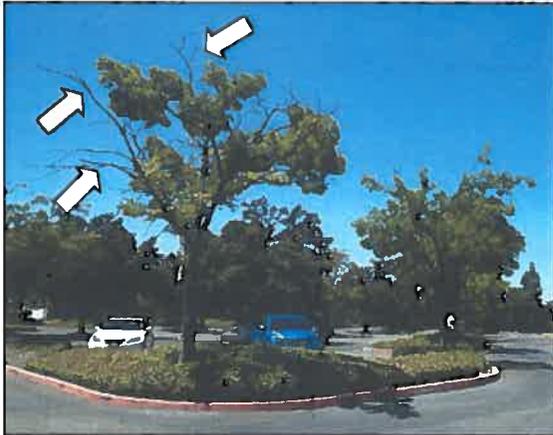
Chinese hackberry trees, the most common species, were located in planters in the parking lot. Most of the trees were in fair condition. The trees generally had good form and structure. Trees in fair condition had thin crowns, branch dieback and sunscald (Photo 1).

Photo 1 (above): Many of the hackberries in parking lot island had dead branches as illustrated by #101 (left) in poor condition, and 102 (right) in fair condition.

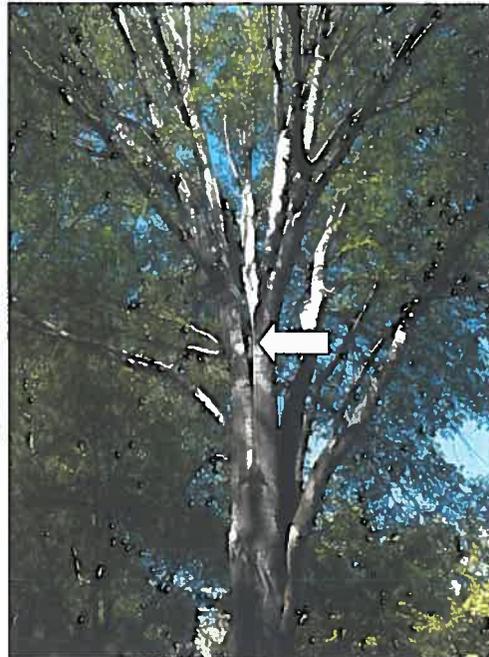
Photo 2 (right): Evergreen ash #35 split at a weak attachment (arrow). Further failure of this tree is likely.

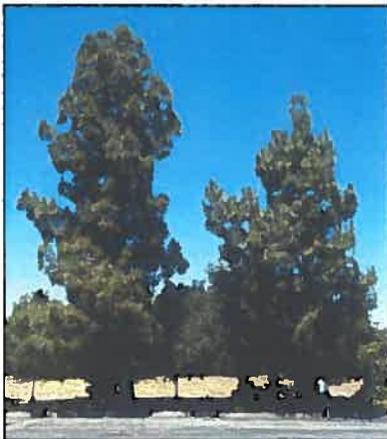
Canary Island pines were located in a narrow planter near the flood control channel. All but one was in good condition (Photo 3).

Photo 3 (left) Canary Island pines #80 and 81 were in good condition.

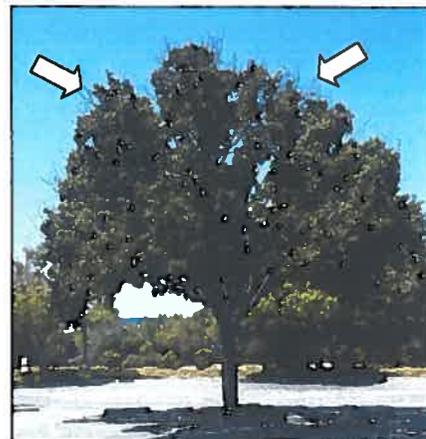
Photo 4 (right) Callery pear #109 was surrounded by pavement. Physiological stress is noted by the branch tip dieback present.

Callery pears were located in the planters in the parking lot. They were all in fair condition. The trees had fair structure, multiple attachments with included bark and some branch dieback (Photo 4).

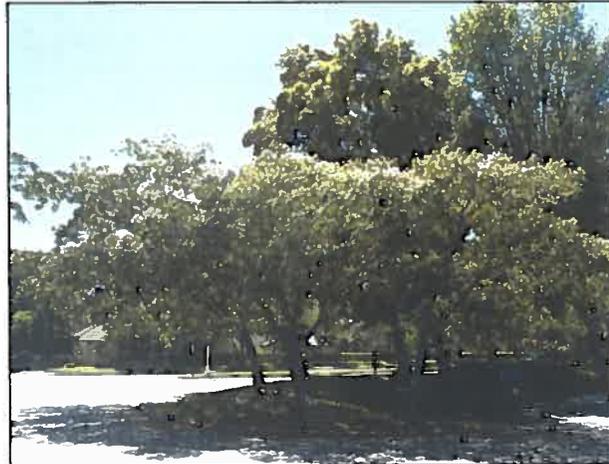
Silk trees were located in the turf area at the existing entrance on W. Las Positas Blvd (Photo 5). The trees were in good to fair condition. Some had suppressed crowns due to competition with neighboring trees, trunks that leaned and surface roots. The surface roots were damaged from maintenance activities resulting in some decay.

Photo 5: Silk trees #24-26 at the entrance to the site on West Las Positas Blvd.

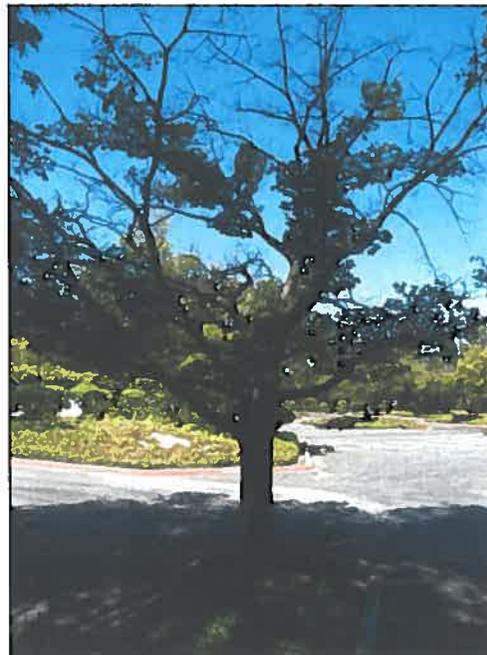
Photo 6: Although the development plan allows for preservation of hackberry #32, it is in poor condition and is not expected to survive. We recommend removing this tree.
