# PRELIMINARY ARBORIST REPORT

Roselyn Estates II  
Pleasanton, CA

August, 2012

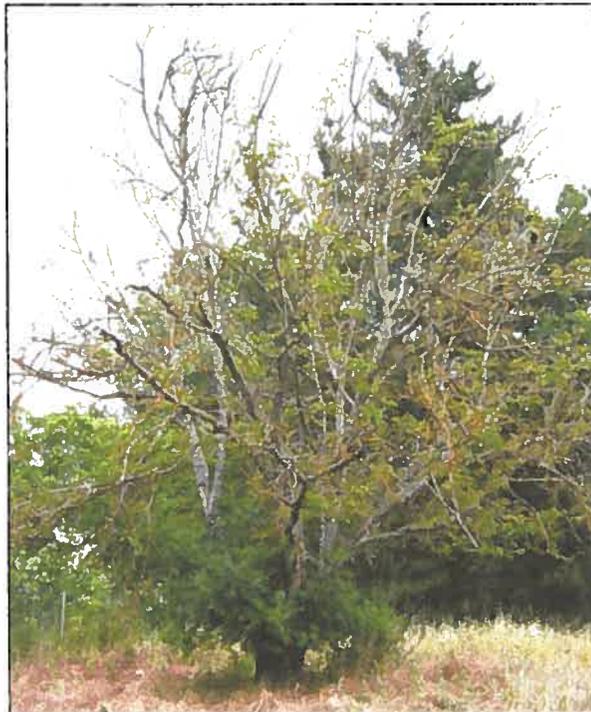
**Photo 1:** English walnut #26 was in poor condition, with a dead top. The black walnut root stock was sprouting vigorously from the base.
