**Tree Report
4202 Stanley Blvd.**

Prepared for:
**Ponderosa Homes Inc.
6130 Stoneridge Mall Road, Suite 185
Pleasanton CA 94588**

Prepared by:
**HortScience, Inc.
325 Ray Street
Pleasanton, CA 94566**

**May 2012
Revised June 18, 2013**

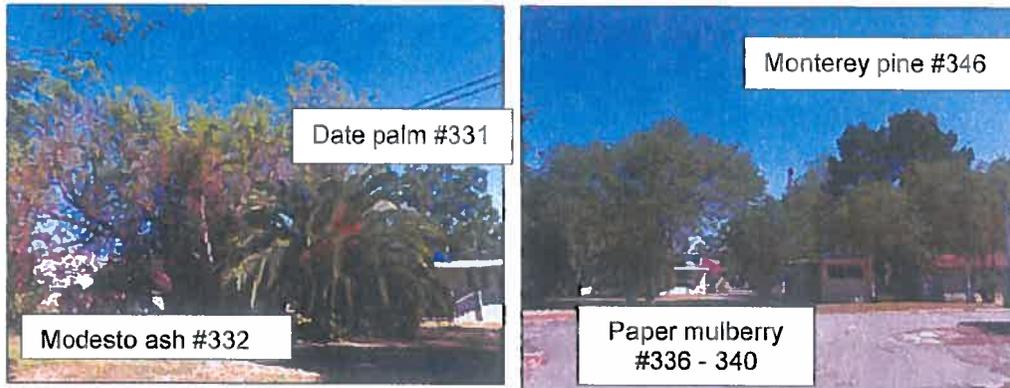
Photo 1. Typical appearance of trees in the landscape. Left. Modesto ash #332 had been topped to provide clearance from the overhead power lines. Right. Paper mulberries had been topped.

Six (6) paper mulberries were similar in form to the Japanese privets: multiple stems that arose at or near the base and a history of topping (Photo 1). The largest stem was 17". Paper mulberries #338, 339 and 340 were in poor condition; #367, 337 and 344 were fair.

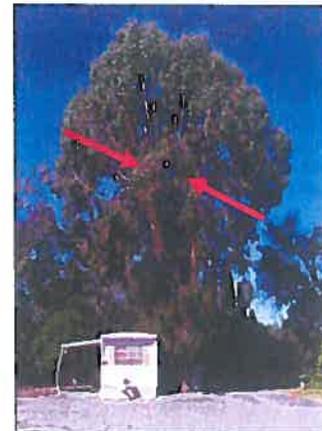
Photo 2. Although blue gum #341 had a dense canopy, the tree had been topped in the past (red arrows).

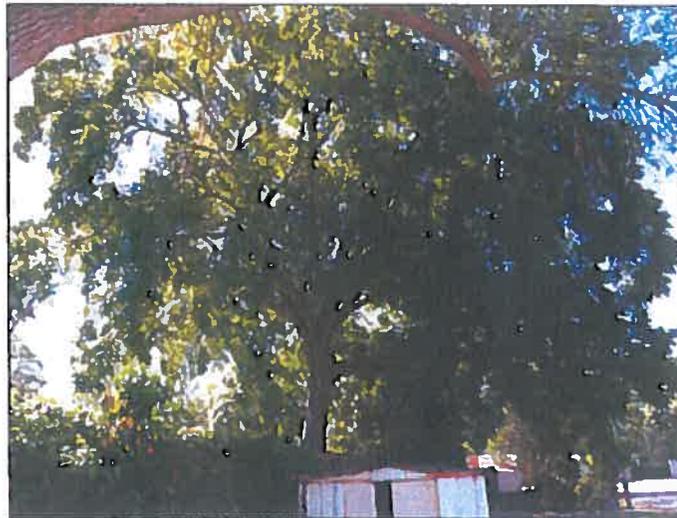
- Paradox walnut #354 was a large mature tree with a diameter of approximately 36" (Photo 3). Overall condition was good. The two main stems had separated and a gap was present in the tree's canopy. The canopy extended approximately 35' into the project area and hung to 6'.

Photo 3. Paradox walnut #354 was located on an adjacent property but a large portion of the tree's canopy extended into the proposed project area.

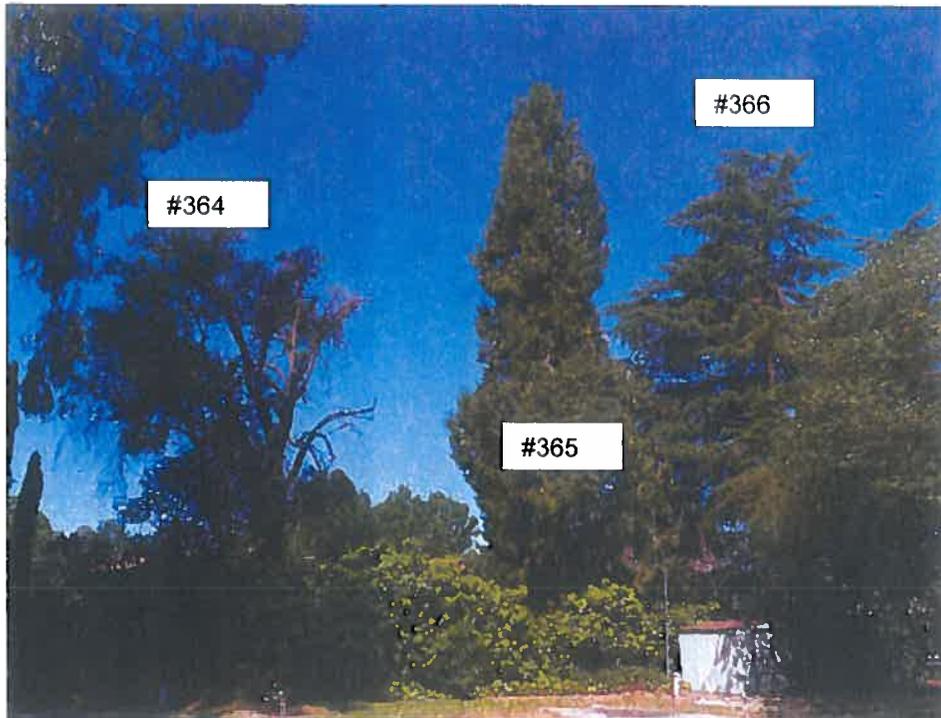
- Siberian elm #364 was poor in both form and structure with extensive dieback in the crown (Photo 4). I estimated the trunk diameter to be near 25".
- Calif. incense cedar #365 was approximately 28" in diameter and 10' from the property line (Photo 4). Overall condition was excellent.

- Deodar cedar #366 was approximately 30" in diameter and 10' from the property line (Photo 4). Overall condition was excellent. The canopy extended 10' into the proposed project area.

Photo 4. Siberian elm #364, Calif. incense cedar #365 and Deodar cedar #366 were located on the adjacent property to the west.
