ARBORIST REPORT

California Center
Pleasanton, CA

October 2012

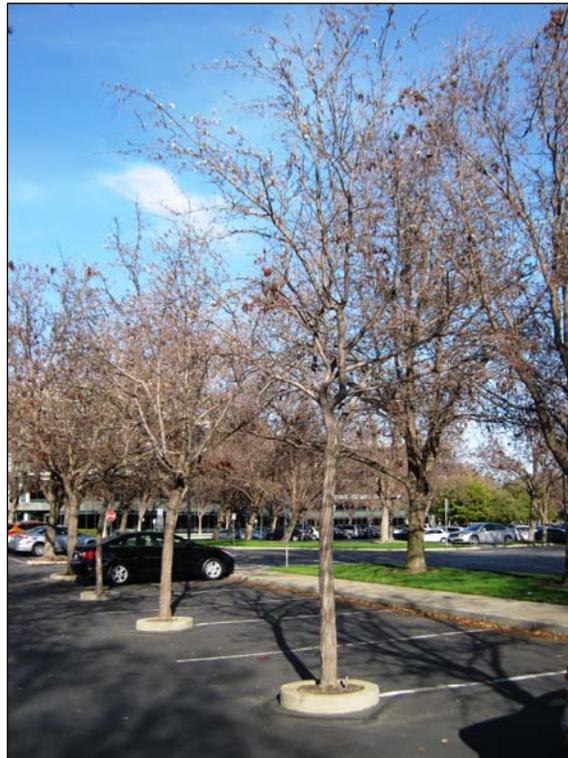
There were 12 species represented at the site. The most frequently occurring species was callery pear, with 166 trees or 36% of the population. One hundred fifteen (115) of the trees (69%) were in good condition, 49 were in fair (30%) and two (2) were in poor (1%). In general, the species had been planted in the larger end-cap islands or landscaped areas throughout the parking lots, where adequate soil volume and moisture were available. Where the tree had been planted in small islands, drought stress and stunted growth resulted (**Photo 1**).

Photo 1: In general, callery pears had been planted in larger end-cap islands or landscaped areas (background). Where the species had been planted in small parking lot islands (foreground), drought stress and stunted growth were common.

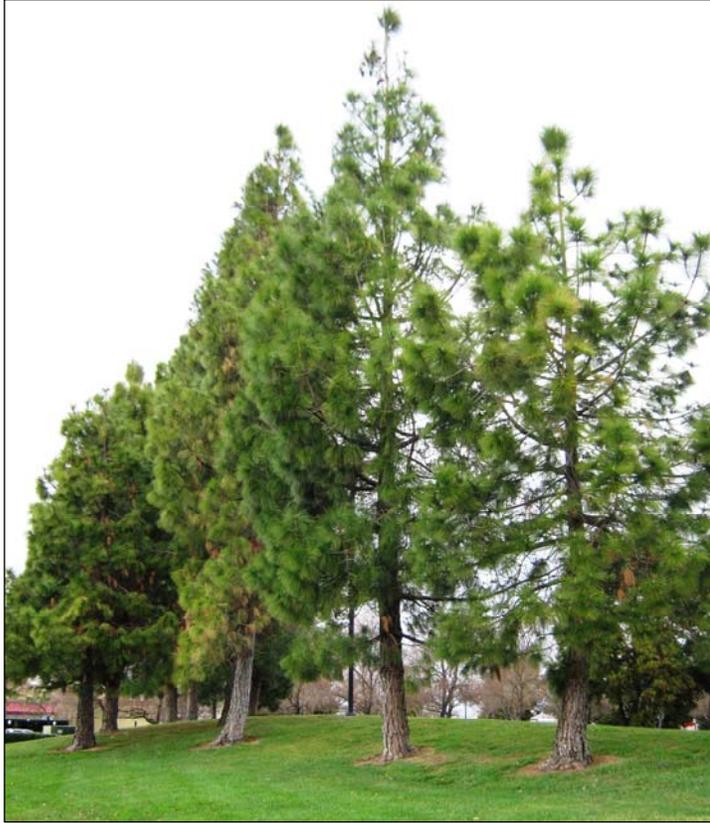
Photo 2: Canary Island pines, blackwood acacias and Chinese tallows had been planted in the southwest corner of the site. Canary Island pines and blackwood acacias were growing on the soil berm and Chinese tallows were planted in the Rosewood Dr. frontage landscape.
