Reddy Residence
3737 W. Ruby Hill Drive
Lot O-02

Side-by-side Comparison of
Approved Plans and As-built
Condition

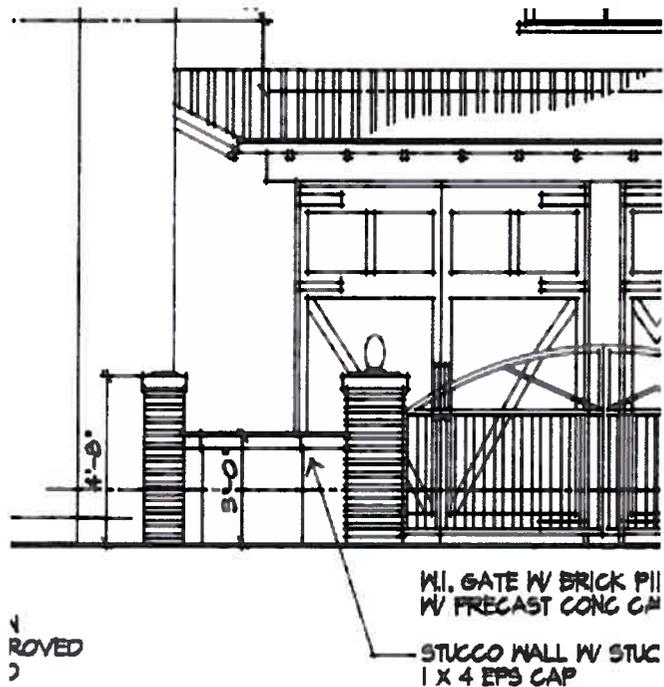
Reference: Sheet 4 – Front Elevation

Columns depicted on final approved drawings (6.30.10). Height shown at 56".

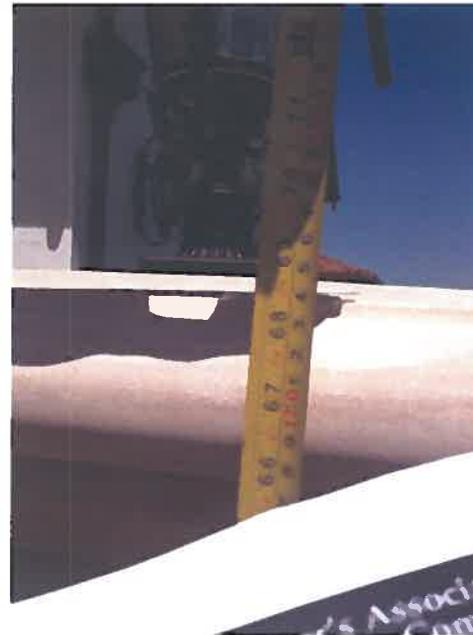
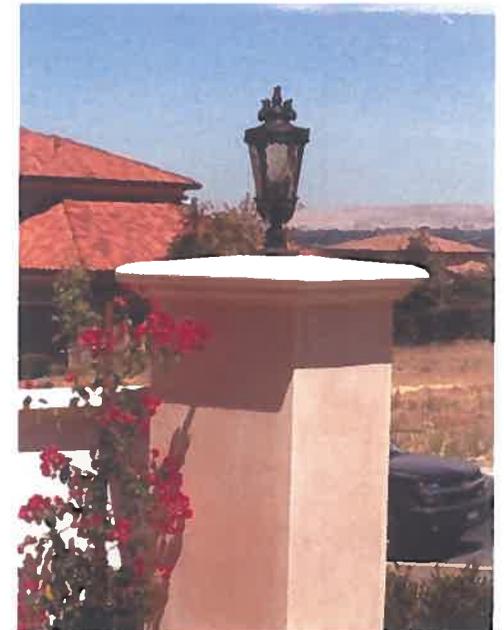
COLUMNS AT AUTO COURT

As-built condition. ADC approved variance of max height of 60". Column measures 68" from grade, w/14" light fixture on top.

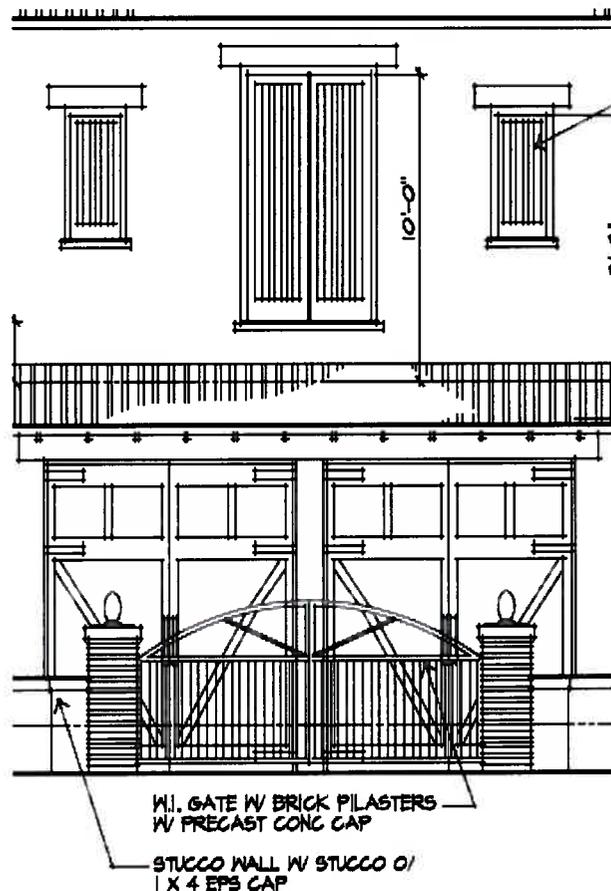
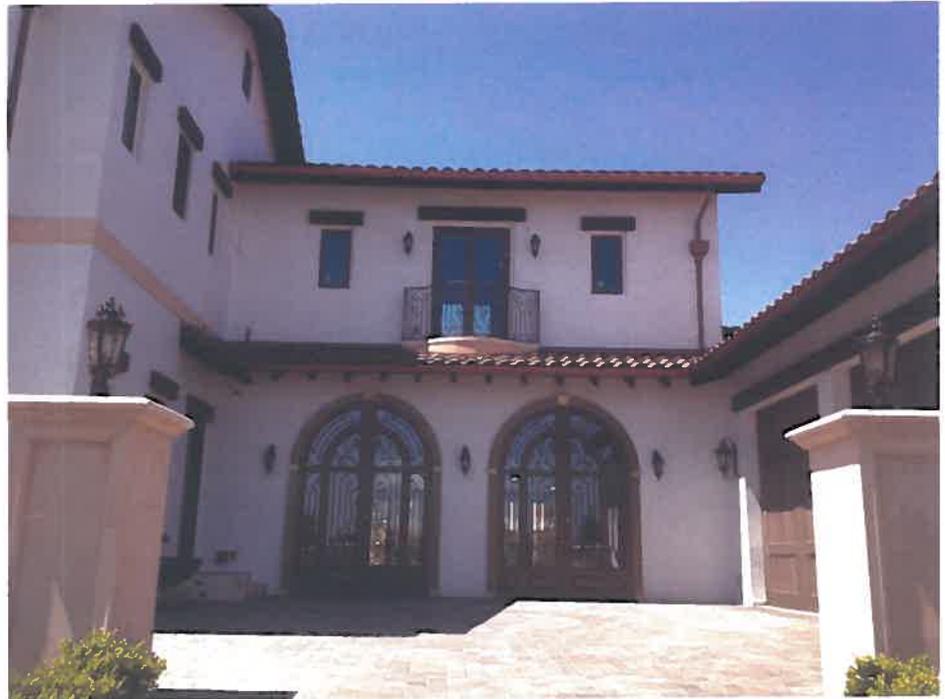
Reference: Sheet 4 – Front Elevation

As-built condition. Original garage space converted to a “lanai”. Lanai concept not approved – space must remain a garage. Glass is not allowed in garage doors. Iron work and gold accenting is too ornate and would not be approved if submitted.

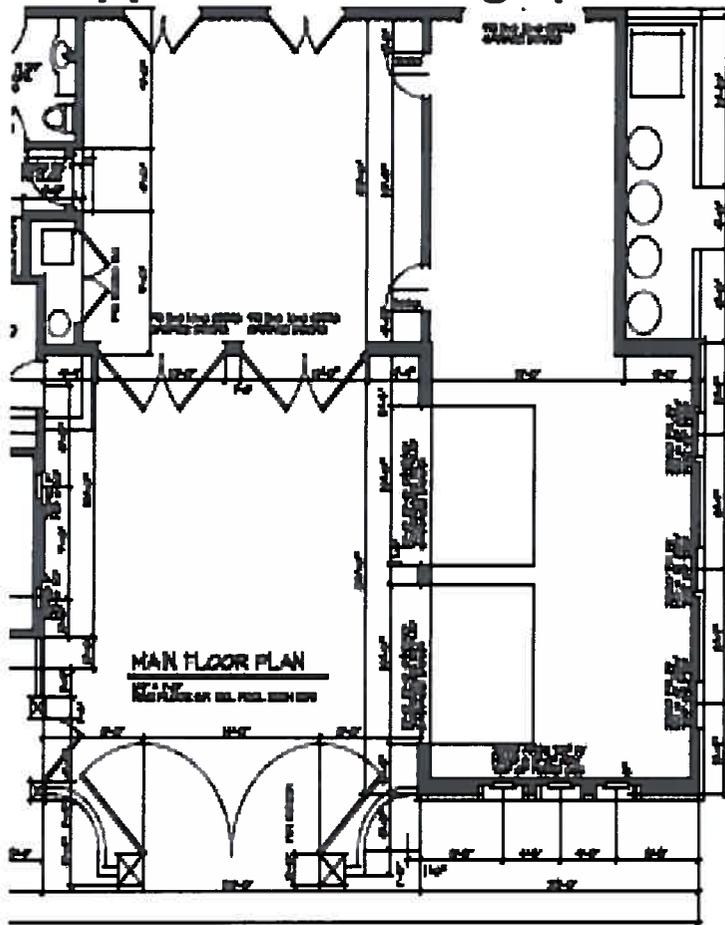
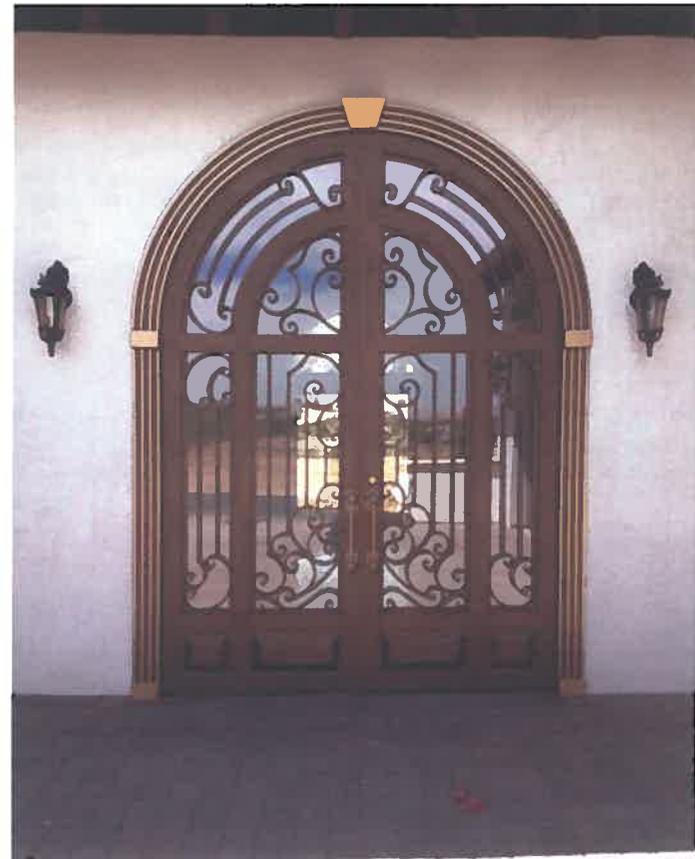
Reference: Sheet 1 – Front Elevation

As-built condition. Original garage space converted to a "lanai". Lanai concept not approved – space must remain a garage. Glass is not allowed in garage doors. Iron work and gold accenting is too ornate and would not be approved if submitted.

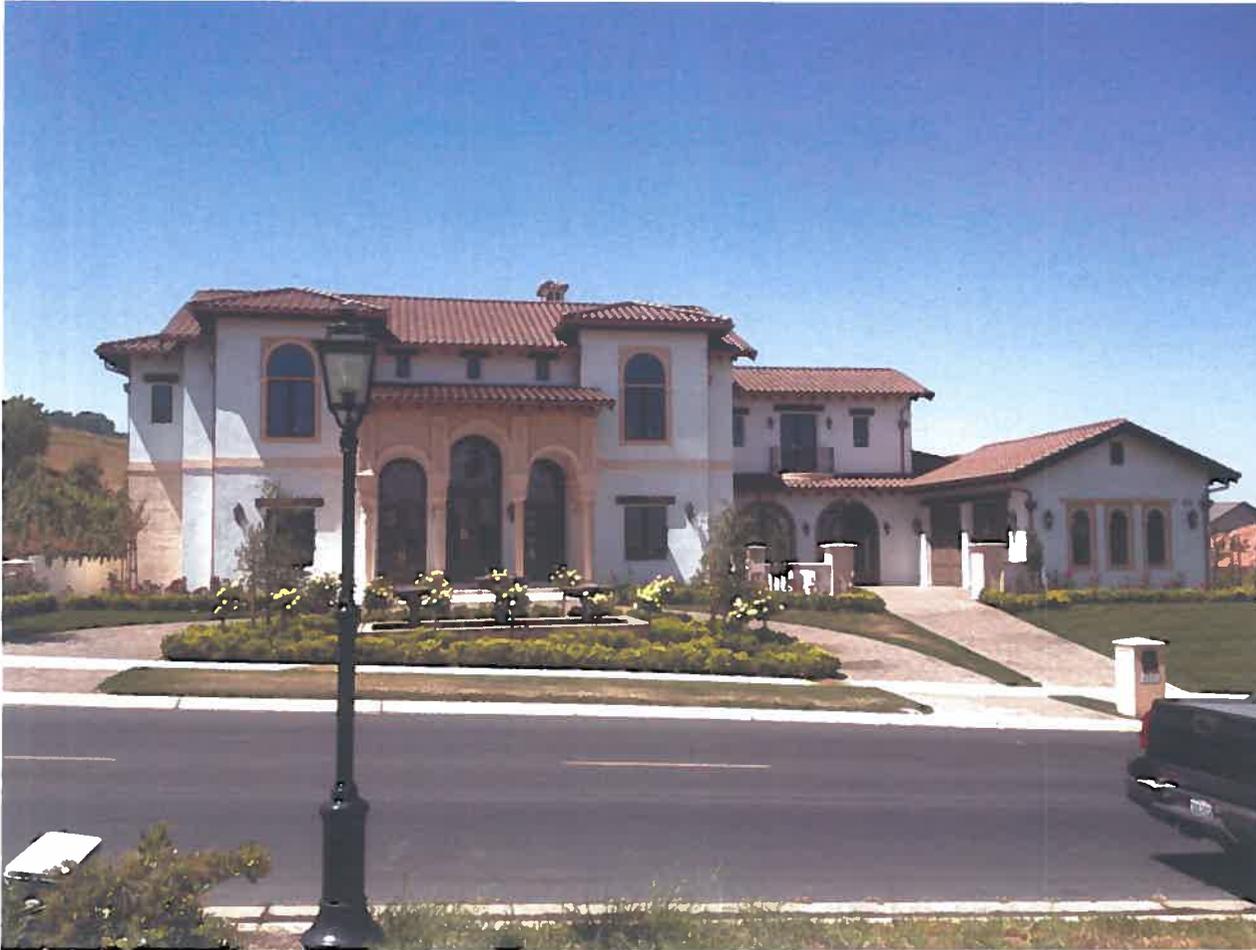
EXTERIOR COLORS – FRONT ELEVATION

Colors and materials never submitted for approval. Stark white, bright pastels or bright intense colors in large expanses are not allowed. The ADG prohibits harsh contrasts of color and/or materials; illogical or inappropriate combinations of scale

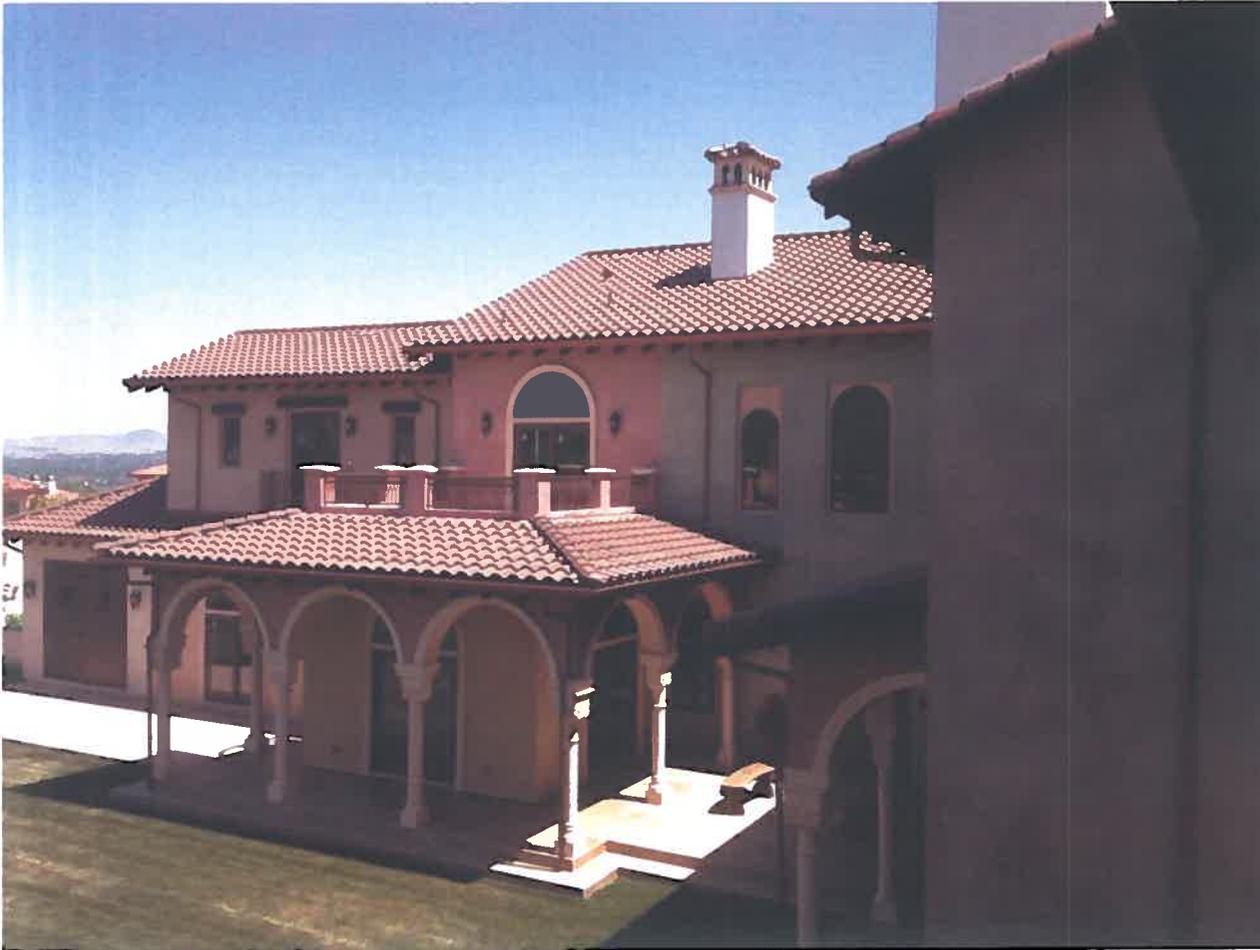
EXTERIOR COLORS – REAR ELEVATION

Colors and materials never submitted for approval. Stark white, bright pastels or bright intense colors in large expanses are not allowed. The ADG prohibits harsh contrasts of color and/or materials; illogical or inappropriate combinations of scale. There are 9 different colors applied to the body on the rear.

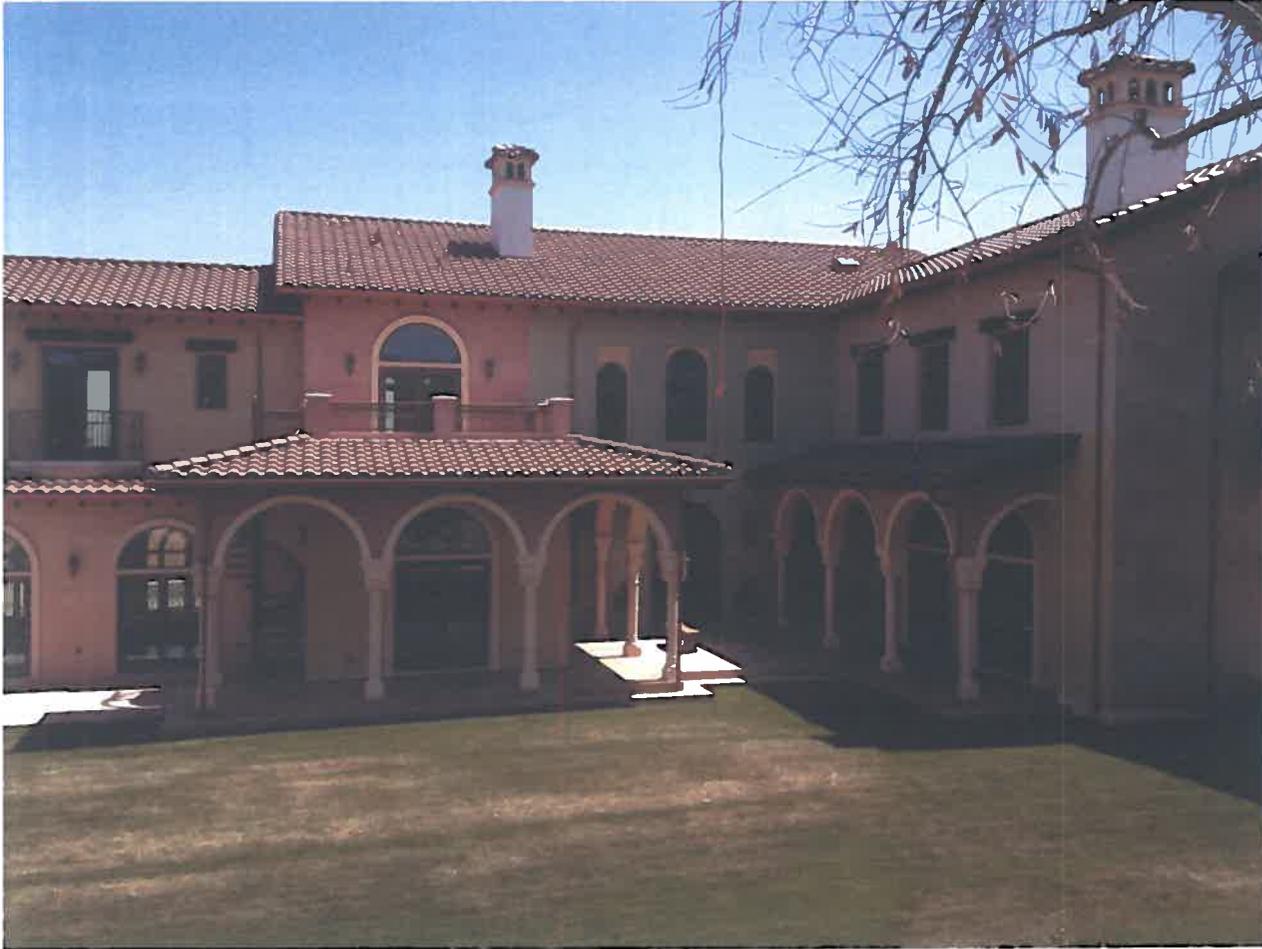
EXTERIOR COLORS – REAR ELEVATION

Colors and materials never submitted for approval. Stark white, bright pastels or bright intense colors in large expanses are not allowed. The ADG prohibits harsh contrasts of color and/or materials; illogical or inappropriate combinations of scale

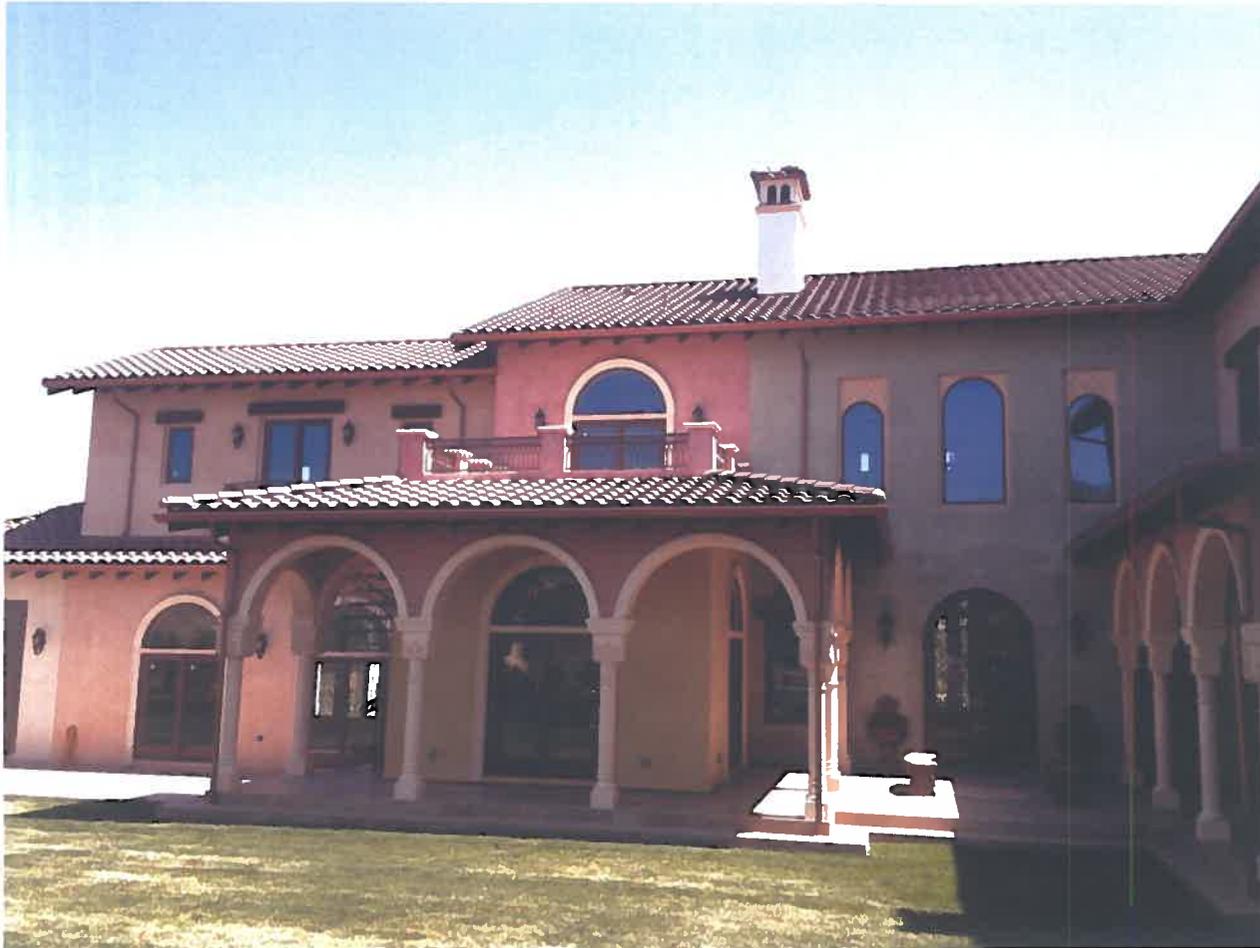
EXTERIOR COLORS – REAR ELEVATION

Colors and materials never submitted for approval. Stark white, bright pastels or bright intense colors in large expanses are not allowed. The ADG prohibits harsh contrasts of color and/or materials; illogical or inappropriate combinations of scale

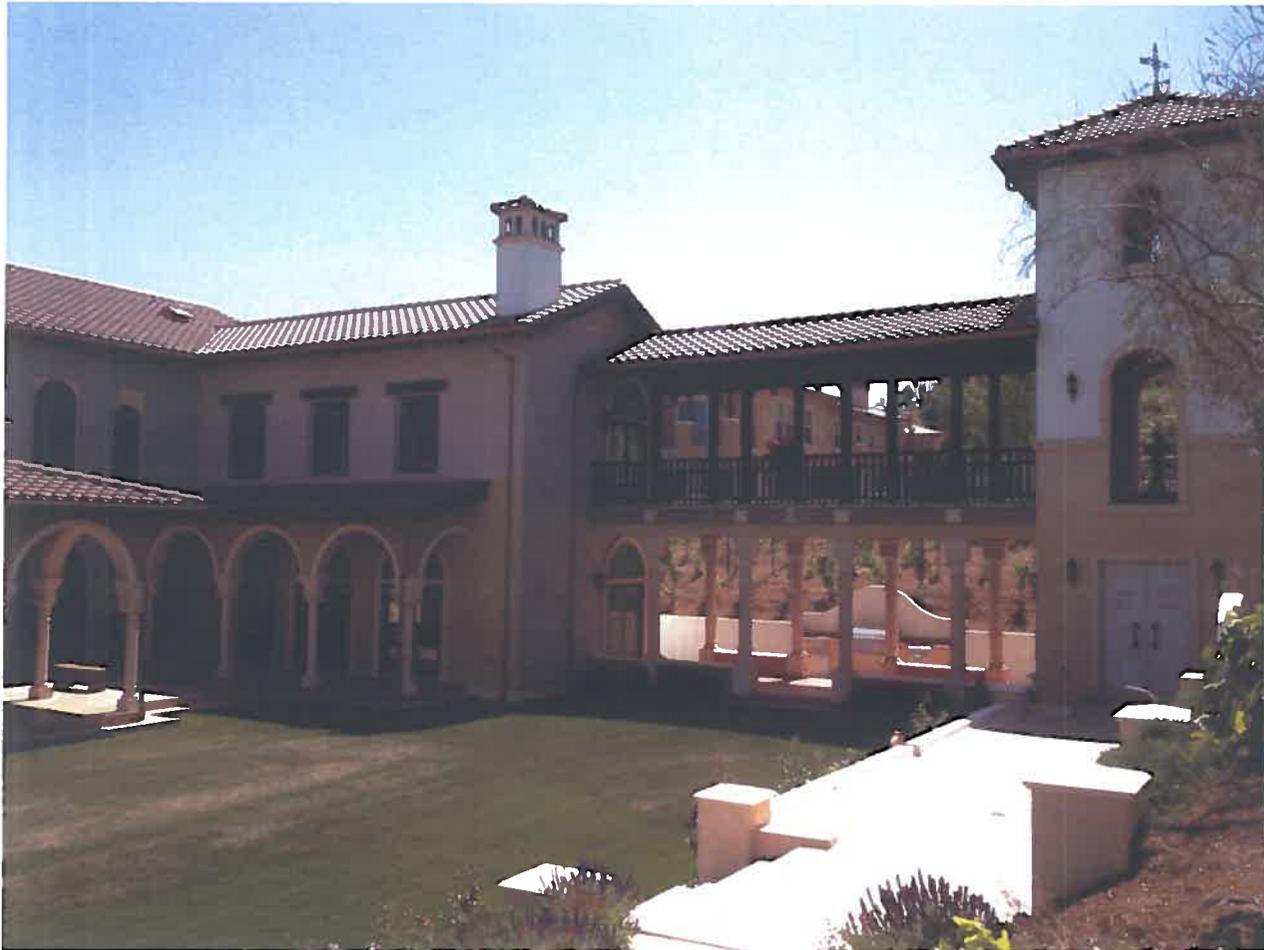
EXTERIOR COLORS – REAR ELEVATION

Colors and materials never submitted for approval. Stark white, bright pastels or bright intense colors in large expanses are not allowed. The ADG prohibits harsh contrasts of color and/or materials; illogical or inappropriate combinations of scale

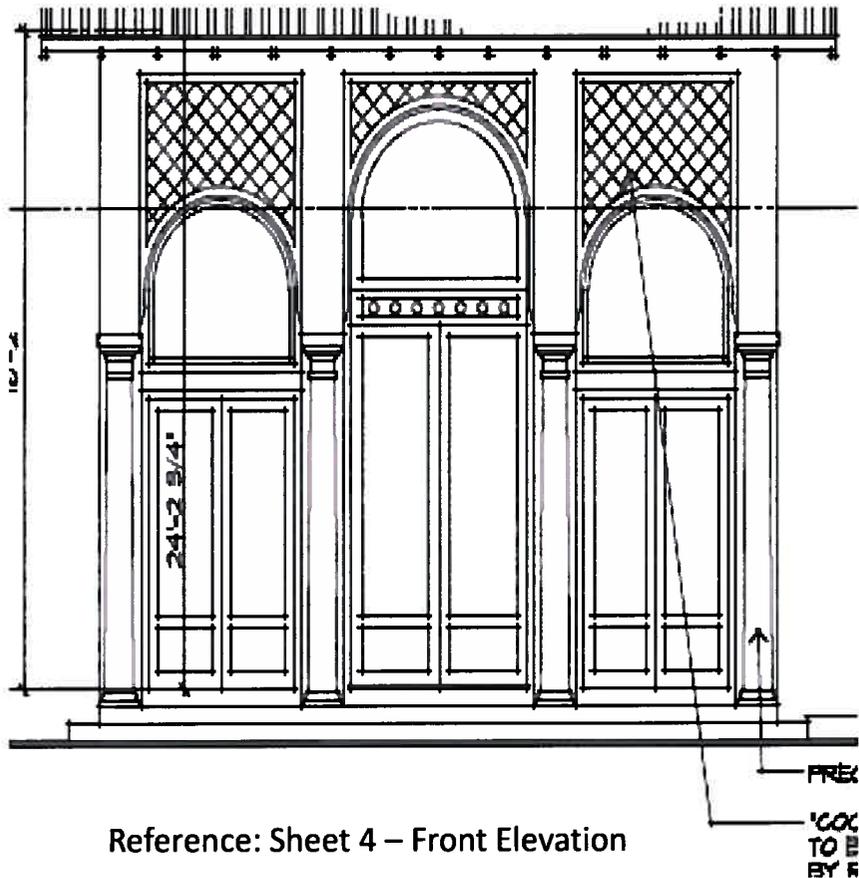
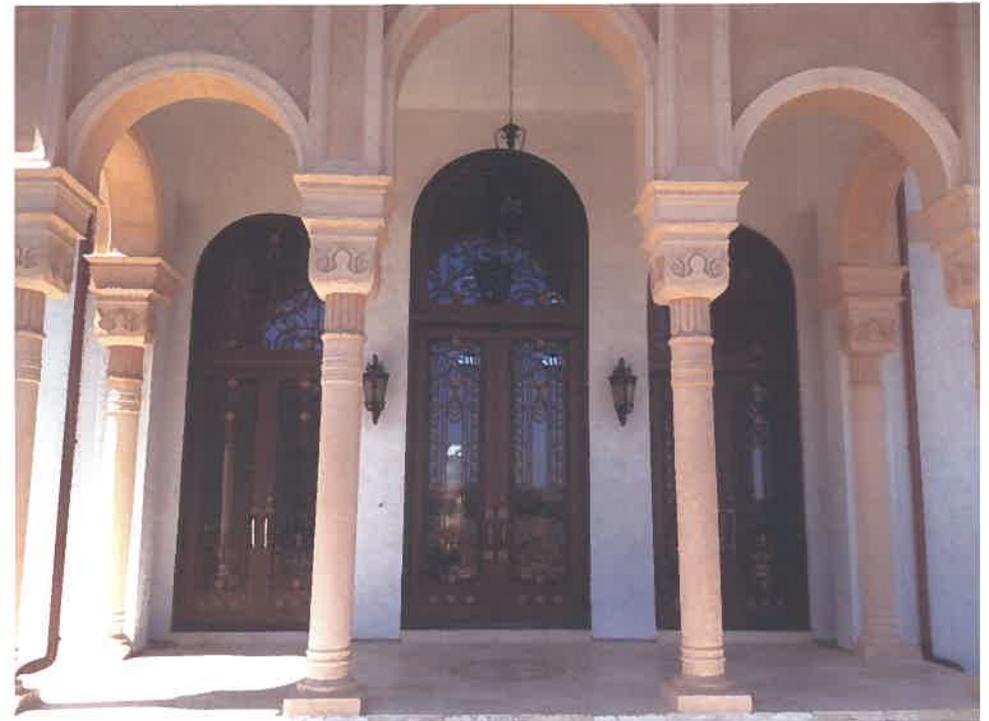
Reference: Sheet 4 – Front Elevation

- Iron frame w/glass inserts
- Overly ornate ironwork with gold accent for both door and transom above

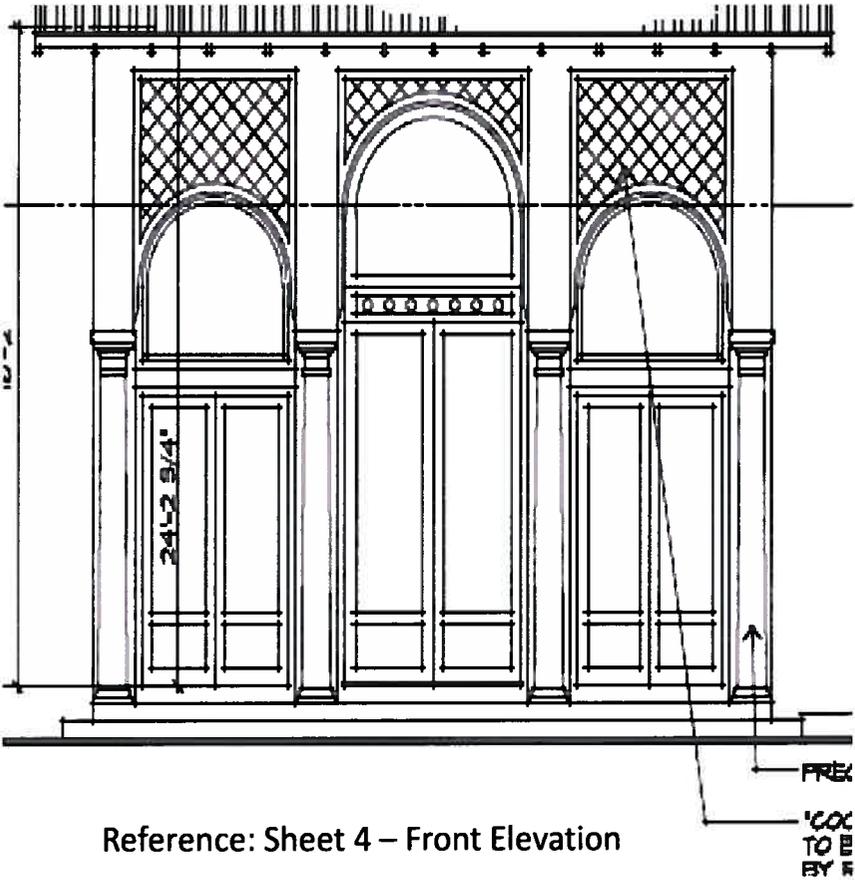
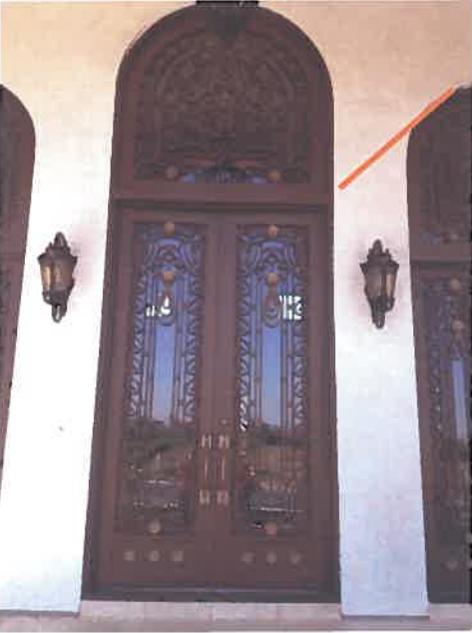
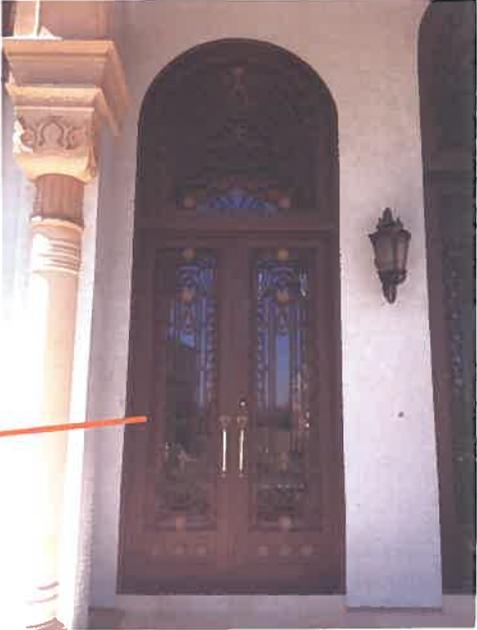
Reference: Sheet 4 – Front Elevation

- As-built condition:
- Iron frame w/glass inserts
 - Overly ornate ironwork with gold accent for both door and transom above

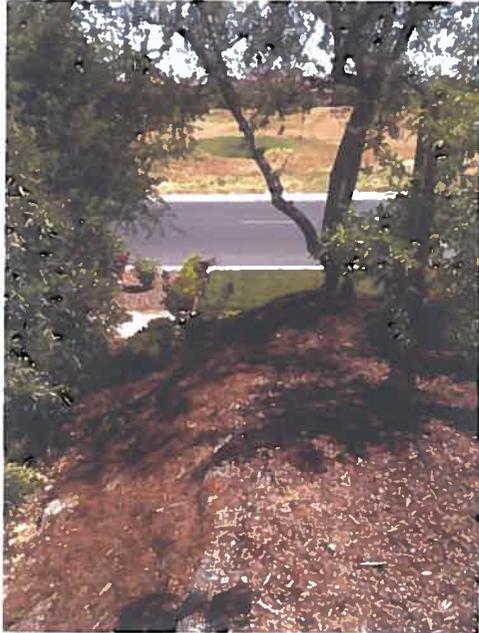
Grading performed by Reddy at north end of property. Current condition sheds water onto adjacent neighbor and is not contained.

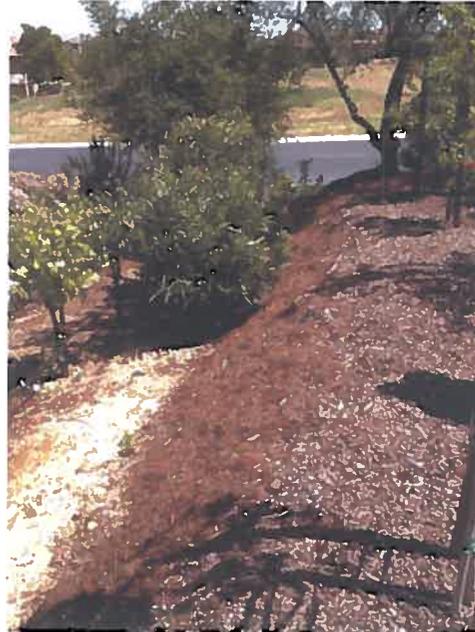
Grading performed by Reddy at south end of property. Current condition created a negative drainage situation which causes water from south property to shed onto Reddy property

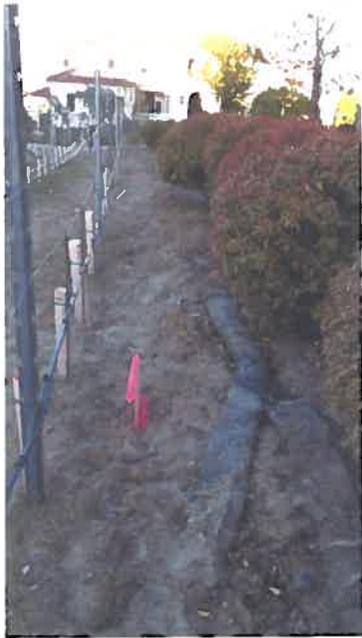
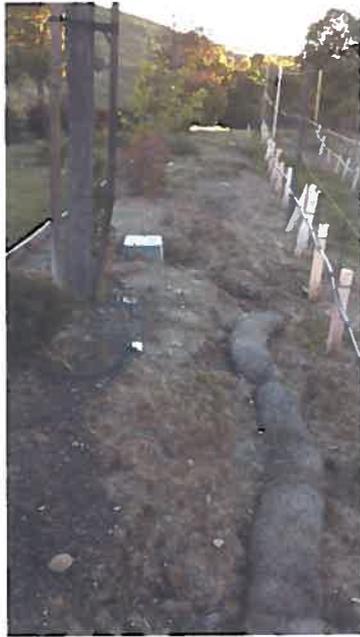
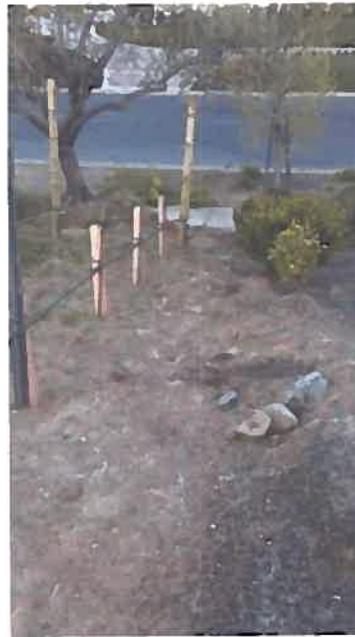
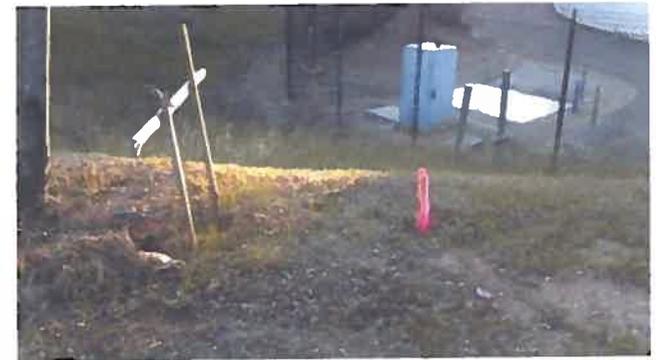
DRAINAGE & GRADING

These pictures depict the grading over the property line at the southern adjacent lot (taken prior to the installation of the landscaping).

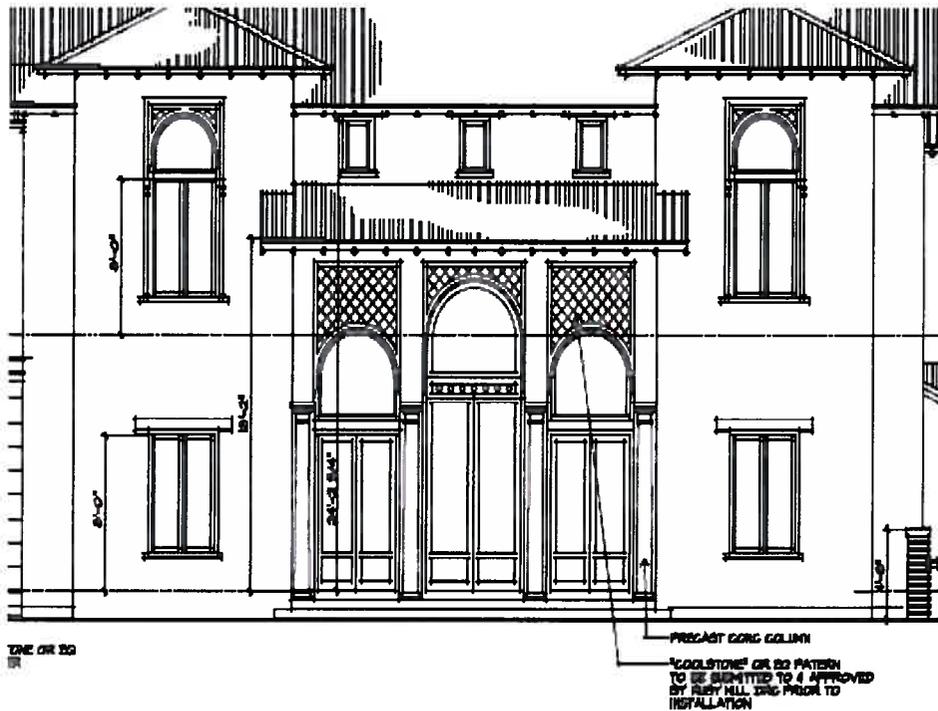
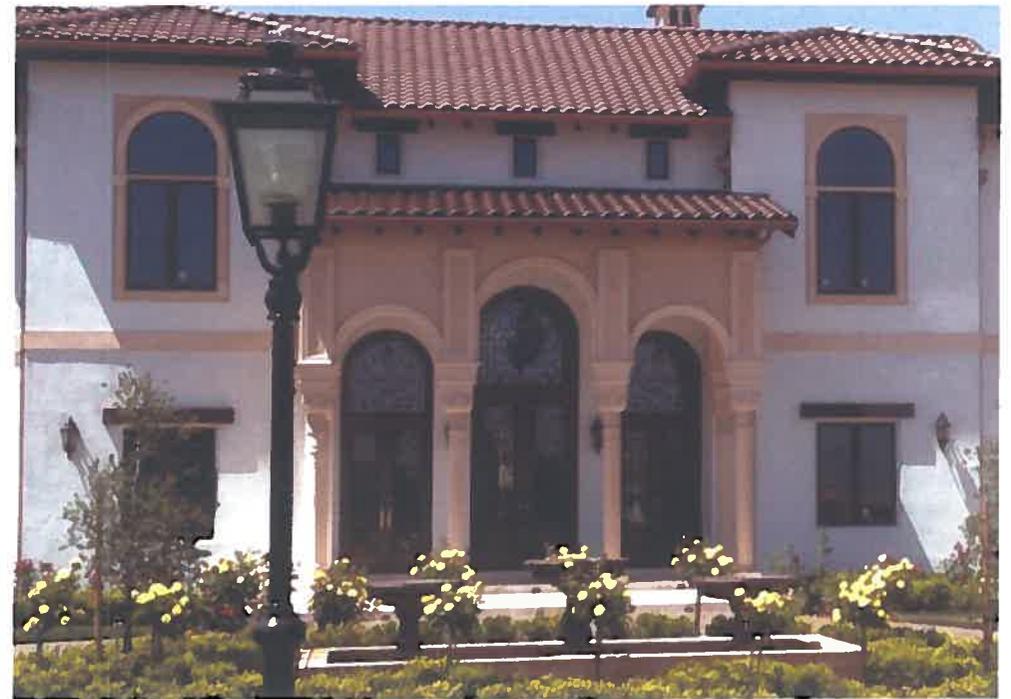
Reference: Sheet 4 – Front Elevation

As-built condition. Horizontal banding added without approval. ADC will accept the added trim work under the condition that it is painted to match the approved body color.

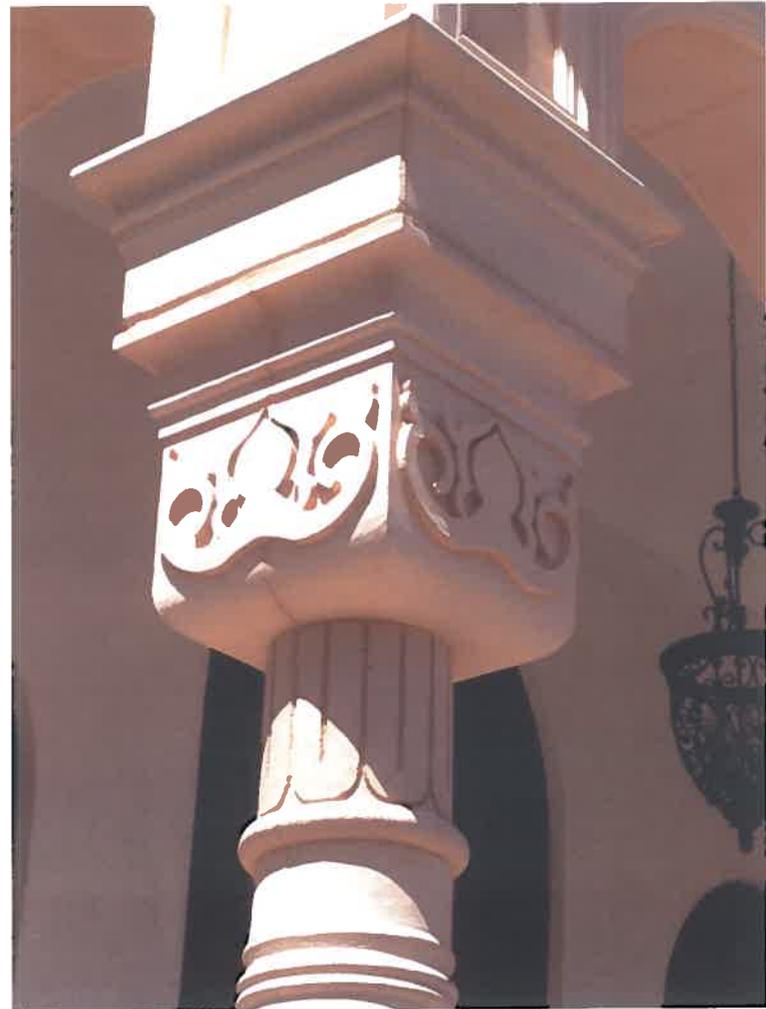
As-built condition. Design is inconsistent with the Spanish Eclectic architectural style.

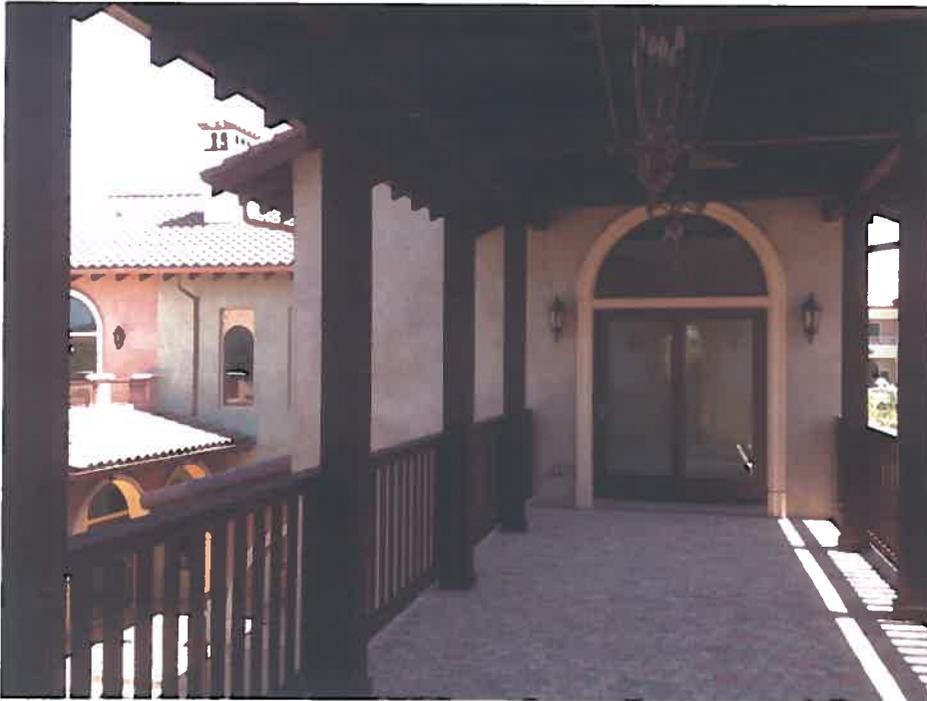
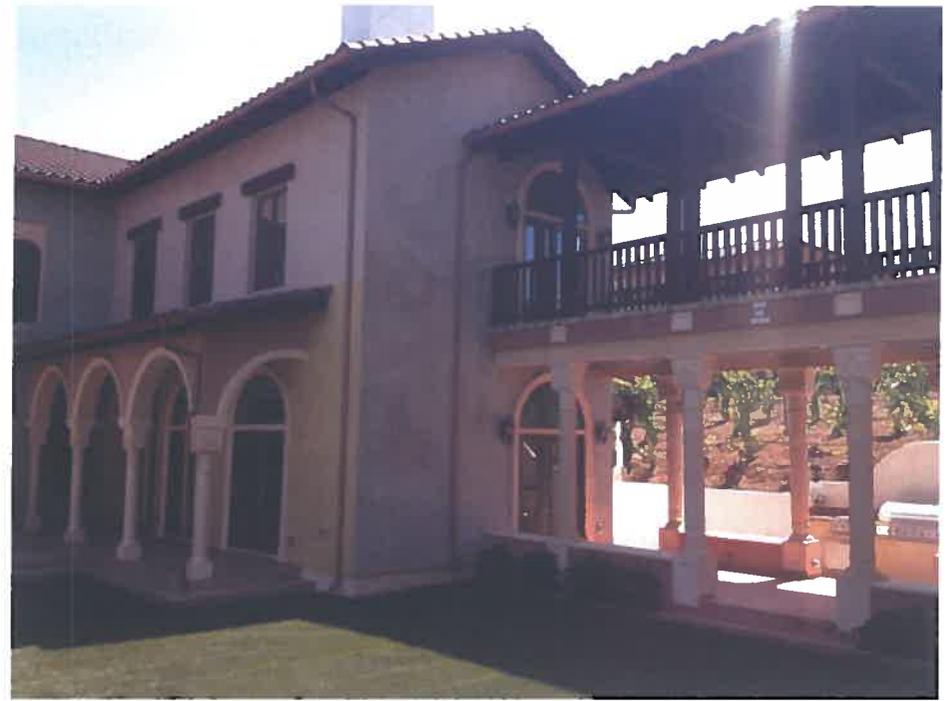
STUCCO WALL AT MASTER SUITE

Color at back wall of master bedroom suite appears unfinished. Must be painted to match the approved body color.

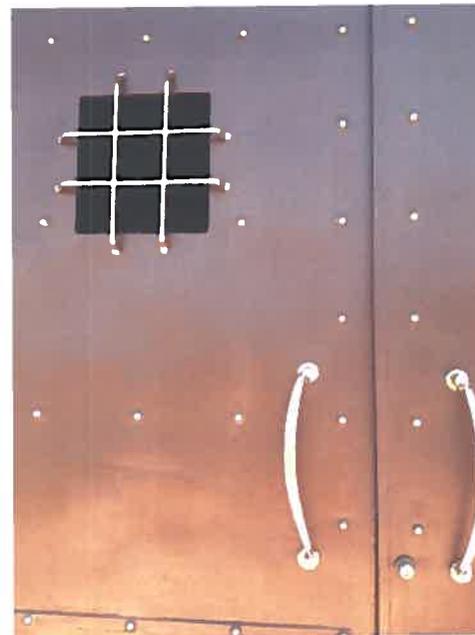
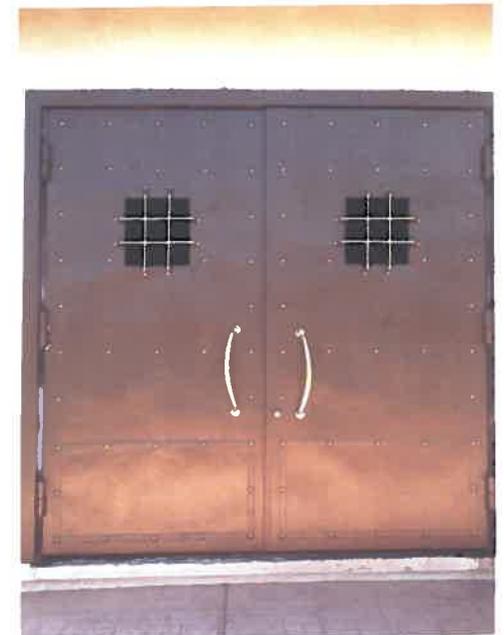
REAR GARAGE DOORS

- Iron doors with gold accent and opening with iron bars
- Iron work and gold accenting is too industrial and would not be approved if submitted.
- Does not match Spanish Eclectic architectural style

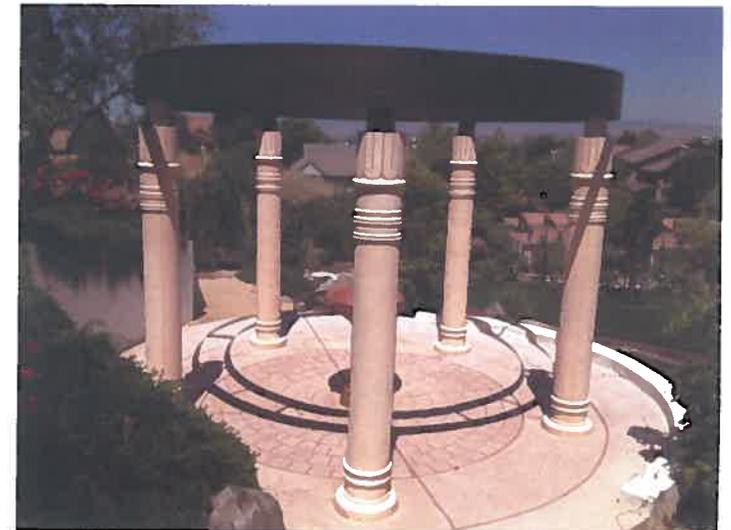
Reference: Sheet L-8 –Gazebo Elevation

- Owner proceeding with construction of gazebo without approval from the ADC or required permits from the City of Pleasanton.
- Original comments from ADC specified that gazebo columns must match final approved columns of the house.
- The iron work submitted in the proposed illustration (4.12.11) was not approved and will not be approved – it is too ornate and is inconsistent with the architectural style of the home.
- The height of the proposed dome exceeds the maximum height limit for a shade structure and accessory structure.
