**Arborist Report**

**434 Rose Ave.  
Pleasanton, CA**

**PREPARED FOR  
Peter Michno  
4049 1st. Street  
Livermore, CA**

**January 30, 2014**

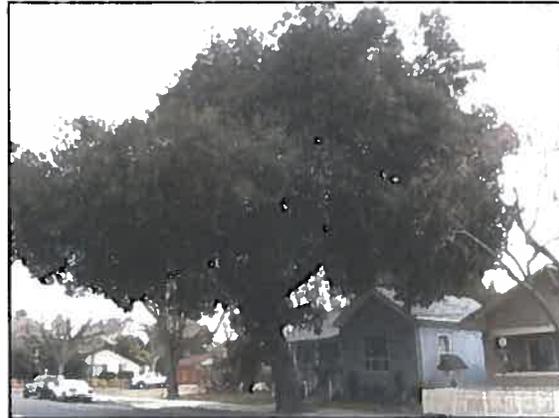
The most common species assessed was coast live oak (7 trees). The largest was 36" diameter #70, a street tree growing in front of the existing house (Photo 1). Six coast live oaks were along the eastern property line, between the subject site and a vacant lot to the east (Photo 2). Those six trees were in poor (4 trees) to fair (2 trees) condition; they were young to semi-mature with a trunk diameter ranging from 9 to 15 inches. Many of the trees on the eastern border had been poorly pruned, creating asymmetrical and narrow canopies and trees with poor form (photo 3).

**Photo 1:** Coast live oak #70 was the largest tree assessed with a canopy spreading across the street.

Street tree #70 will not be affected by the planned construction. Due to the heavy scaffold branches at awkward angles, I recommend an aerial inspection and pruning to reduce end weight. Pruning specifications are provided in the *Tree Preservation Guidelines*.

4. Prune trees to be preserved to raise canopies as needed for construction activities.
  - a. Street tree #70 should have an aerial inspection by a Certified Arborist to determine stability of branch connections. Prune tree to reduce end weight on heavy scaffold branches.

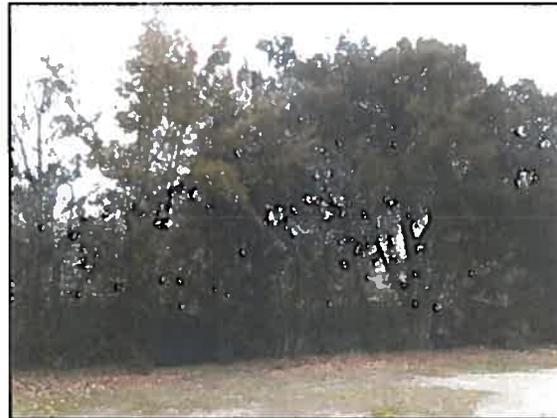
**#77 #78 #79 #80 #81**

**Photo 2:** Trees lined the eastern property boundary.

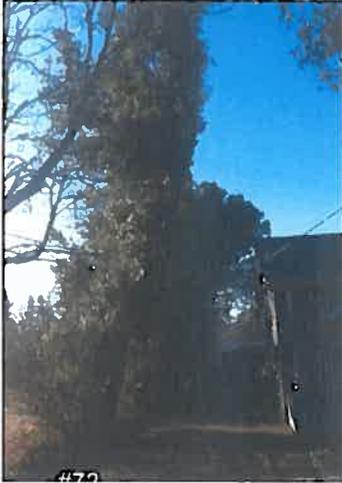
**Photo 3 (left):** Oaks #72-76 were pruned to remove branches on the west, creating asymmetric canopies.

The proposed site plan indicated that all trees except #82, 83 and 84 would be preserved. I recommend removing 13 trees, however, because of their poor condition: #71-77, 79, 82-86. Two of the trees identified for removal were *Heritage* (#71 & 77).

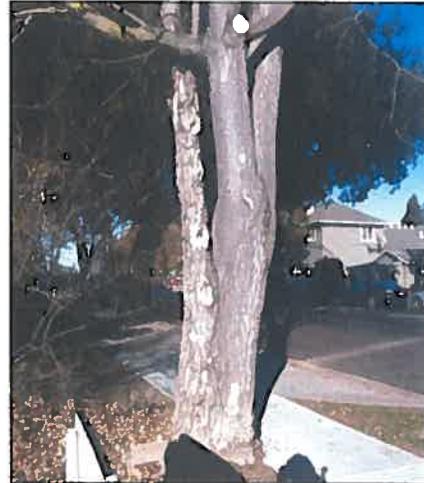
fair (2 trees) to poor (2 trees) condition. The trees of heaven ranged in maturity with diameters from 6 to 26 inches. The largest tree of heaven (#71) was the closest tree to the street on the eastern border (Photo 4). This tree was off-site and part of the trunk bulging over the sidewalk.

**Photo 4 (right):** Tree of Heaven #71 was not on the property, but its canopy extended over the drive way. One trunk was dead; the base of the larger trunk was growing over the sidewalk.

Tree of heaven #71 is off the property. I recommend removing it because of its poor condition, conflicts with the sidewalk, and its invasive nature. Following removal, the stump should be treated with an herbicide to prevent sprouting. I suggest contacting the owner of the tree to request his/her support in applying for a permit to remove the tree.
