Subject: **Tree Report**
2523 Yolanda Court, Pleasanton

You are planning to build a two-story home on the lot at the subject address. Currently, the lot remains undeveloped with three trees growing on the site. The City of Pleasanton requires that a Tree Report be prepared as part of project submittals. You asked HortScience, Inc. to visit the site, inspect the trees, and assess the potential impacts to the trees. This letter responds to that request.

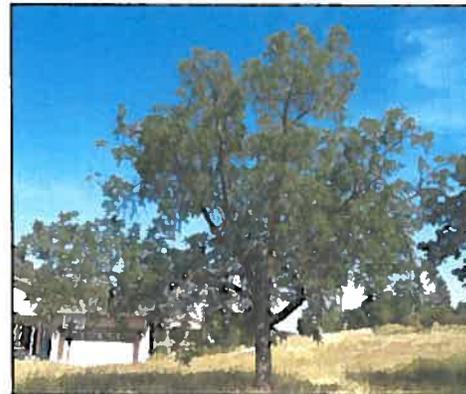
Photo 1: Calif. black walnut #45

The tree was located on the south end of the lot nearest to the street. The tree was in good condition (Photo 1) with a full, green canopy. It was semi-mature in development with a 16" diameter trunk (measured at 4.5' above the ground), and it had good form and structure. Codominant trunks emerged at 11' above ground. Minor twig dieback was visible throughout the crown.

- A paved parking area 4' east of tree #45 and walkway 5' north of tree #45;
- The north wall of the house 9' south of tree #59;
- A driveway along the east property line, requiring the removal of tree #60.

As a species, California black walnuts are extremely sensitive to construction impacts and changes in the environment. Following even minor root injury or changes to water table, trees can be expected to decline slowly within several years following construction. For this reason, a tree protection zone at or beyond the tree's dripline is required when preserving Calif. black walnuts. For tree #45, this would translate to maintaining a 16' impact-free zone in all directions from the trunk of the tree; for tree #59, a 13' radius impact-free zone. Because plans show construction within these zones, I recommend against preserving trees #45 and 59; I recommend removing all three on-site trees.

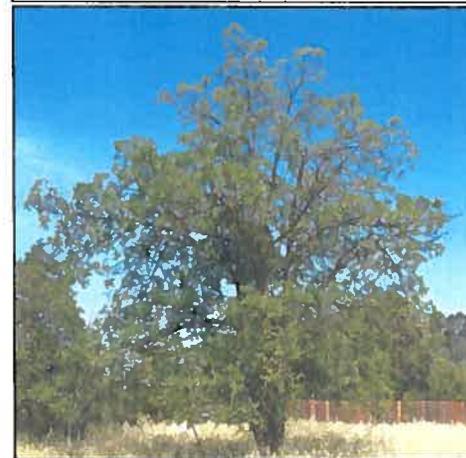
Photo 2: Calif. black walnut #59

This tree was located at the north end of the property. It was semi-mature in development with fair form and structure (Photo 2). Three trunks emerged at 3.5' above the ground with 10", 9", and 8" diameter stems. The tree's crown was slightly thin with twig dieback throughout the canopy, and broken stubs indicated a history of branch failure.

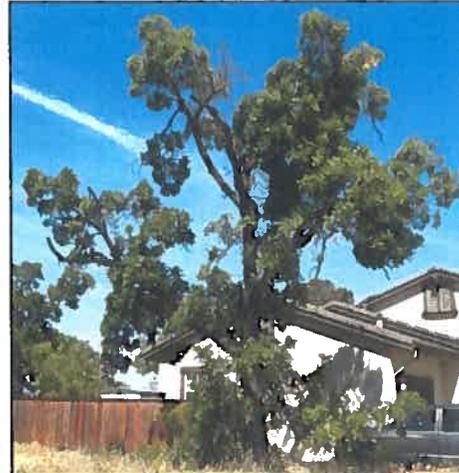
Photo 3: Calif. black walnut #60

This tree was located near the east property line, close to the wood fence that separates this property from the adjacent home. It was mature in development with a 17" diameter trunk. This tree was in poor condition (Photo 3, following page) with poor form and structure. The crown was thin and several dead stems and limbs were scattered throughout the crown.
