Preliminary Tree Report

**Kottinger Senior Housing Project
Pleasanton, CA**

Prepared for:
**MidPen Housing Corp.
303 Vintage Park Dr. Suite 250
Foster City, CA 94404**

July 3, 2013

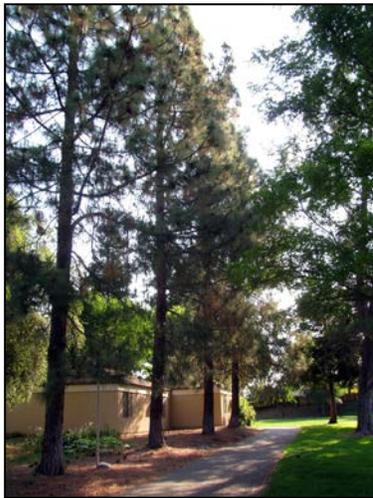
Canary Island pine was the most common species present, with 20 trees (12% of the population). They were planted around structures and along pedestrian pathways adjacent to Kottinger Village Park (photo 1). The trees ranged in condition from fair to good, some with somewhat thin canopies. The majority of the trees was tall and upright exhibiting good form and structure, and averaged 18" in diameter. Within the group were 15 Heritage trees.

Photo 1: Canary Island pines along path bordering Kottinger Village Park. #55-58 are Heritage trees.

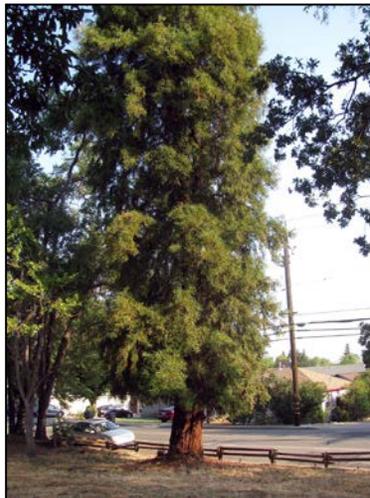
Photo 2: Heritage coast redwood #162 located at 4138 Vineyard Ave.

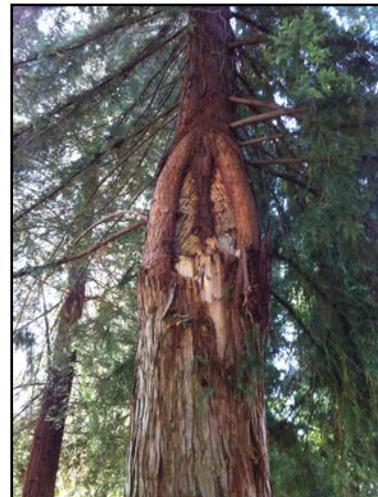
Coast redwood was the second most common species with 14 trees (8% of the population). Averaging 30" in diameter, 11 trees were in good or excellent condition, and 12 were large enough to qualify as Heritage trees (Photo 2). Off-site trees (#62, 63, 66-68, 70, 71, 75 and 76) were located on the east side of Kottinger Place in Kottinger Village Park along the edge of a pedestrian path. Coast redwood #70 was distinctive among the off-site trees, with an extensive wound resulting from a codominant stem failure (Photo 3).

Photo 3: Heritage coast redwood #70 was located in the park on the outside of a pedestrian path. It had a large trunk wound created when the codominant stem failed several years ago.

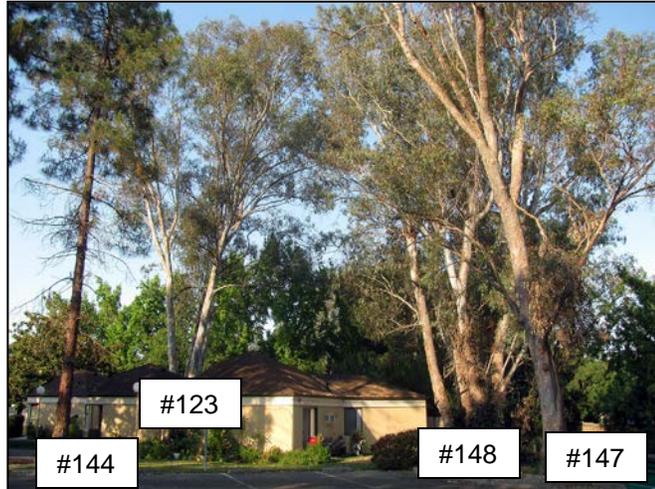
Two eucalyptus species were present; river red gum and silver dollar gum. Many were multi-trunked trees, inter-planted in a linear plane along the western perimeter of Kottinger Place and Regalia House. The red river gum was represented by nine trees (5% of the population) and the silver dollar gum by six trees (less than 4% of the population). As a group, eucalyptus ranged from fair to good, and was predominately characterized by poor structure, multiple attachments, branch failure, and wound decay. All eucalyptus trees with the exception of silver dollar gum #109 had Heritage status.

Photo 4: Heritage river red gums were the largest trees on the site. These were located on the northeast corner of Kottinger Place.

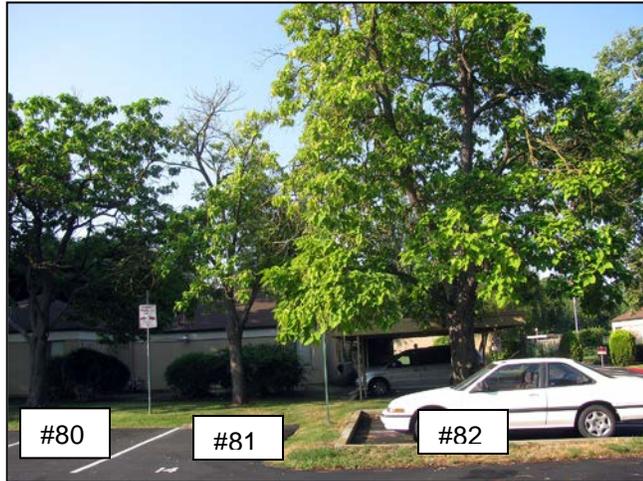
Photo 5: Catalpas #80 (Heritage) and 81 were in poor condition due to extensive branch dieback and trunk decay. Heritage tree #82 was in fair condition.

Located primarily inside the pedestrian pathway in Kottinger Place, the *Catalpa* species was represented by eight trees (less than 4% of the population). All the trees had a single trunk, with the exception of tree #52, which was multi-trunked. Large in stature (average diameter 22"), all but one of the trees had Heritage status and an average. It was noteworthy that trees #77, 80 and 81 exhibited extensive trunk and branch wounds, dieback and decay (Photo 5).

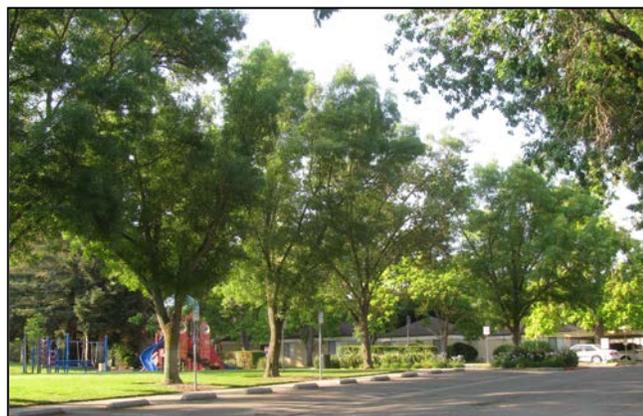
Photo 6. Raywood ash #175-177, 161 (left to right).

Eight Raywood ash were present that were in good to fair condition (Photo 6). Several had symptoms of Ash Dieback, a disease caused by the fungus *Botryosphaeria*. All were located along the parking area between Regalia House and the park.

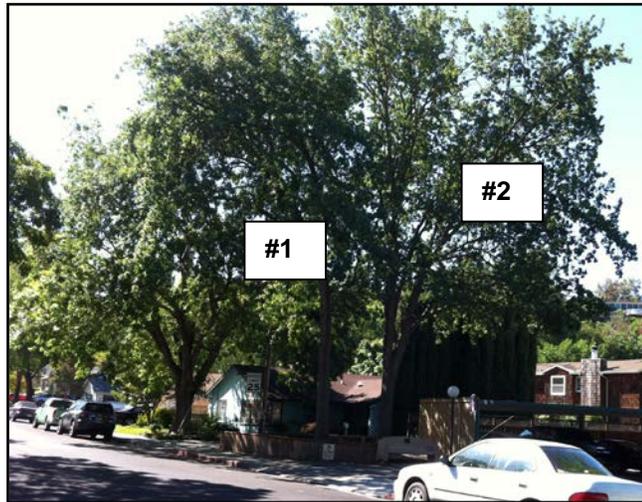
Photo 7. Valley oaks #1 and #2 have grown next to each other and now form one canopy.

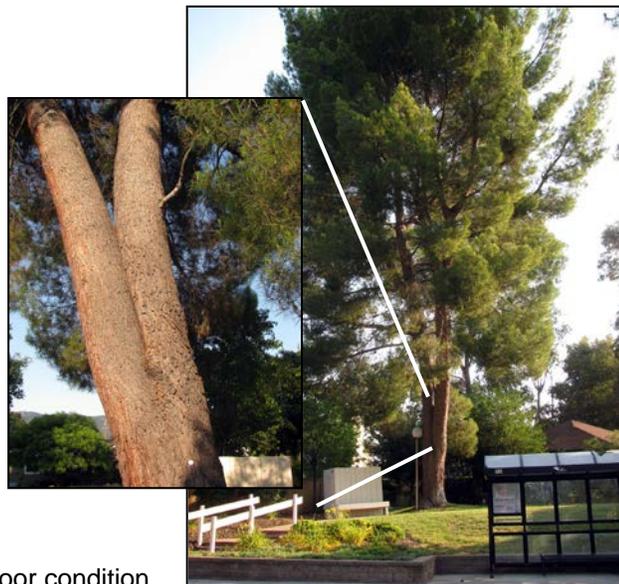
- Aleppo pine generally in fair to good condition; two heritage trees on the west side (#90, 113) and two off-site trees on the east side, one with heritage status (#61). Tree #90 was impressively large, but had a significant structural defect that compromises its structural stability (Photo 8).
- Almond in a linear planting at Regalia House (#149-151, 154). Trees had poor form and structure with an average diameter of nine inches.
- California black walnut (#166-169) in linear planting on the west side of Vineyard Ave. with three trees off-site. Two trees were multi-trunked and two had heritage status. Tree #167 was in poor condition with poor form and two dead stems. The other three were in fair condition with codominant stems and multiple attachments.

Photo 8. Aleppo pine #90 had codominant stems with included bark (see inset). This is a structurally weak condition that is likely to result in tree failure. A cable had been installed between the two stems to provide some support.

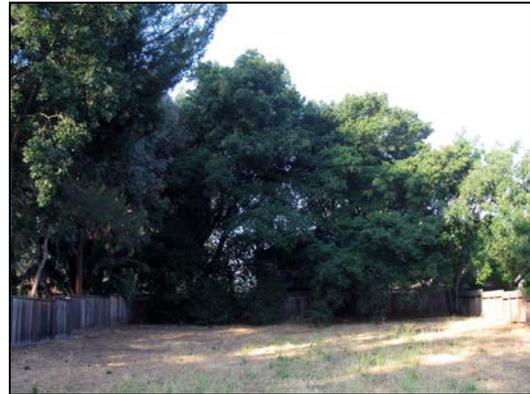
- Coast live oak #164 in good condition, albeit with codominant trunks, and #165 in excellent condition were both heritage trees (Photo 9). These are naturally-occurring trees native to Pleasanton. The canopies extended to the ground as is typical of the species. This form shades the root system and helps the trees survive the long dry summer. They were located at the west end of 4138 Vineyard Ave.
- Ginkgo #7 was a good young tree in Pleasanton Gardens (Photo 10), and moderate-sized #163 in the Vineyard Ave. was suppressed in form and in fair condition.
- Zelkova #51 was in fair condition because of multiple branch attachments and presence of a girdling root. Zelkova #132 was in good condition.

Photo 9. The canopy of Heritage coast live oaks #164 and 165 occupied the west end of the Vineyard Ave. property.

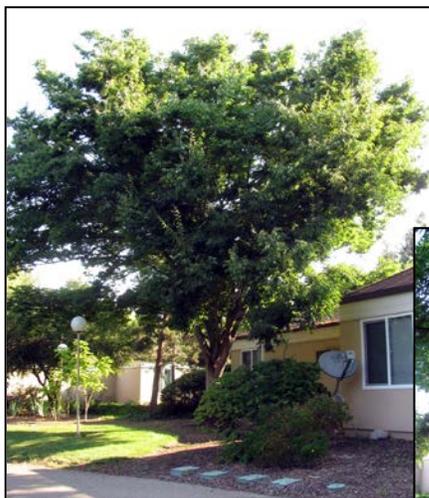
Photo 10 (left). Zelkova with multiple branch attachments (inset).

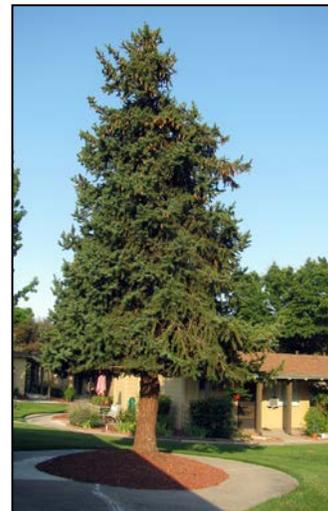
Photo 11 (right). Colorado spruce with good form and health.

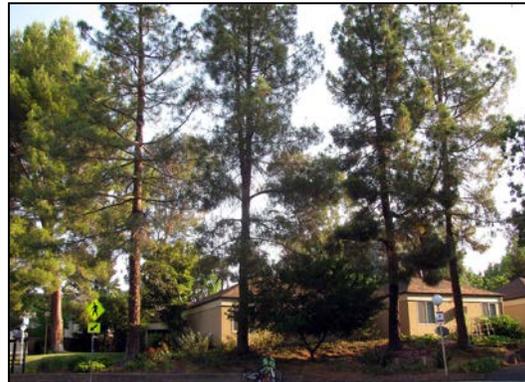
Photo 12. Canary Island pines #83-86 are located at the Kottenger Dr. entrance to Kottenger Place. They are good candidates for retention. They are in the “possibly preserve” category (Table 4). We recommend accurately locating the trunks and designing for their preservation.
