ARBORIST REPORT

3192 SANTA RITA ROAD

PLEASANTON, CALIFORNIA

July 8, 2013

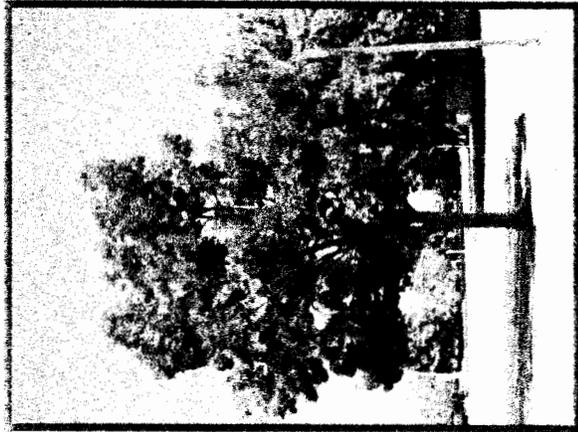
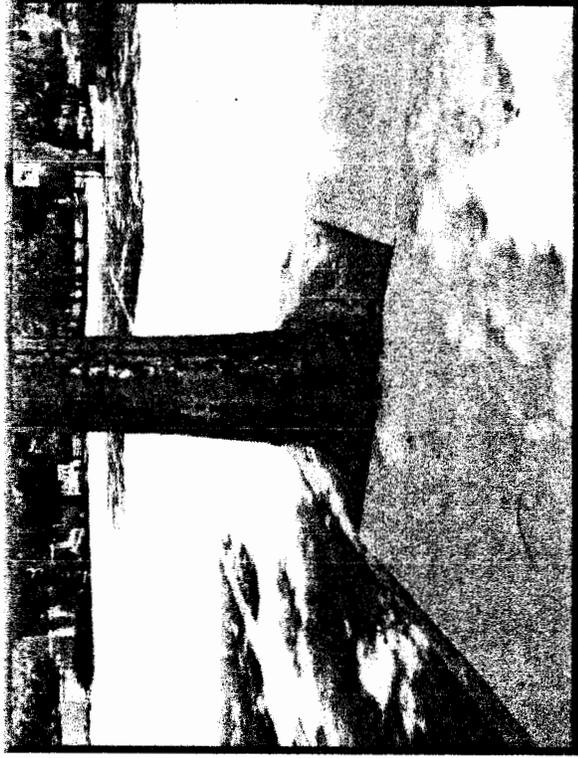
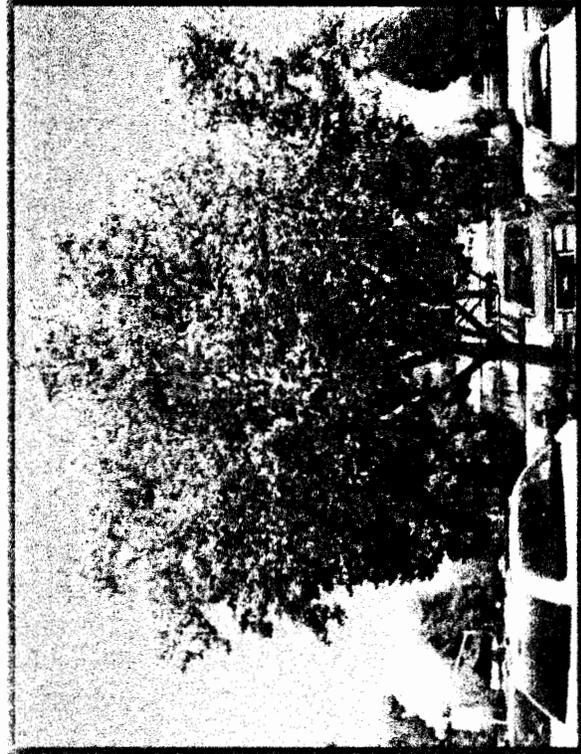
Page C-1: Trees #1 and 2

Comments: Street tree. Trunk within a rectangular-, nearly square-shaped planter. Sidewalk raised and repaired in past. Current damage includes a section of walk (road side) being raised and the adjacent curb being slightly damaged. Main trunk divides into codominant leaders at nine feet high and forms a weak attachment. Deadwood in canopy from ash blight. Has a large, pronounced girdling root surfaced around the trunk's base along the sidewalk side.

Comments: Street tree. Trunk within a rectangular-, nearly square-shaped planter. A girdling root was partially cut sometime ago. On road side, the sidewalk is raised and curb somewhat damaged.

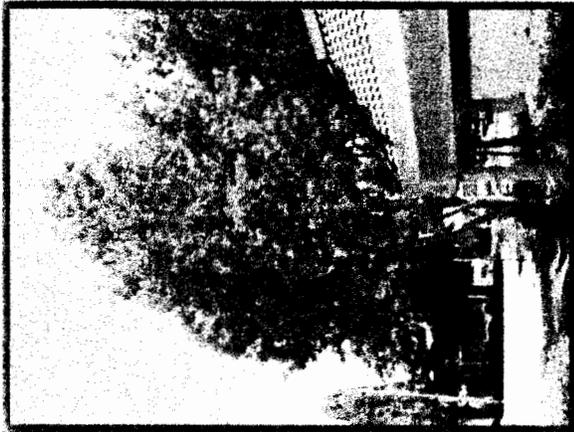
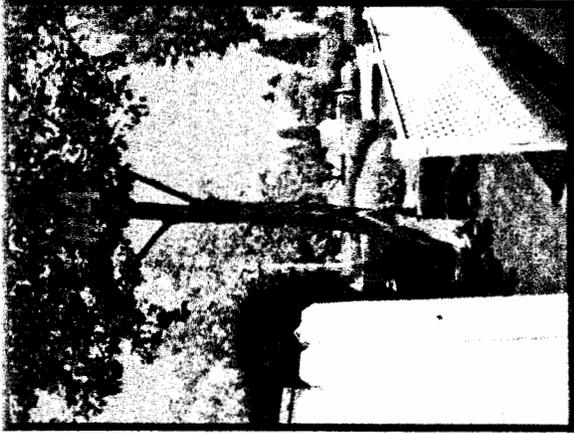
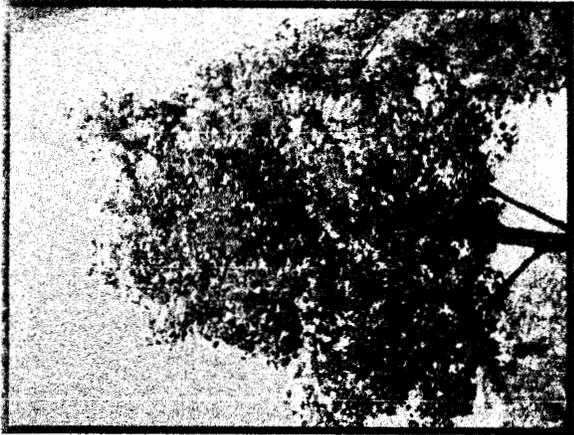
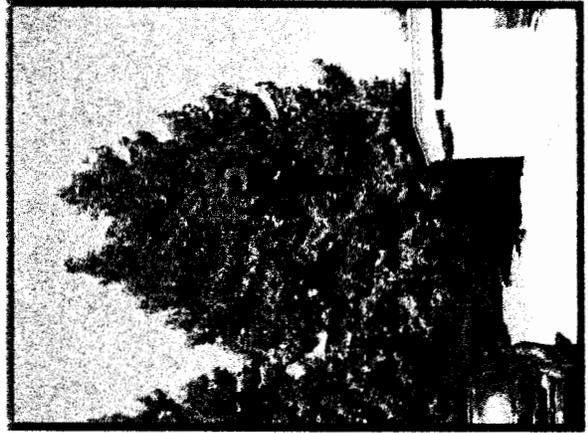
Page C-2: Trees #3 thru 7

Comments: Trunk is situated on adjacent property, and canopy overhangs site by a few feet. Has an asymmetrical canopy that has been significantly raised. Formed by a main trunk that divides into multiple leaders.

Comments: Trunk is situated on adjacent property, and canopy overhangs site by five or more feet. Canopy has been significantly raised. Has a pronounced buttress root that surfaces and is directed towards the project site. Decay visible at trunk's base, and possibly has a girdling root along the opposite side.

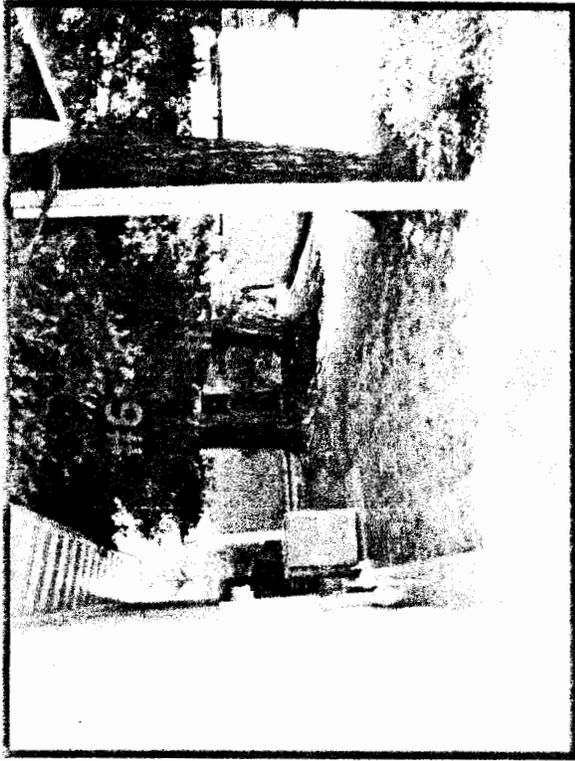
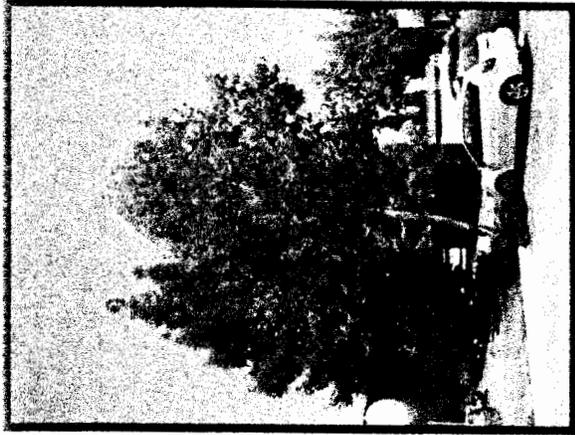
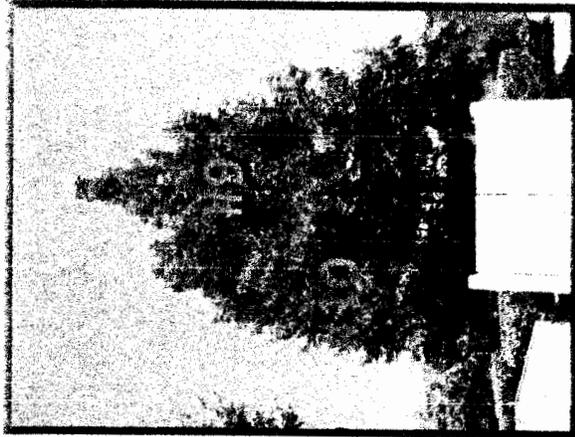
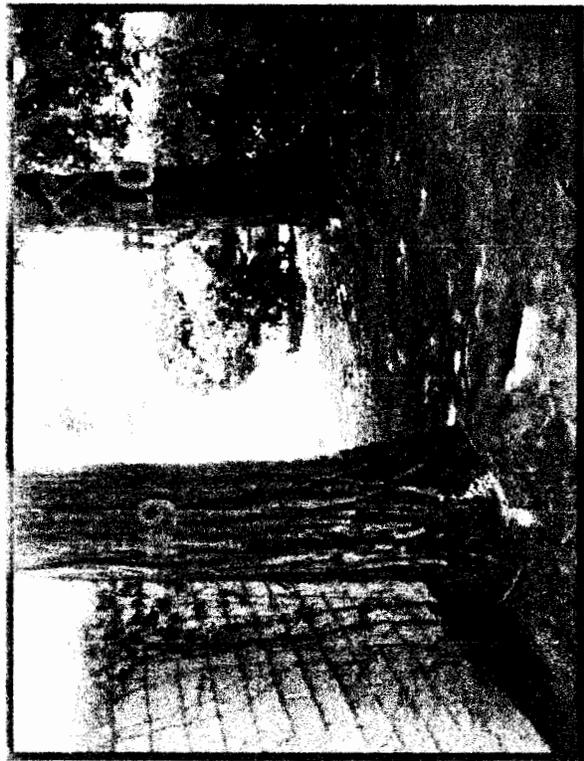
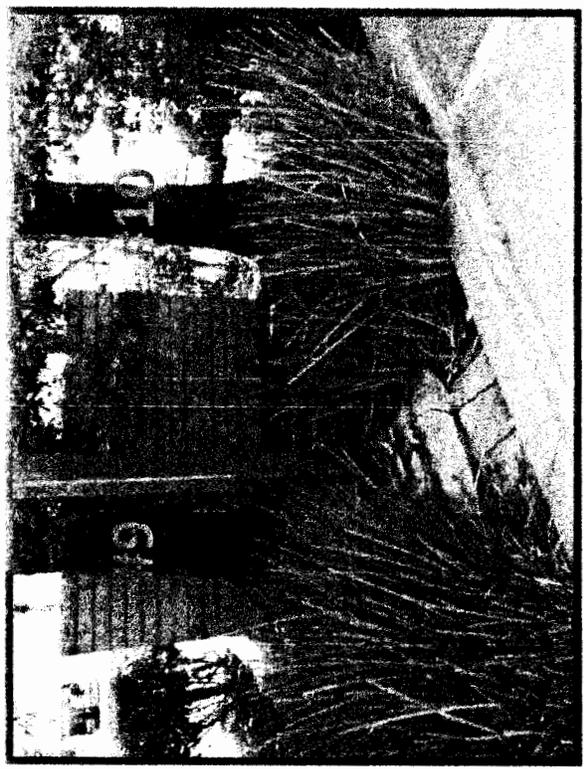
Page C-3: Trees #5 thru 10

Trees #9 and 10 are coast redwoods and considered "heritage trees," #9 for its trunk diameter and height, and #10 only for its height. The proposed drive aisle for the future car wash would excavate into their root zones, and potentially within only a few feet of the trunks when considering overexcavation to form and pour the new drive. If this impact was to occur, the trees would become exposed to premature decline and possible uprooting (due to the loss of numerous buttress roots serving to anchor the trees into the ground).

<p>Comments: Has a contiguous canopy with #10. Prominent buttress root in direction of proposed drive aisle. Base of trunk is two feet from existing trash enclosure wall. Some of the canopy's outer foliage is scorched (appears to be from excessive heat). Also appears to be drought-stressed (due to sparse canopy). Has small girdling roots developing. Trunk appears to span shared property line.</p>									
10	coast redwood (<i>Sequoia sempervirens</i>)	17.2	40	20	50%	70%	Fair	X	\$2,050
<p>Comments: Has a contiguous canopy with #9. Base of trunk is 6.5 feet from trash enclosure wall. Has a sparse canopy likely due to the tree being drought-stressed.</p>

Should **#9 and/or 10** be retained with a reasonable degree of assurance for their survival and stability, I recommend the drive aisle is setback by *at least* **nine feet** from the base of their trunks, and overexcavation beyond the proposed drive aisle edge is reduced to **12 inches**. Any additional distance from the trunks would only decrease the risk of potential impacts.

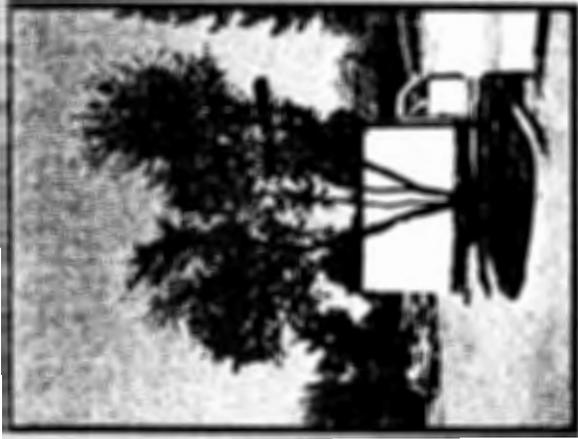
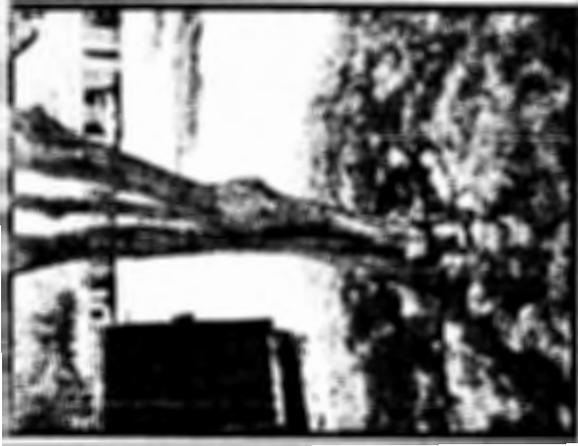
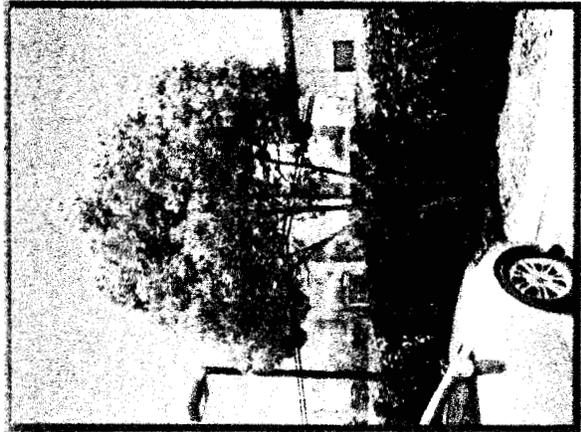
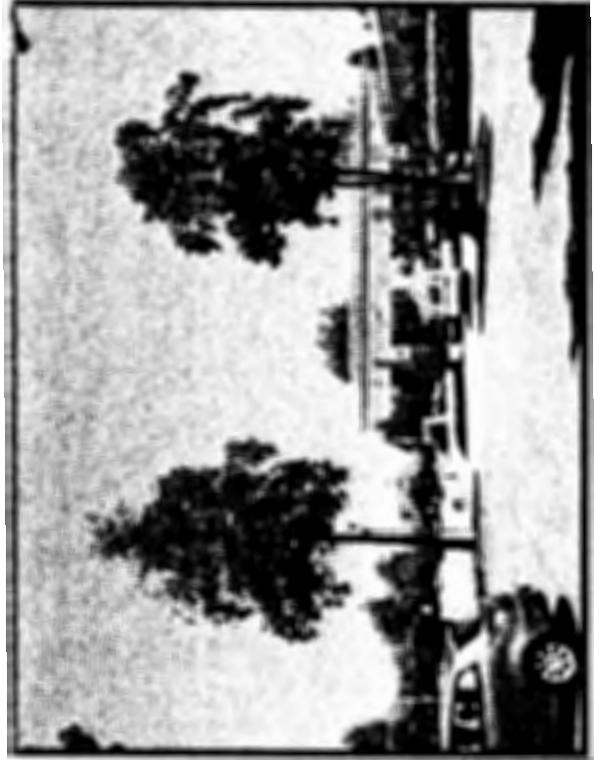
Page C-4: Trees #11 thru 15

Tree #11 is a small, non-heritage tulip tree that has a dying top (nearly half of the tree), and its removal is appropriate regardless of the proposed project.

Comments: Top eight feet is dead, and has numerous dead branches in lower canopy.

Comments: Sparse and one-sided canopy. Large stem wound along lower trunk, and substantial wounds (with decay) along all leaders. Is situated on adjacent property.

Comments: Multi-trunk tree. Umbrella-shaped canopy. Is situated on adjacent property.

Comments: Has deadwood throughout canopy. Small girdling roots developing. Main trunk divides into codominant leaders at nine feet high. Within a narrow planter and canopy has been significantly raised. Is situated on adjacent property.

Comments: Within a narrow planter and has girdling roots. Canopy is sparse and has been significantly raised. Is situated on adjacent property.
