Tree Report **5850 W. Las Positas Blvd.**

Prepared for:
SummerHill Homes
777 S. California Avenue
Palo Alto CA 94304

Prepared by:
HortScience, Inc.
325 Ray Street
Pleasanton, CA 94566

December 12, 2013

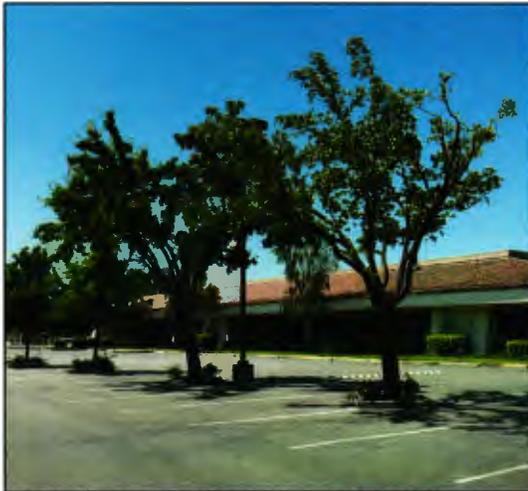
Callery pear (33 trees) was the most frequently encountered species (Photo 1). Trees were semi-mature and mature in development with trunk diameters ranging from 6" to 22" (tree #3). Seven trees met the City's criteria for Heritage status. Condition of pears was generally fair (24 trees) with 9 trees in good condition. Key elements to tree condition were the presence of codominant or multiple stems that arose at one point and thin crowns.

Photo 1 (top). Callery pears #46 & 47 were 13" in diameter and in fair condition.

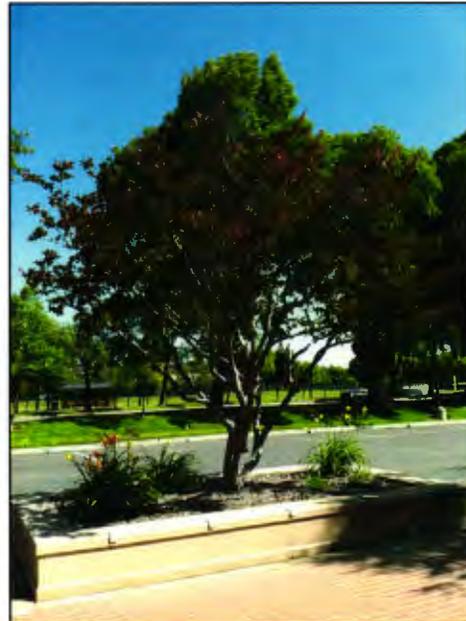
Photo 2 (right). Crape myrtle #68 was growing in an above-ground planter with multiple stems.

Twenty-one (21) crape myrtles were present (Photo 2). Trees were semi-mature and mature in development with trunk diameters that ranged from 4" to 9" (for single-stem trees). Five trees had multiple stems that arose near ground level. Condition of crape myrtles was either good (13 trees) or excellent (8).

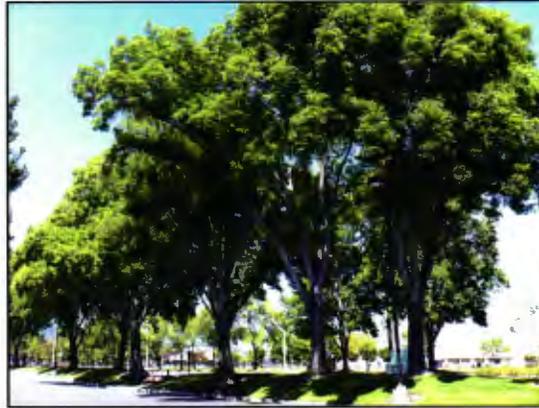
Thirteen (13) evergreen ashes were present along the West Las Positas Blvd. frontage (Photo 3). Trees were generally mature in development with trunk diameters between 18" and 35". All 13 trees were Heritage in size. With a diameter of 35" ash #97 was the largest tree on the site. Ten ashes were in good condition while trees #91 and 99 were fair. Ash #96 was in excellent condition.

Photo 3. Row of ashes along West Las Positas.

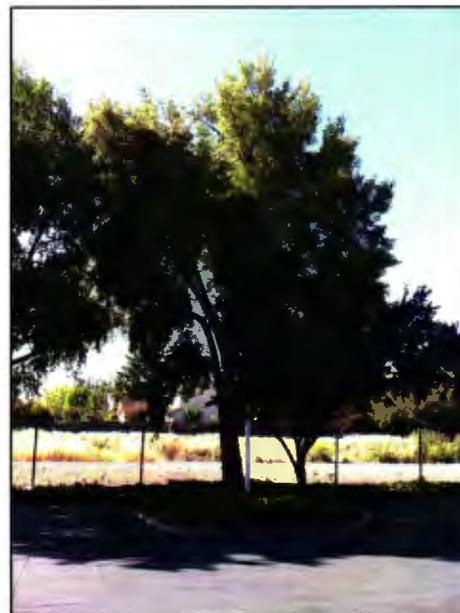
Photo 4. Cork oak #34.

- 6 red ironbarks were located adjacent to the property line on the south. Trees ranged in size from 18" to 30" in diameter and were mature in development. Tree condition was either fair (5 trees) or poor (#17). As has occurred in other areas of the Business Park, adjacent pavement was extensively disrupted and damaged by growth of tree roots. All 6 trees met the criteria for Heritage status.
- 3 African sumac were present. Tree #53 and 85 were fair; #84 was poor.
- Cork oak #34 was located in the southeast corner of the property (Photo 4). It was 19" in diameter, Heritage in size, and in excellent condition.
