ARBORIST REPORT

California Center
Pleasanton, CA

October 2012

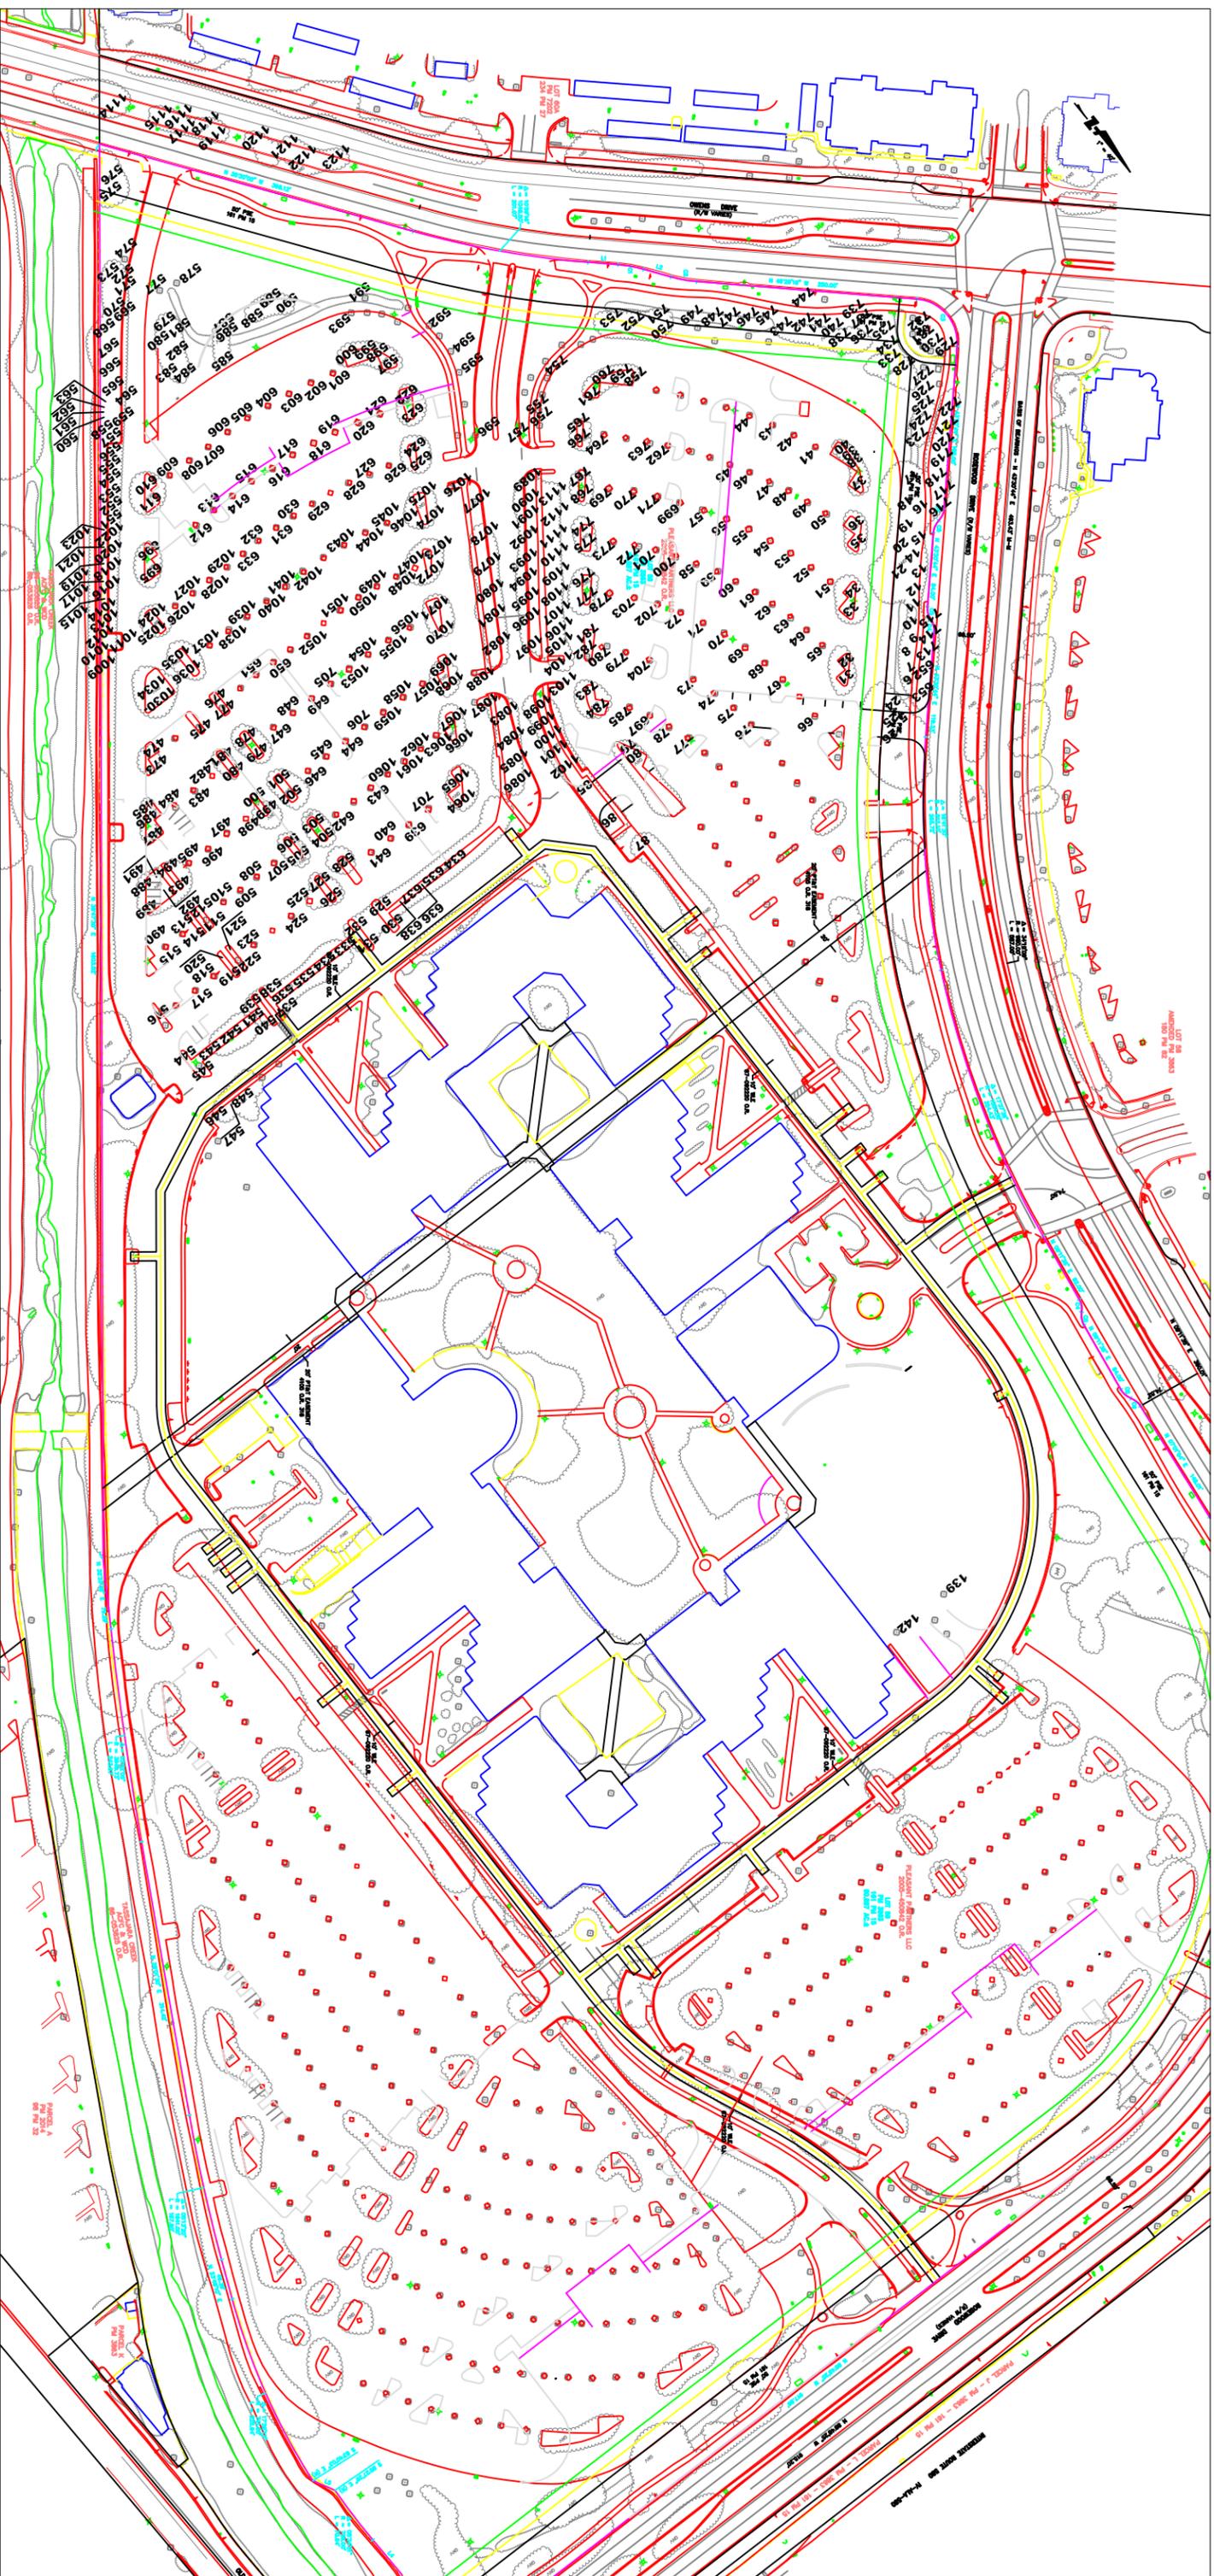
Tree Assessment Map

Four hundred and fifty-seven (457) trees were re-evaluated. This represents only a portion of the total trees previously assessed on the site and therefore, the tag numbers are non-sequential. Descriptions of each tree are found in the **Tree Assessment Form**, locations are shown on the **Tree Assessment Map** (see Attachments), and a summary is provided in Table 1 (following page).
