Reddy Residence
3737 W. Ruby Hill Drive
Lot O-02

Side-by-side Comparison of
Approved Plans and As-built
Condition

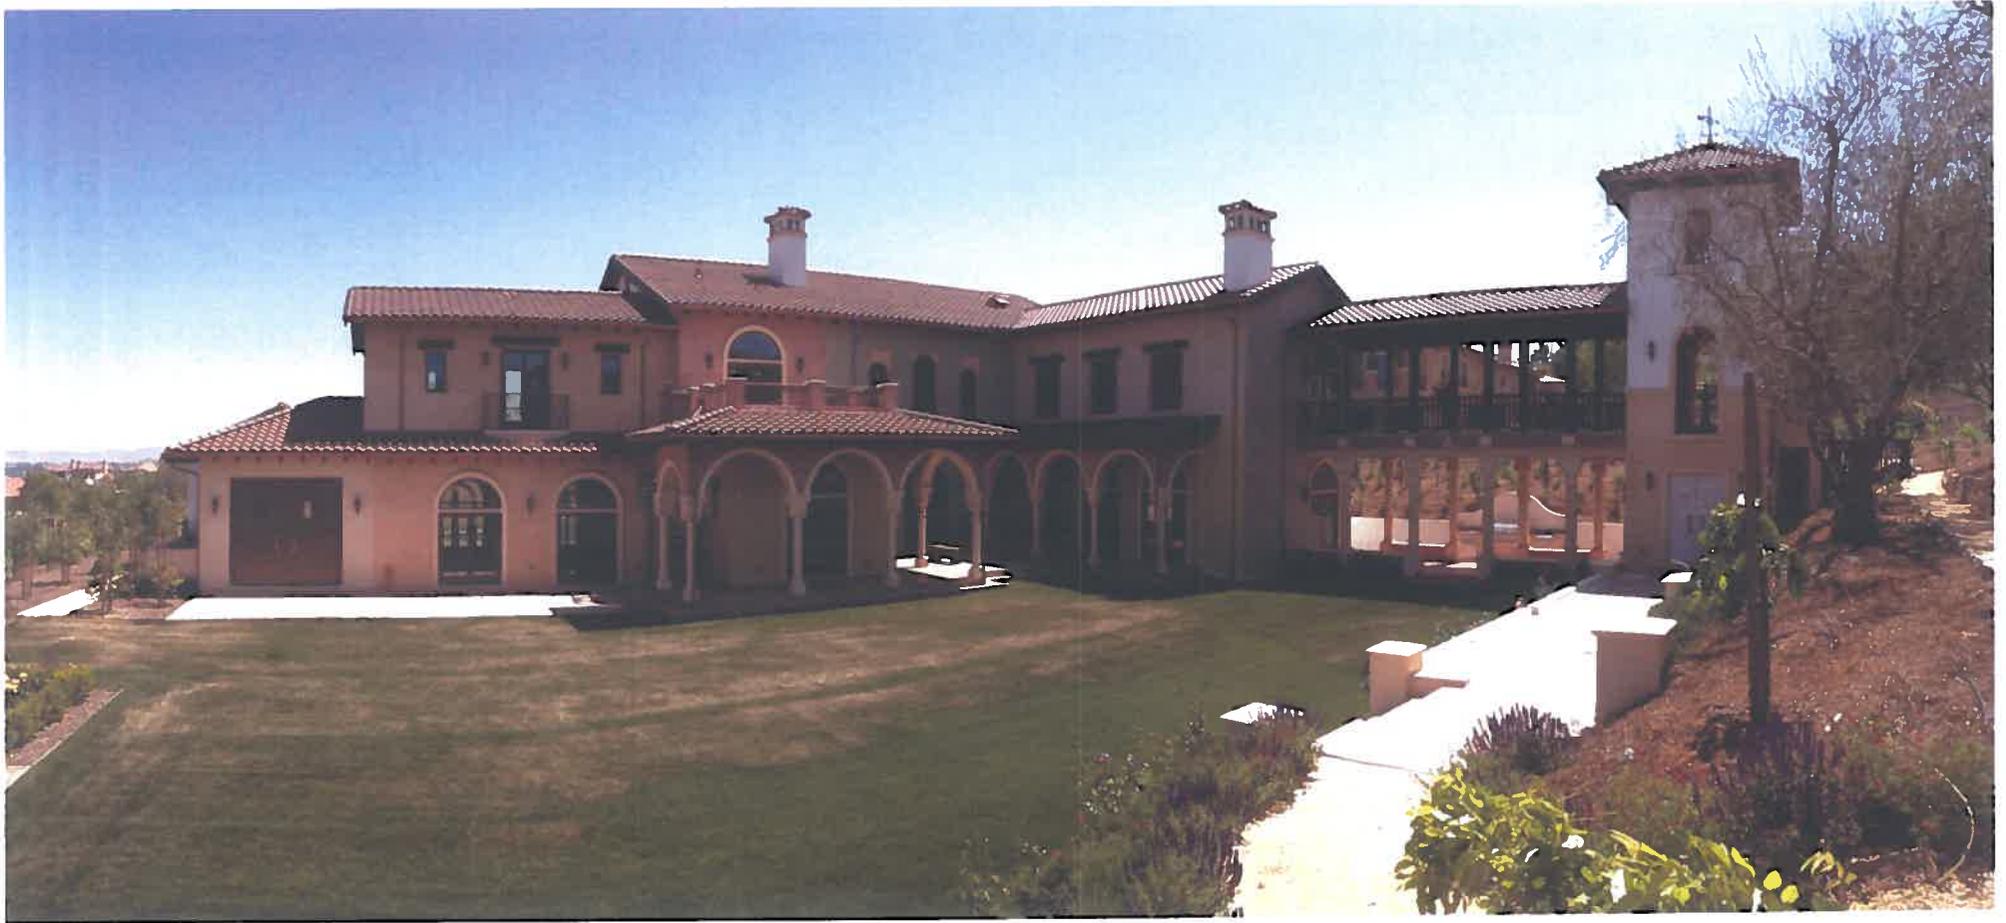
EXTERIOR COLORS – REAR ELEVATION

Colors and materials never submitted for approval. Stark white, bright pastels or bright intense colors in large expanses are not allowed. The ADG prohibits harsh contrasts of color and/or materials; illogical or inappropriate combinations of scale

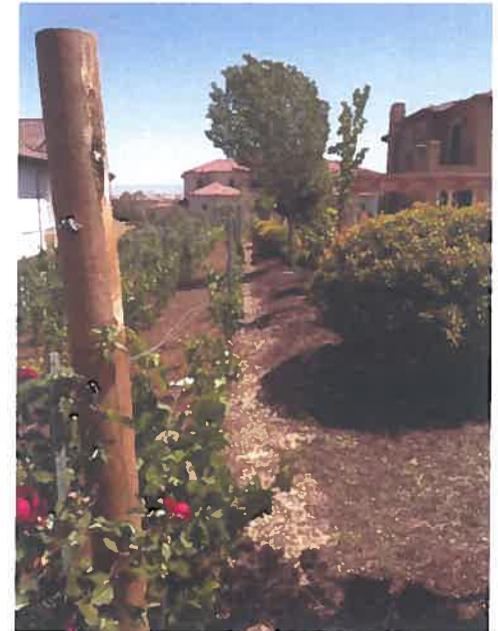
Grading performed by Reddy at south end of property. Current condition created a negative drainage situation which causes water from south property to shed onto Reddy property

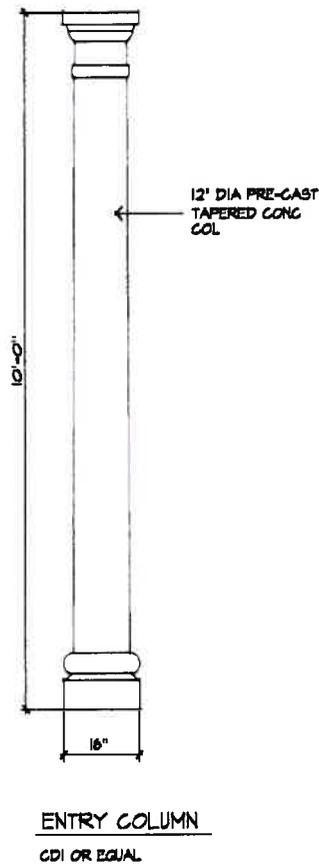
Reference: Sheet 7 – Entry Column

Column elevation depicted on final approved drawings (6.30.10). Simple Tuscan capital

As-built condition. Design is inconsistent with the Spanish Eclectic architectural style.

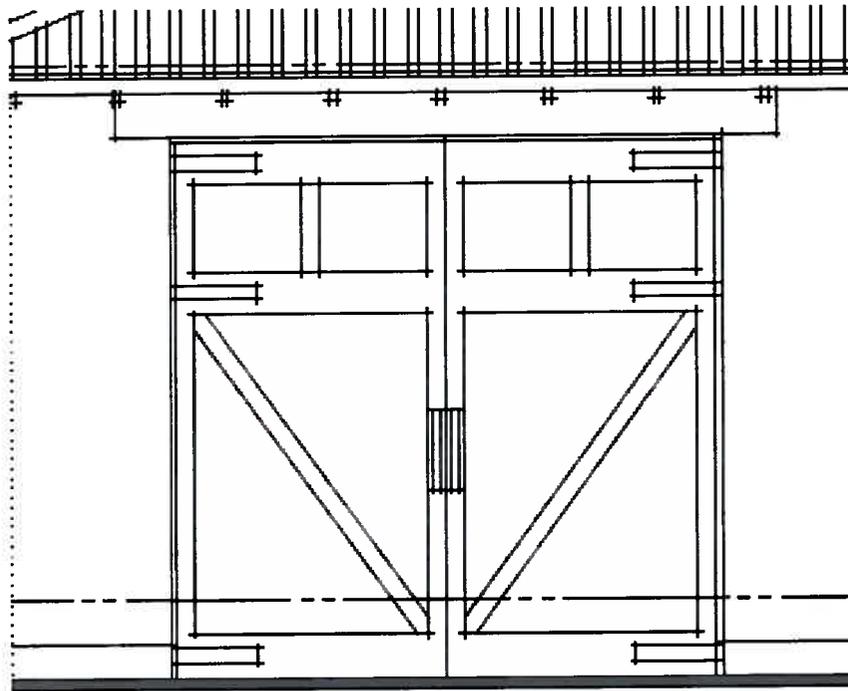
Reference: Sheet 5 –Rear Elevation

Rear garage door depicted on final approved drawings (6.30.10). Matches wood garage doors at front.

- Iron doors with gold accent and opening with iron bars
- Iron work and gold accenting is too industrial and would not be approved if submitted.
- Does not match Spanish Eclectic architectural style

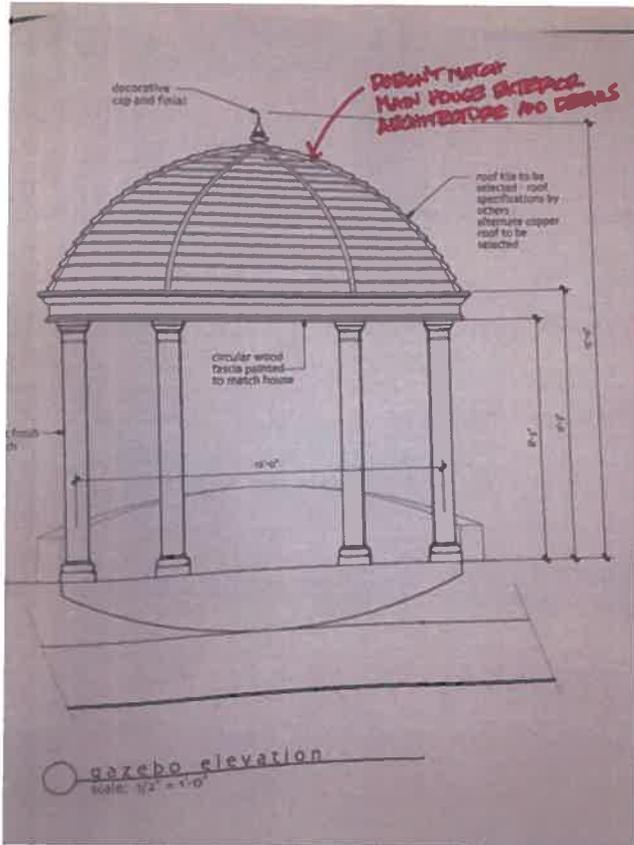
Original gazebo design submitted (8.20.10) – NOT APPROVED

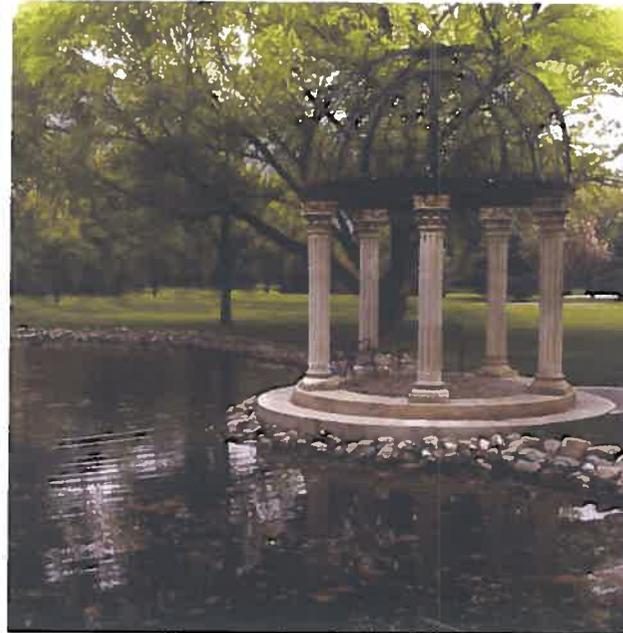
Photo of proposed gazebo submitted to the ADC by Reddy on 4.12.11

- Owner proceeding with construction of gazebo without approval from the ADC or required permits from the City of Pleasanton.
- Original comments from ADC specified that gazebo columns must match final approved columns of the house.
- The iron work submitted in the proposed illustration (4.12.11) was not approved and will not be approved – it is too ornate and is inconsistent with the architectural style of the home.
- The height of the proposed dome exceeds the maximum height limit for a shade structure and accessory structure.
