**Pre-Demolition  
Asbestos and Lead Inspection Report**

**Pre-Demolition  
Asbestos and Lead Paint Inspection Report**

**KELLCO Job #:** 1201-03

**Location:** 1623 Cindy Way  
Pleasanton, CA 94566

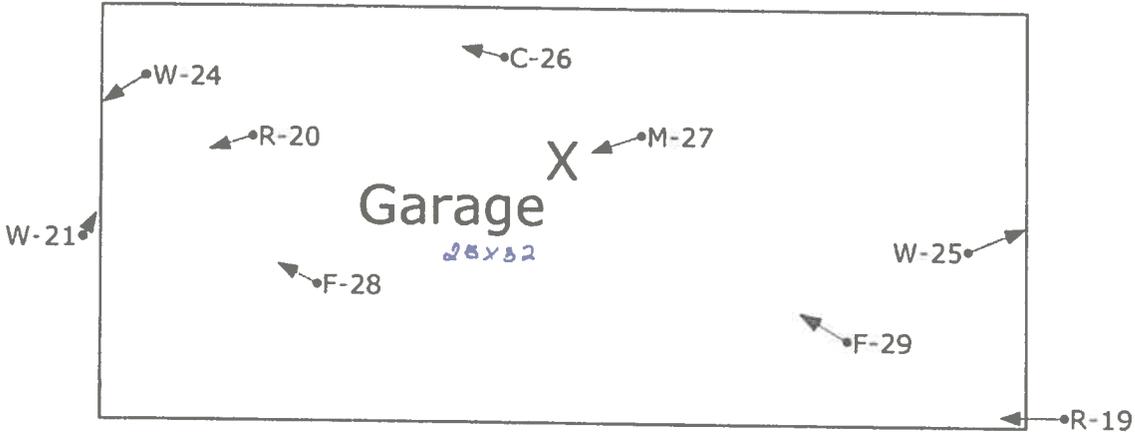
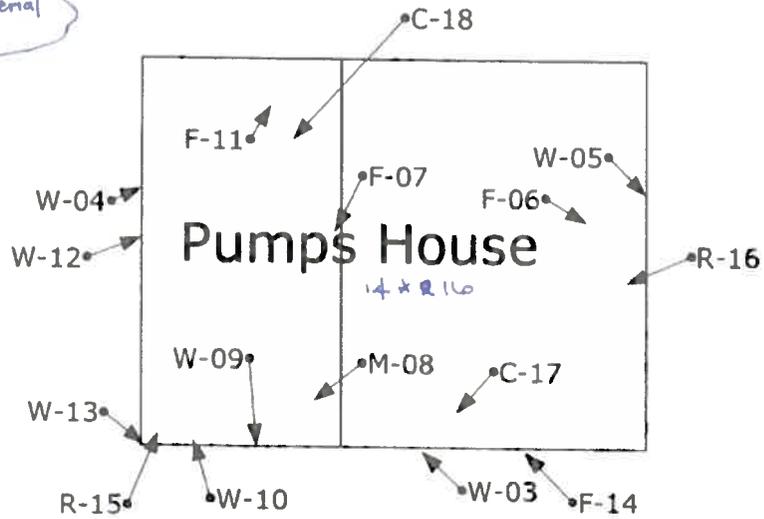
NORTH

North

X-Attic Space

Photographs of sampled materials are included. Sample locations are noted on the attached not-to-scale drawing.
