July 2, 2012
Job No. 1806.101A

**BERLOGAR
STEVENS &
ASSOCIATES**

Subject: Geotechnical Investigation
Tract 7399 - Parcels 1 and 2
Silver Oaks Court
Pleasanton, California

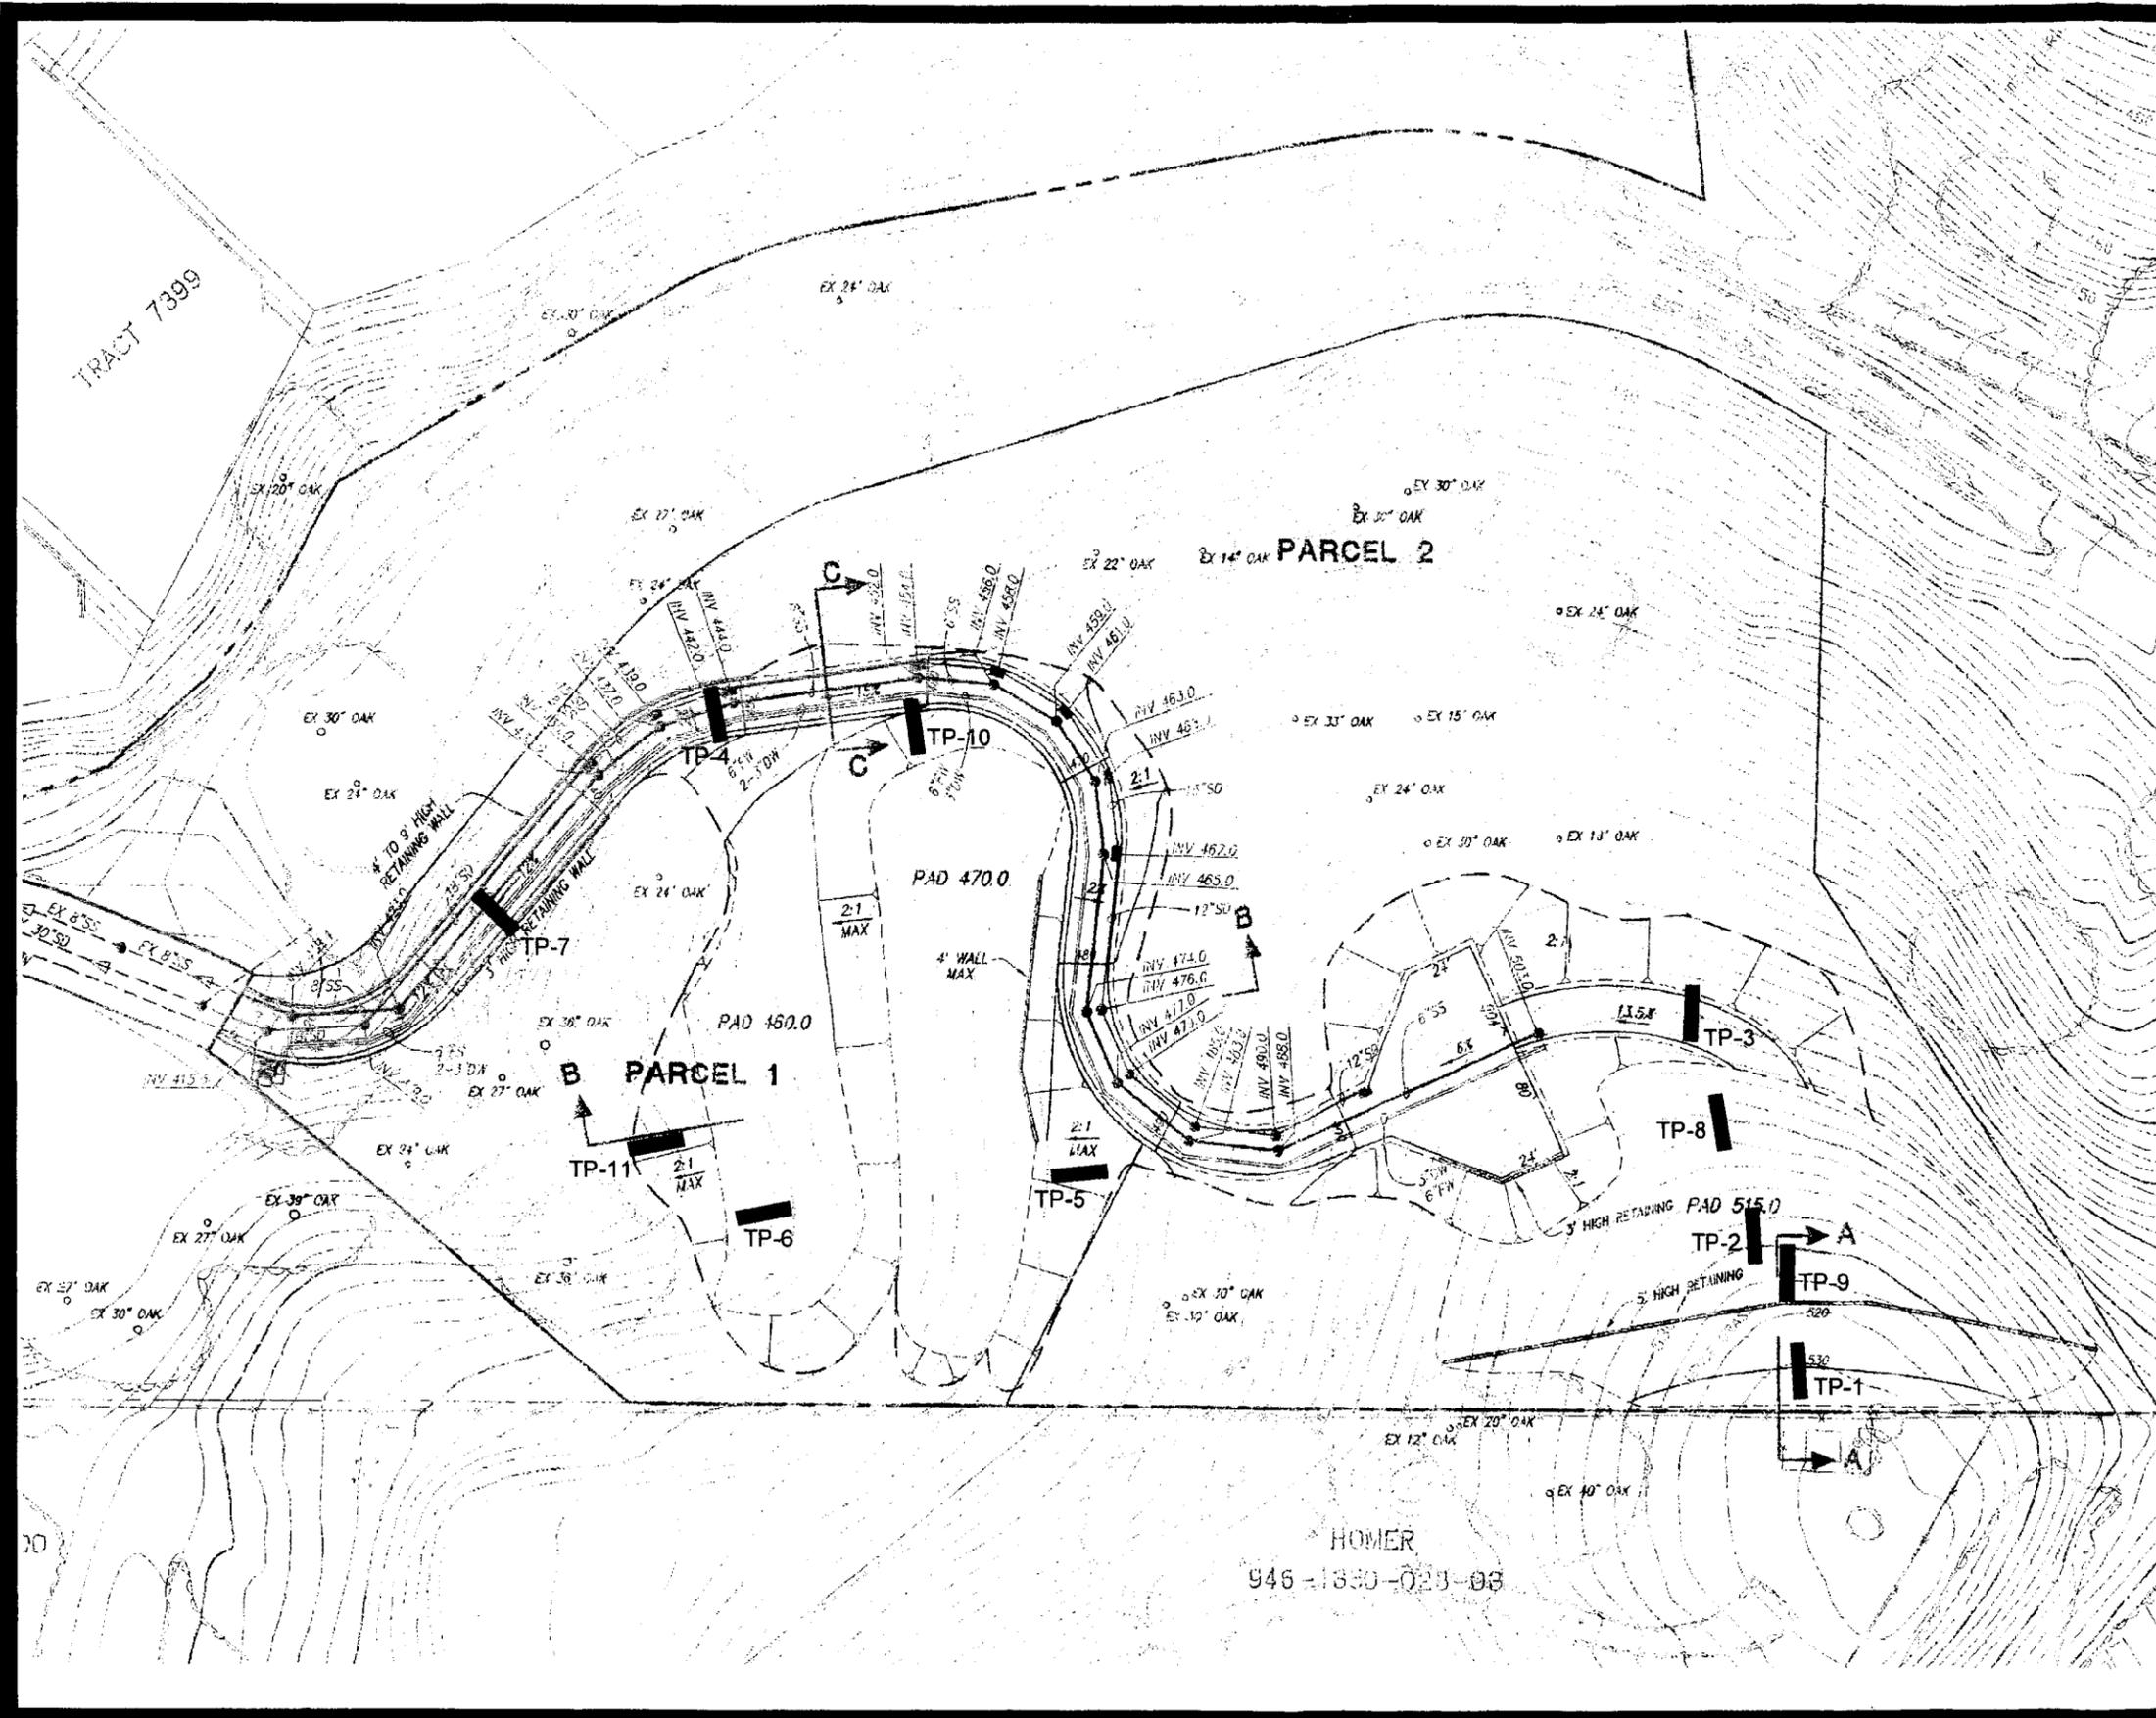
SITE PLAN
TRACT 7399
PARCELS 1 AND 2
SILVER OAKS COURT
PLEASANTON, CALIFORNIA
FOR
BERLOGAR VINEYARDS INC.

EXPLANATION
TP-11
TEST PIT LOCATION

The locations of the test pits were estimated by pacing from existing features and should be considered approximate only. The test pits show subsurface conditions encountered at the locations and dates indicated; it is not warranted that they are representative of such conditions at other locations or times.
