Appendix E: Geology and Soils Geotechnical Supporting Information

E.1 - Updated Preliminary Geotechnical and Geologic Report

TYPE OF SERVICES	Updated Preliminary Geotechnical & Geologic Report
PROJECT NAME	Lester-Shriner Property Residential Development
LOCATION	Dublin Canyon Road Pleasanton, California
CLIENT	Ponderosa Homes
PROJECT NUMBER	132-8-2
DATE	March 31, 2020

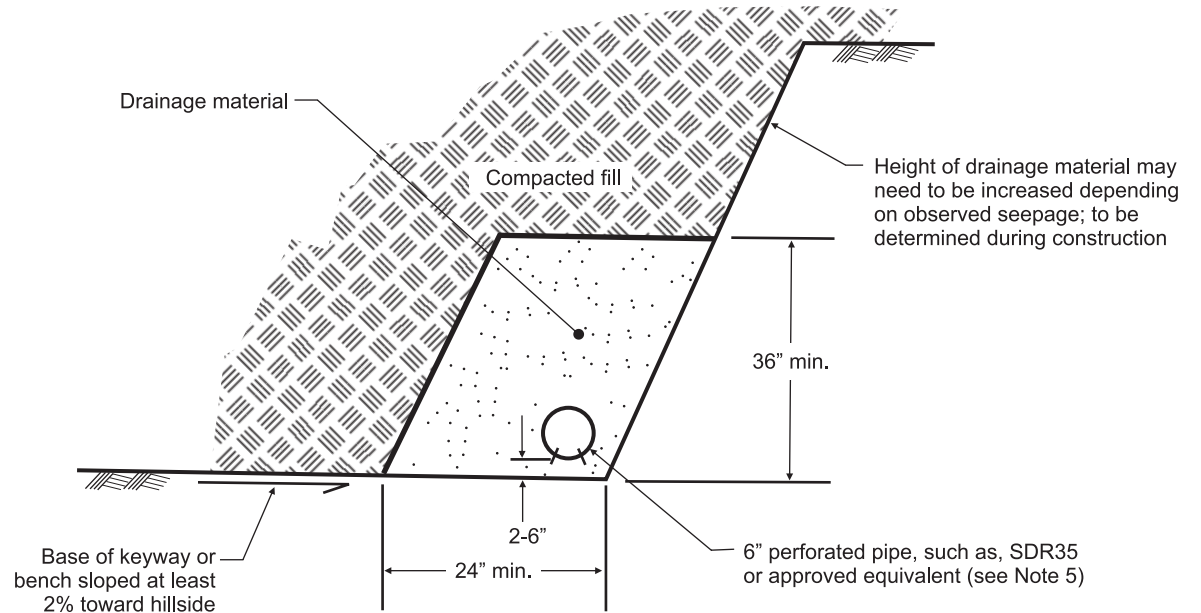
Typical Keyway and Bench Subdrain Detail

- 1% fall (minimum) along all keyways, benches and subdrain lines.
- All perforated pipe placed perforations down.
- All pipe joints shall be glued.
- All subdrains should be discharged to a free draining outlet approved by the Civil Engineer.
- Subdrain pipe (perforated or solid connector) should consist of SDR-35 PVC pipe when placed in fills less than 30 feet deep. SDR-23.5 PVC pipe should be used when fill is greater than 30 feet deep.

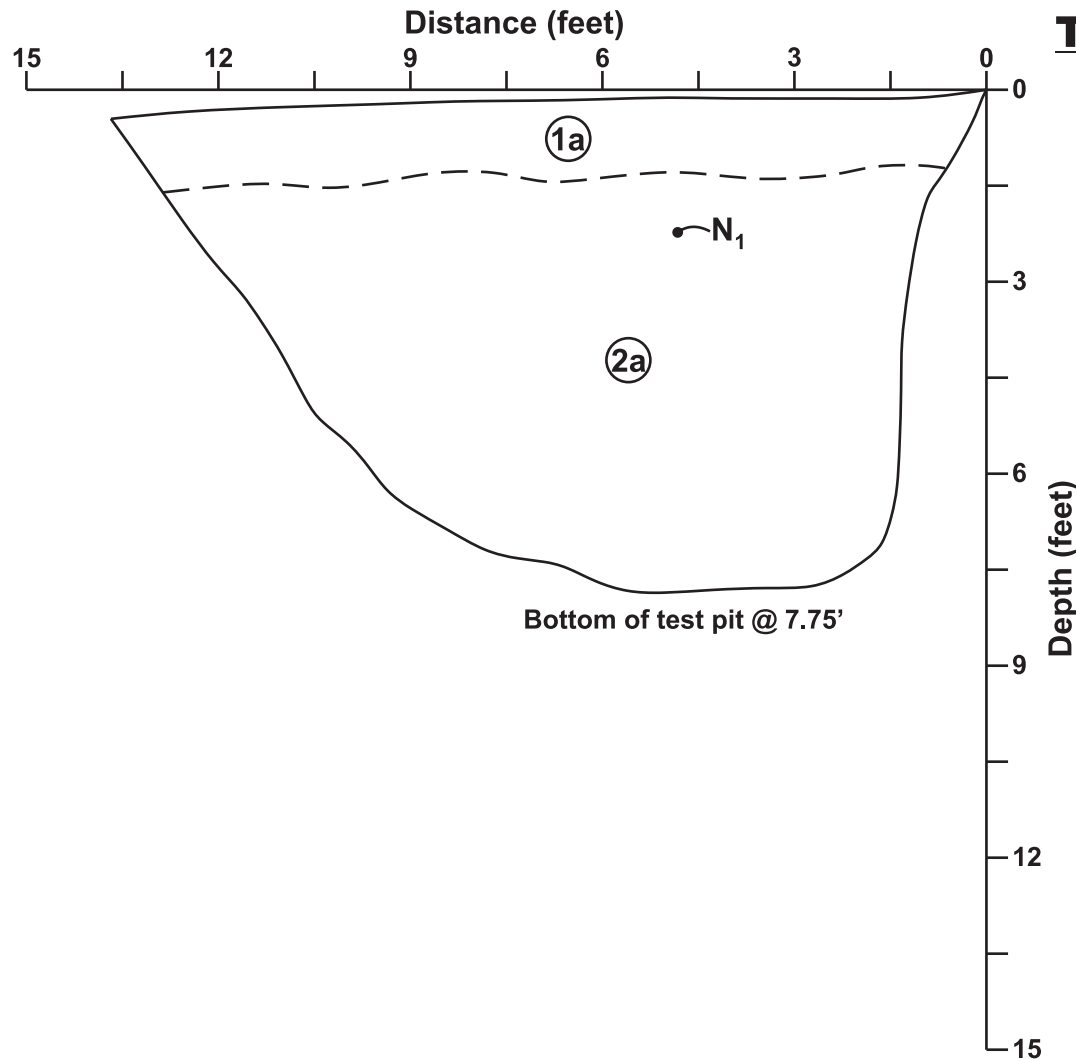
TP-3

- ①a Silty Clay with Sand: Very dark gray-brown, damp, very stiff, [Colluvium]
- ②a Fine Sandy Siltstone: Medium yellow-brown, damp, fractured, thin bedded

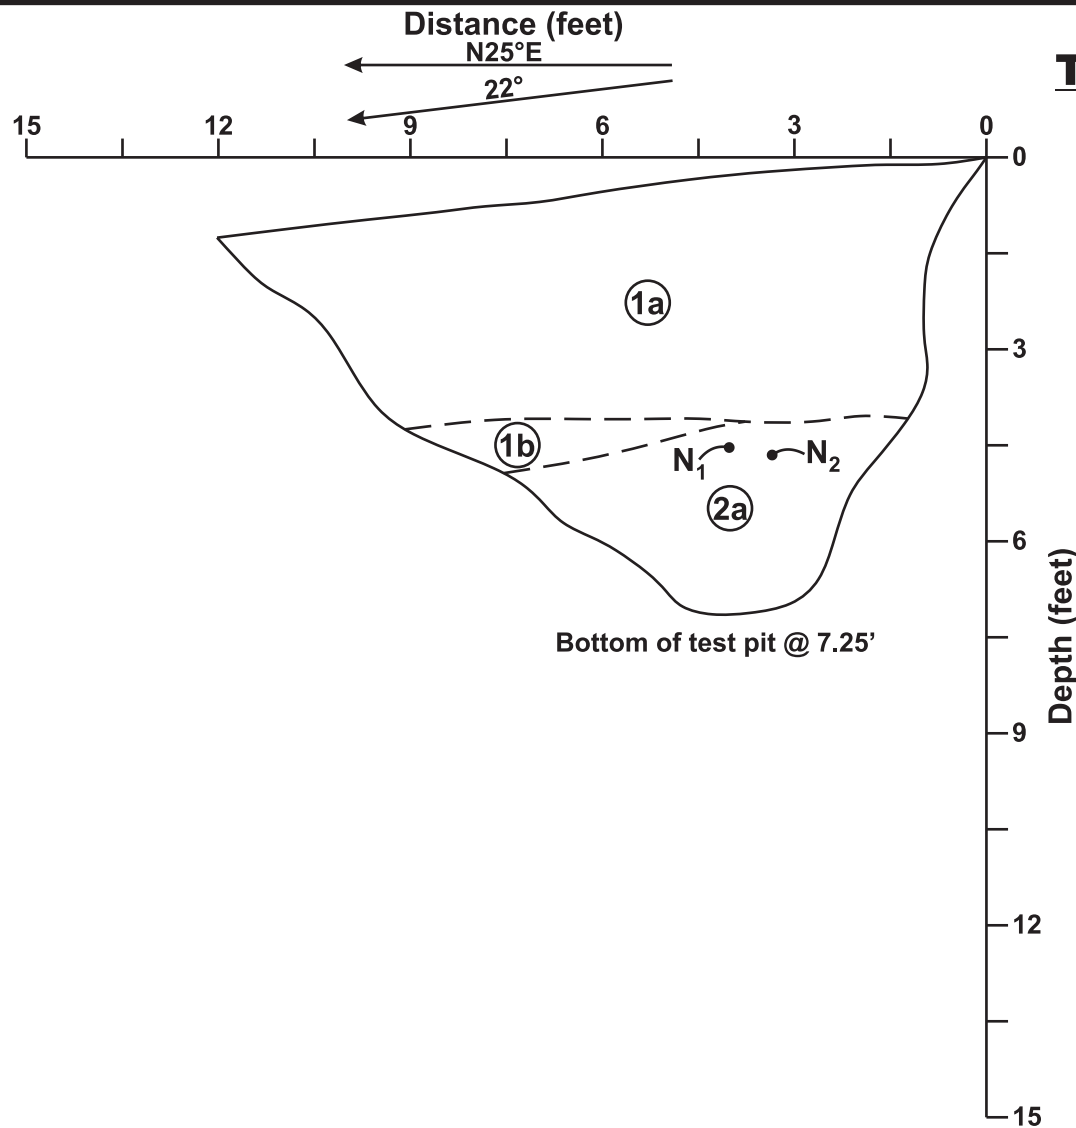
TP-4

- ①a Gravelly Clay: Varigated dark brown and yellow-brown, damp, loose, [fill]
- ①b Sandy Clay: Very dark gray-brown, damp, firm, [residual soil]
- ②a Silty fine Sandstone: Olive, damp, weak but locally strong, thin bedded

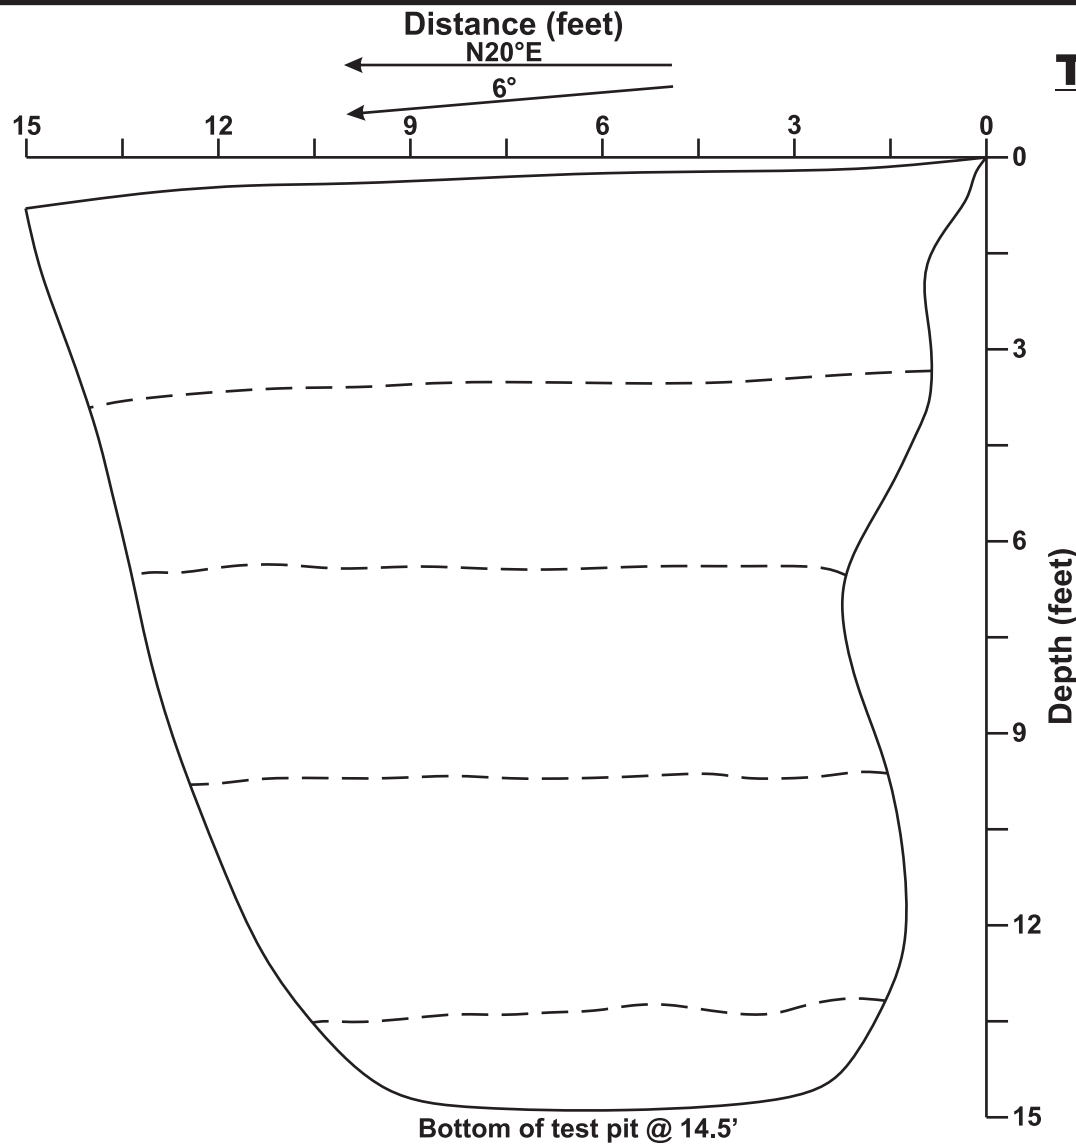
TP-5

- ①a Silty Clay: Very dark gray-brown, damp, very stiff, [residual soil]
- ①b Lean Clay: Medium brown, damp, very stiff, [residual soil]
- ①c Sandy Lean Clay: Olive brown, damp, very stiff, [old alluvium]
- ①d Sandy Clay with Gravel: olive brown, damp, very stiff, gravel is angular, shear
- ②a Siltstone: Olive brown, damp, weak, pervasively fractured, thin bedded

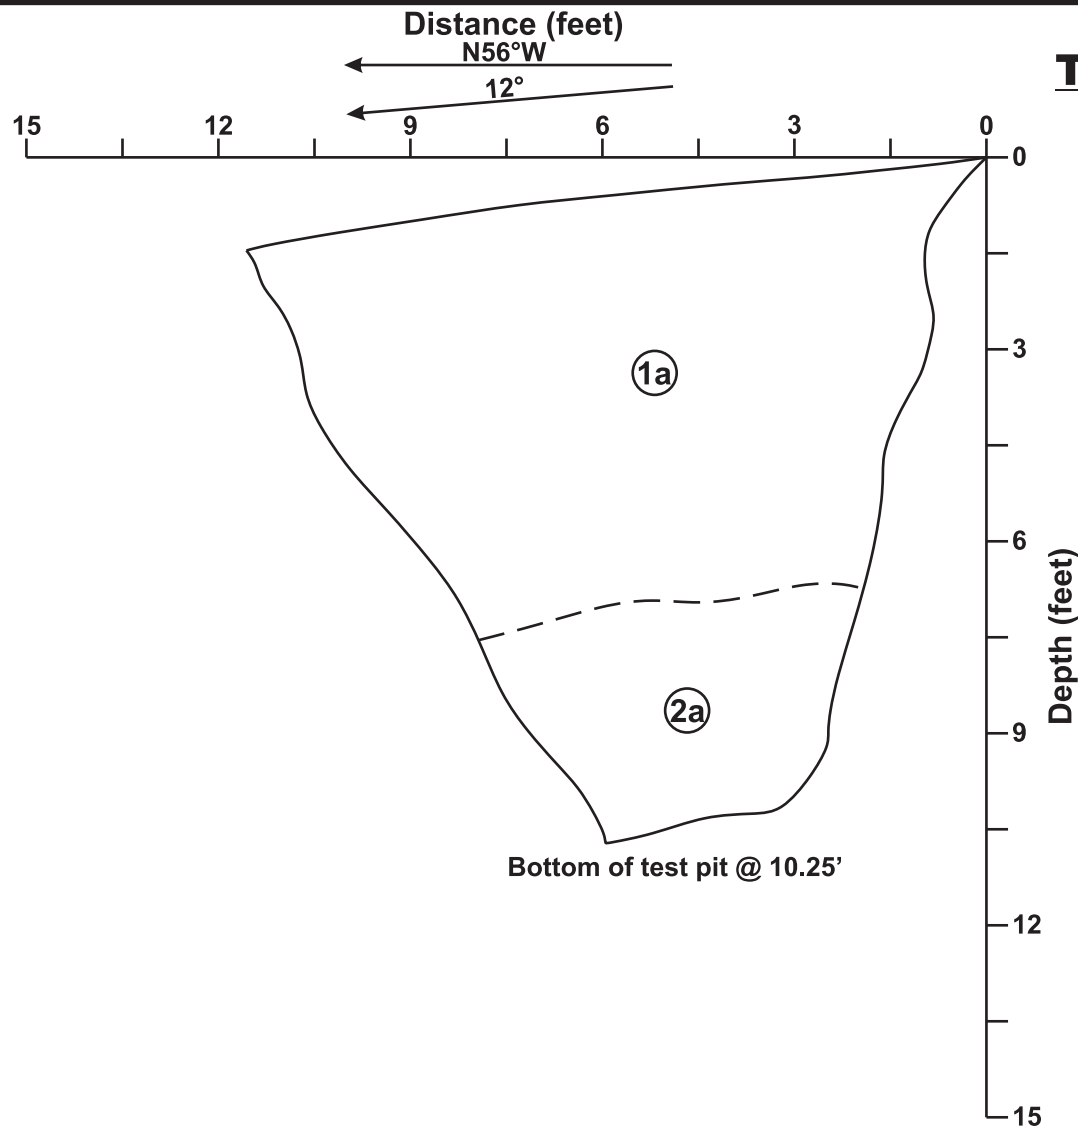
TP-6

- ①a Sandy Silty Clay: Dark gray-brown, damp, very stiff
- ②a Silty fine Sandstone: Light yellow-brown, damp, fractured

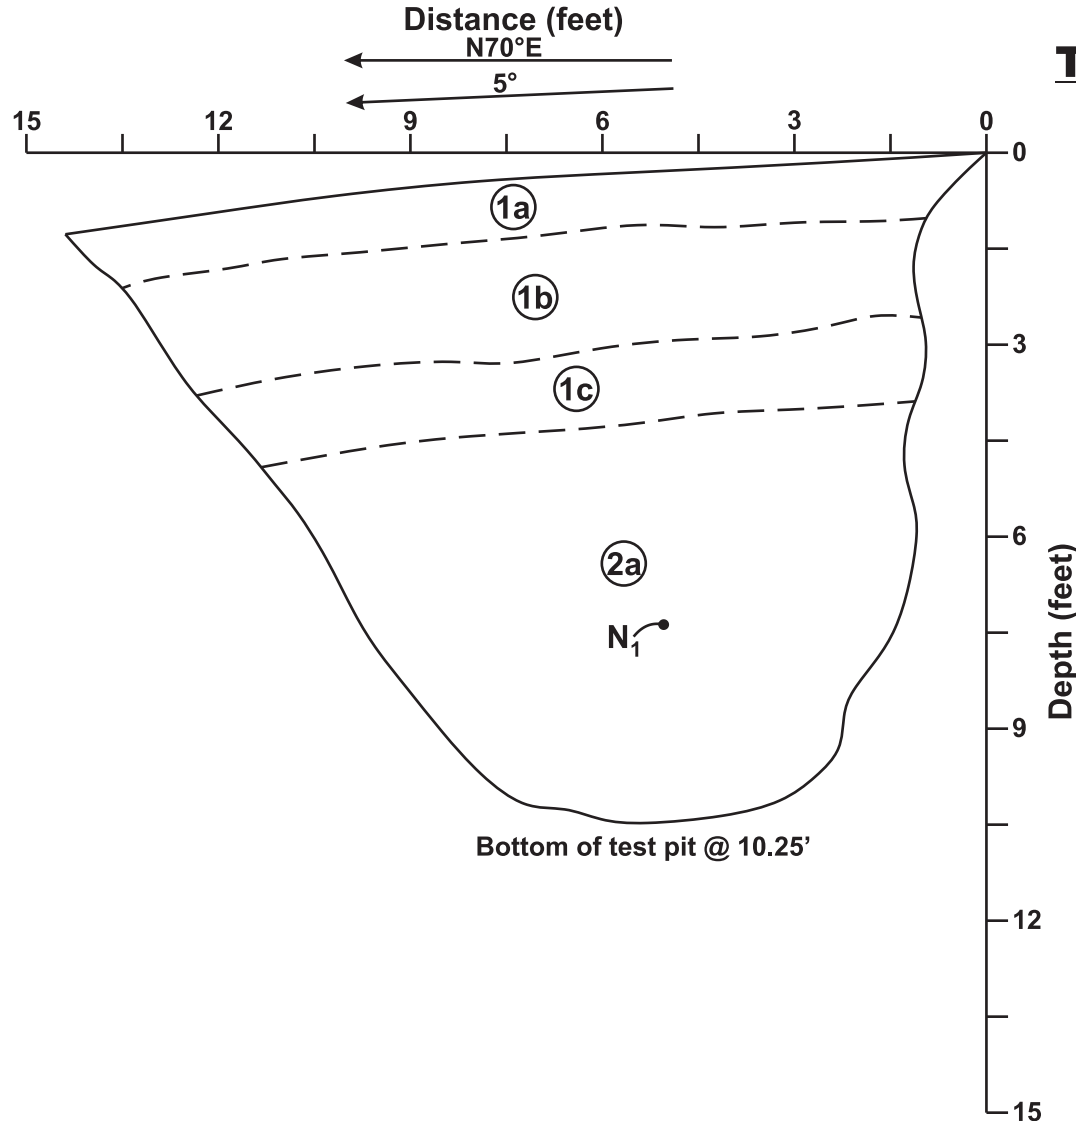
TP-7

- ①a Sandy Silt with Clay: Dark brown, damp, stiff, [residual soil]
- ①b Silty Gravel: Light yellow-brown, damp, medium dense
- ①c Lean Clay: Dark gray, damp, very stiff
- ②a Claystone: Olive gray, damp, very weak, thin bedded

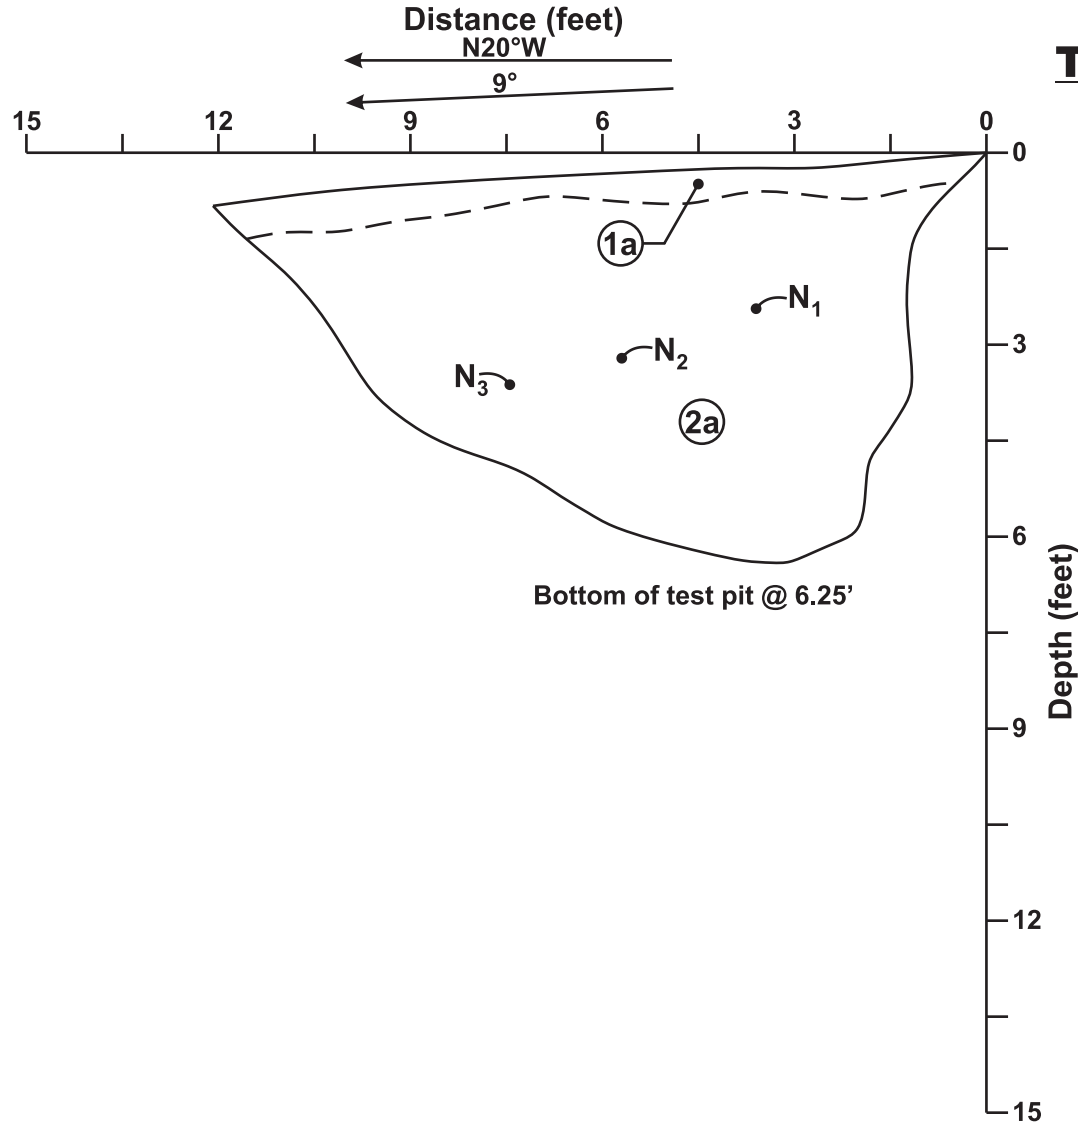
TP-8

- (1a) Silty fine Sand: Medium yellow-brown, damp, [residual soil]
- (2a) Sandstone: Light yellow-brown, damp, weak, thin bedded

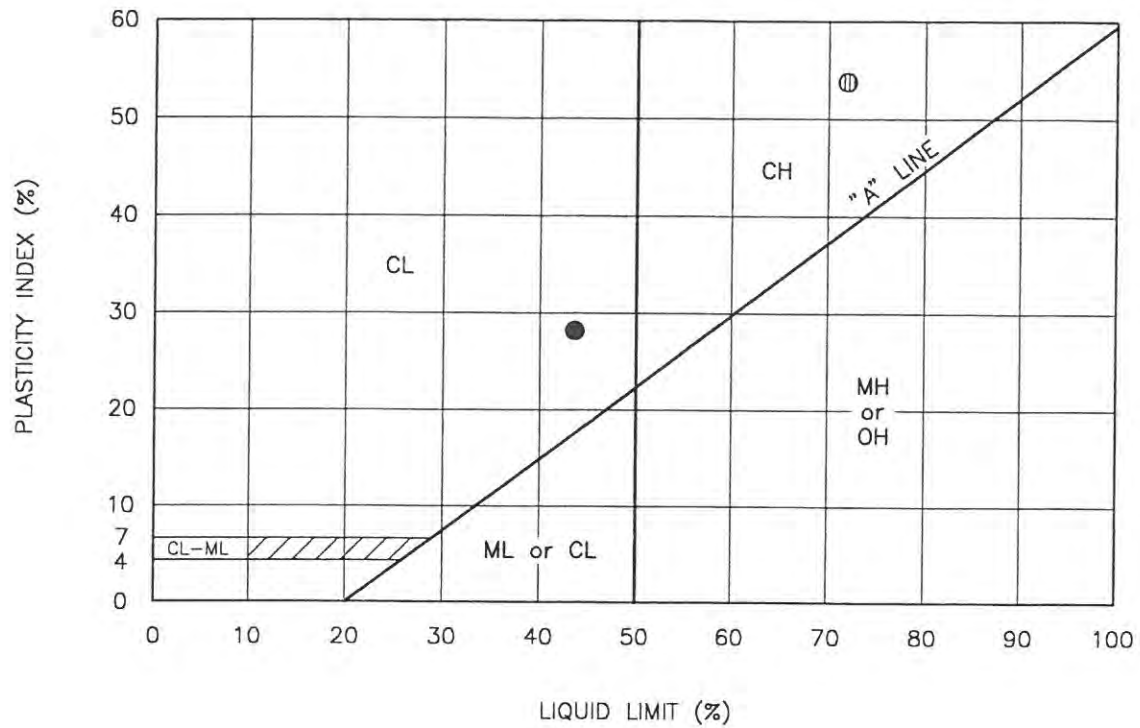
KEY SYMBOL	BORING NO.	SAMPLE DEPTH (feet)	NATURAL WATER CONTENT (%)	LIQUID LIMIT (%)	PLASTICITY INDEX (%)	PASSING #200 SIEVE (%)	LIQUIDITY INDEX	UNIFIED SOIL CLASSIFICATION SYMBOL
●	TP-8/1	3.0	11	44	28	--	-0.2	CL
⊙	TP-16/1	3.0	22	72	53	--	0.1	CH

Plasticity Index: Plasticity Index determinations (ASTM D-4318) were performed on two samples of the subsurface soils to measure the range of water contents over which these materials exhibit plasticity. The Atterberg Limits were used to classify the soil in accordance with the Unified Soil Classification System and to evaluate the soil expansion potential. Results of these tests are presented on Figure B-1.
